## Sabin Dam Removal & River Restoration Photo Report – December 2018

*(Unless noted otherwise, all report content was provided and prepared courtesy of Conservation Resource Alliance)*

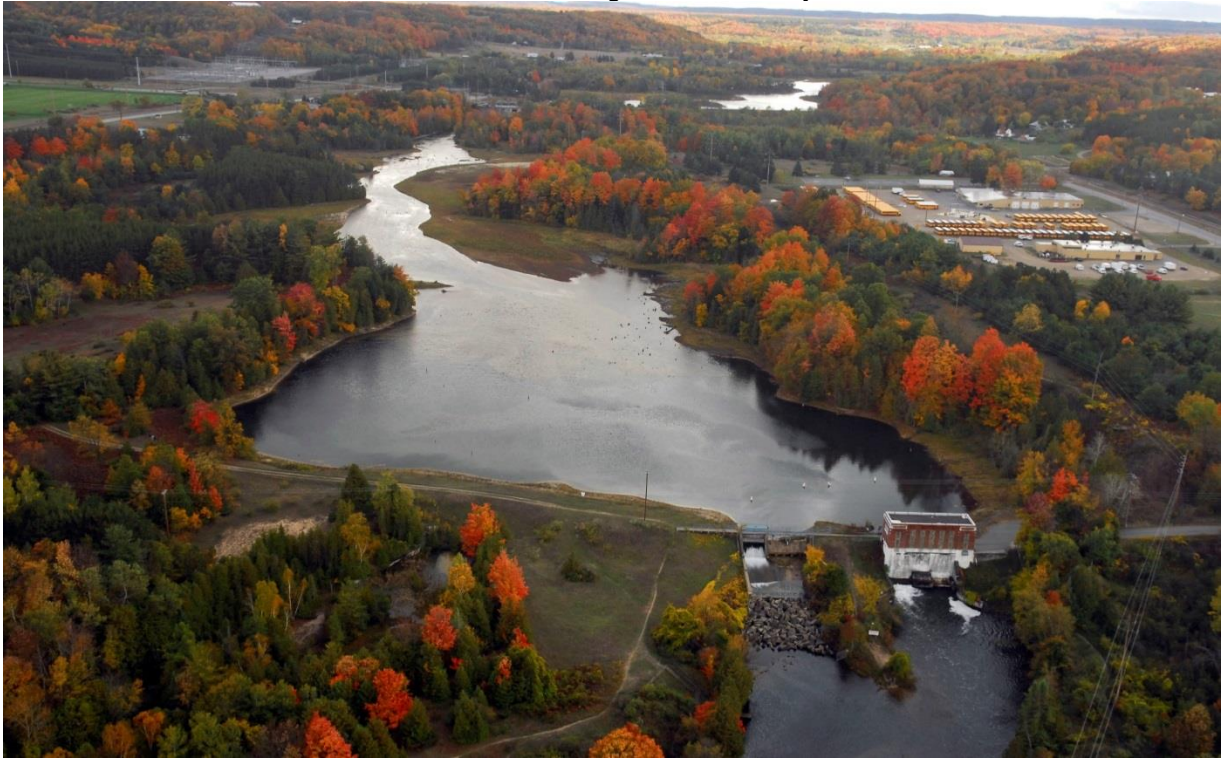
Aerial view from 2013 of Sabin Dam & Sabin Pond, looking upstream or south.  
Boardman Pond is in the background. Photo by John Russel

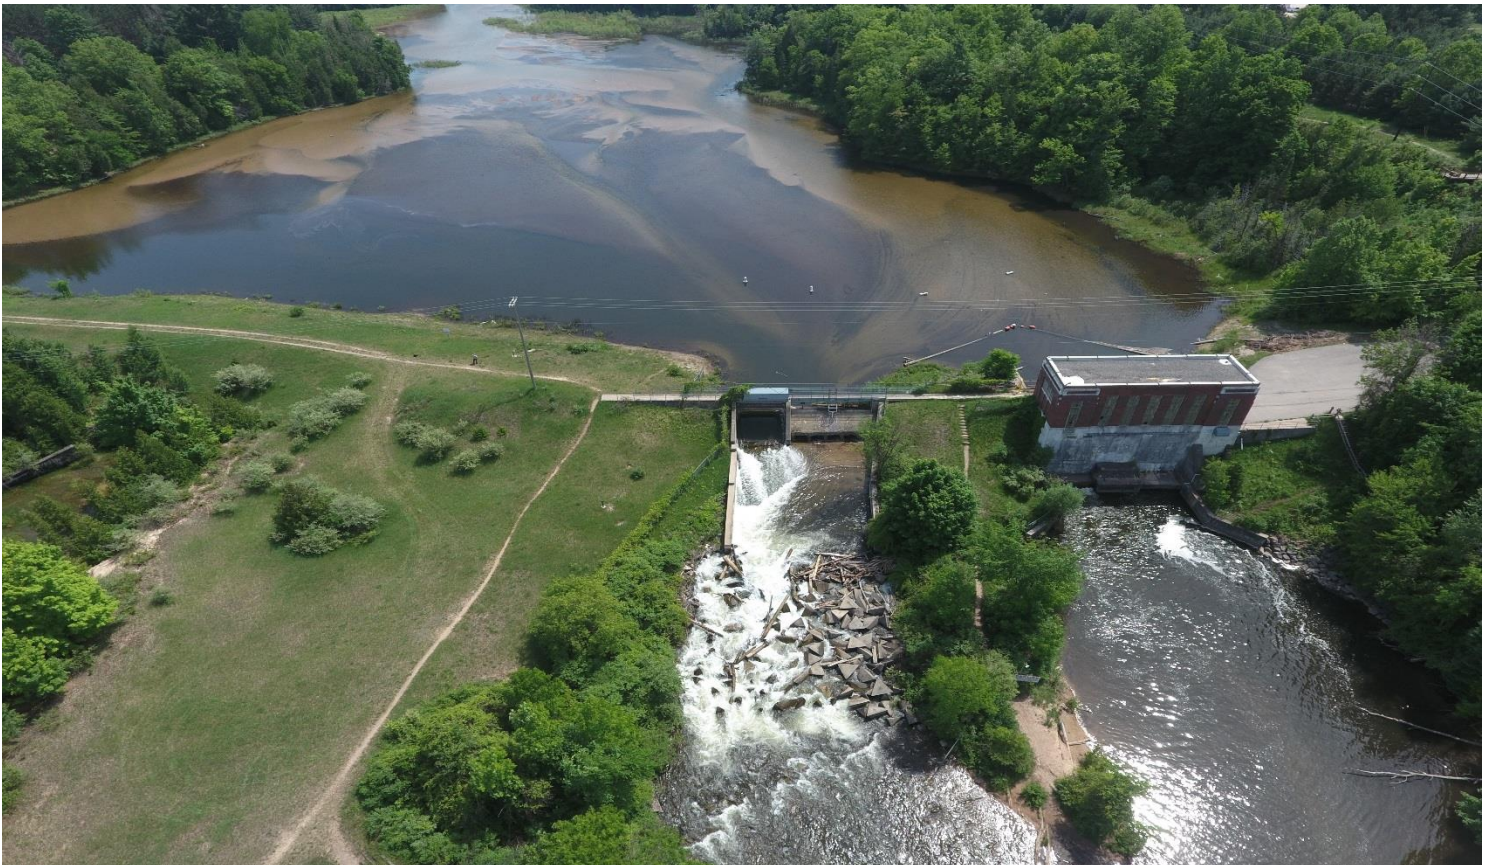
Aerial of Sabin Dam June 7, 2018. Photo by GTB Natural Resources.

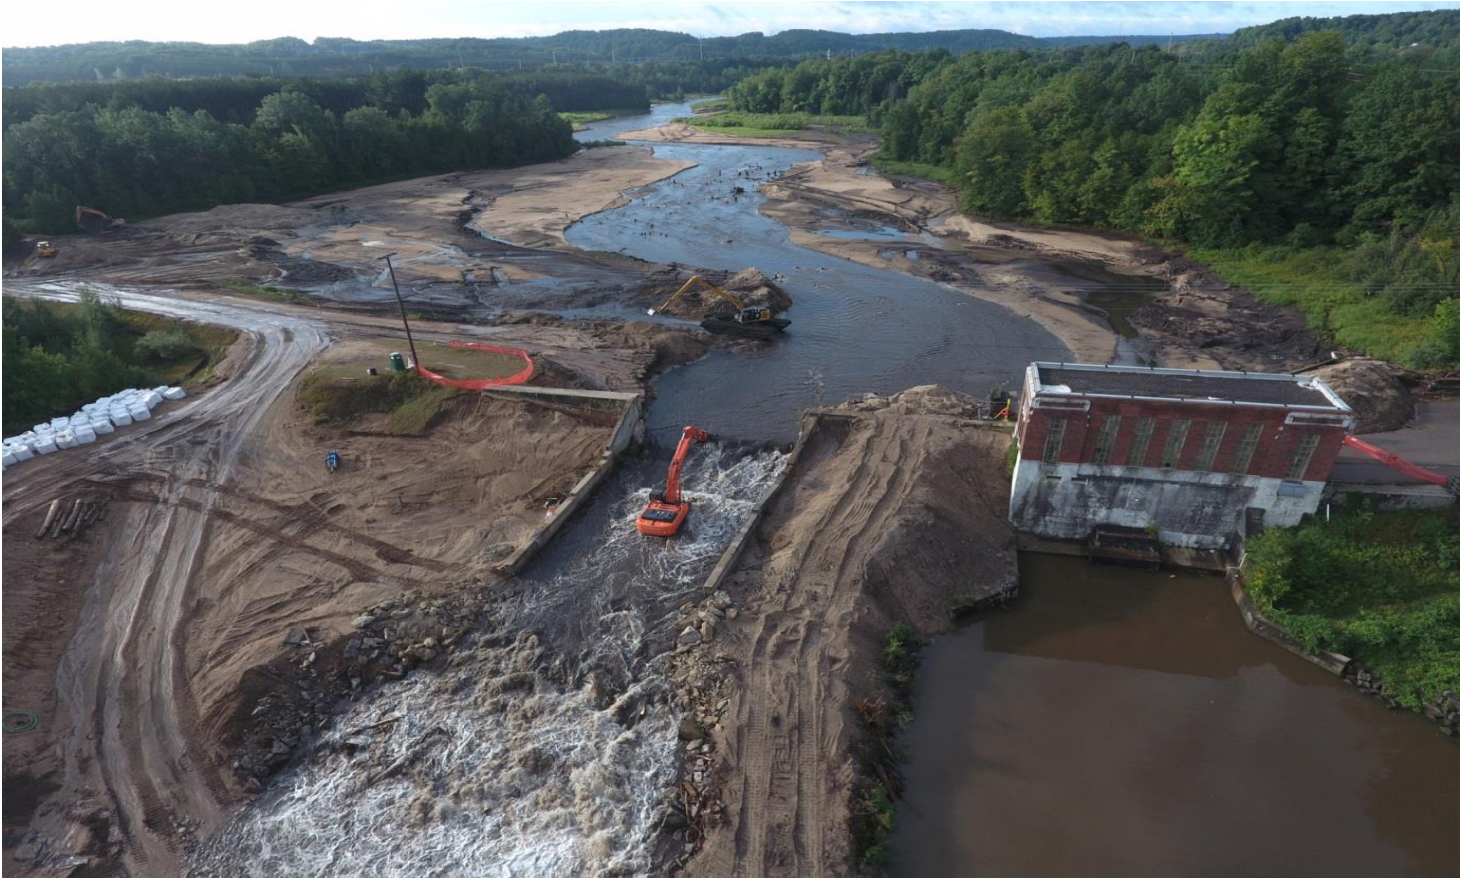
Aerial view of Sabin Dam & Pond drawn down 7' on August 28, 2018. Photo by GTB Natural Resources.

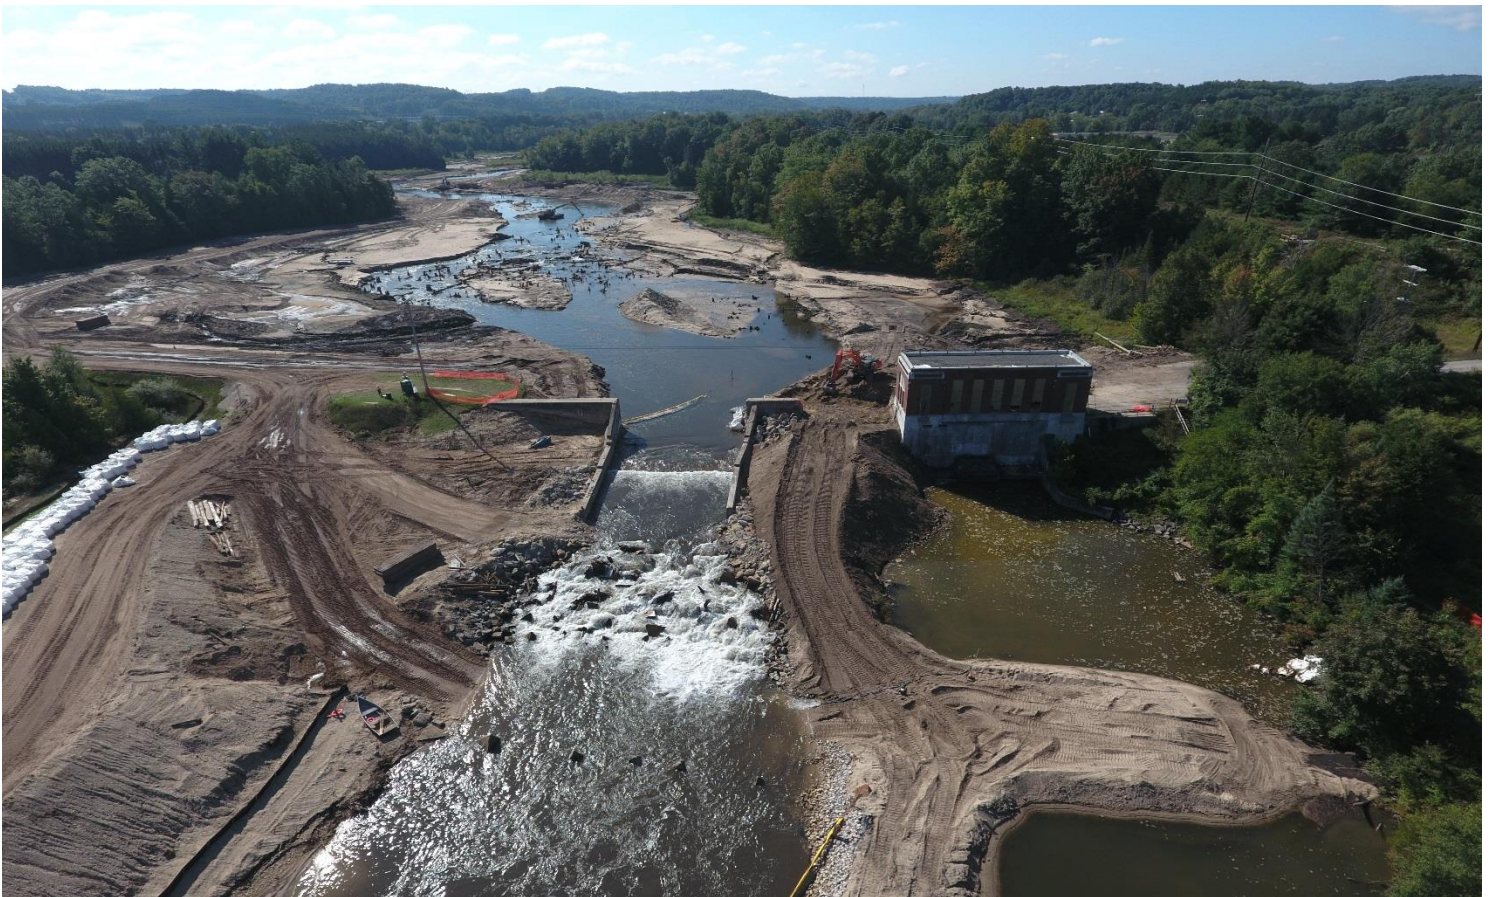
Aerial of Sabin Dam September 14, 2018. Photo by GTB Natural Resources.

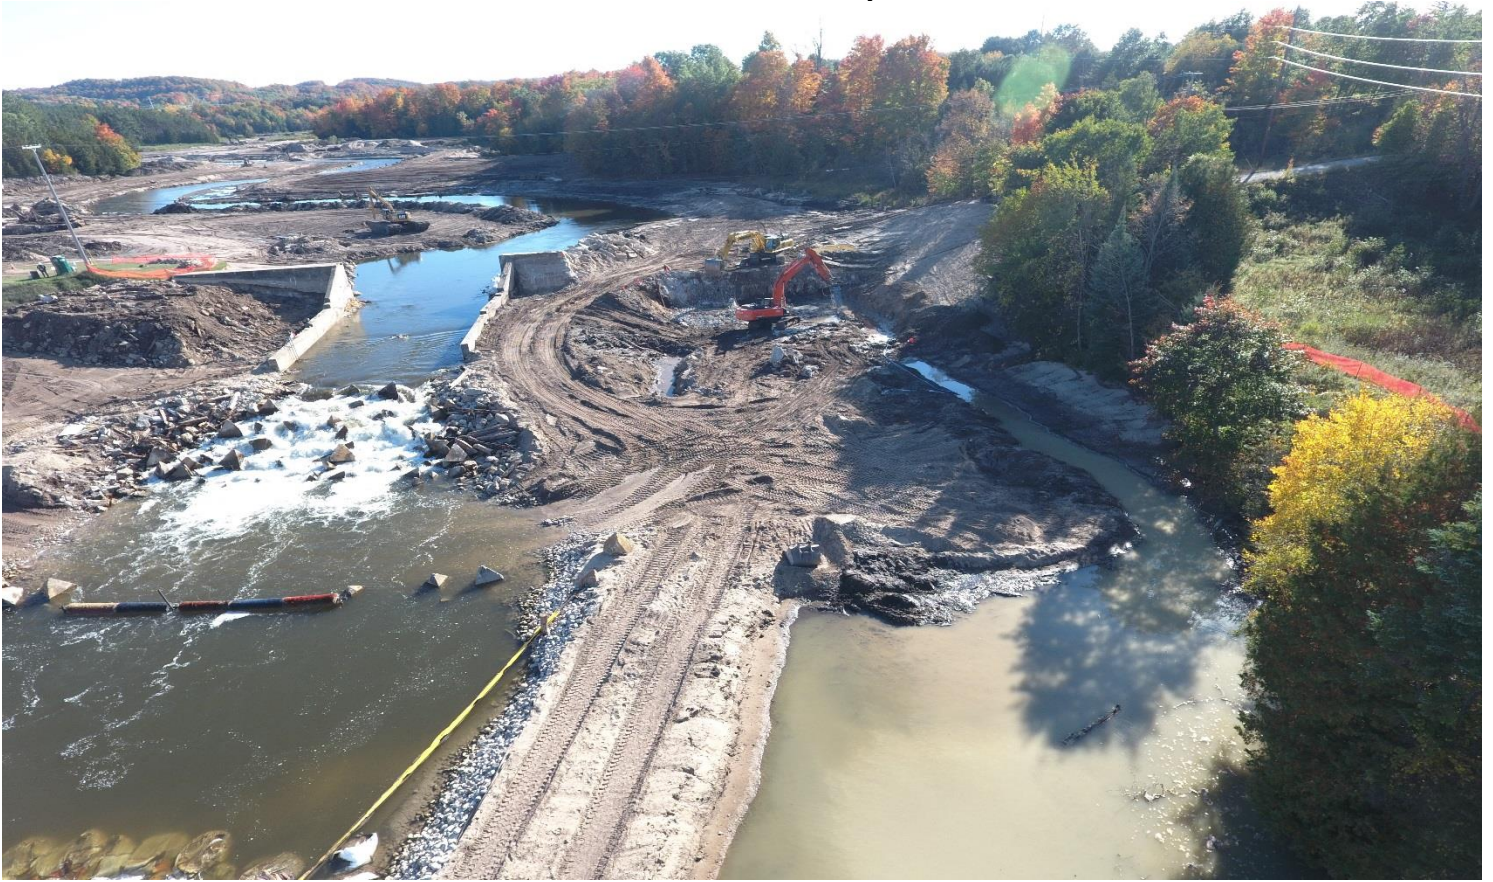
Aerial of Sabin Dam October 13, 2018. Photo by GTB Natural Resources.

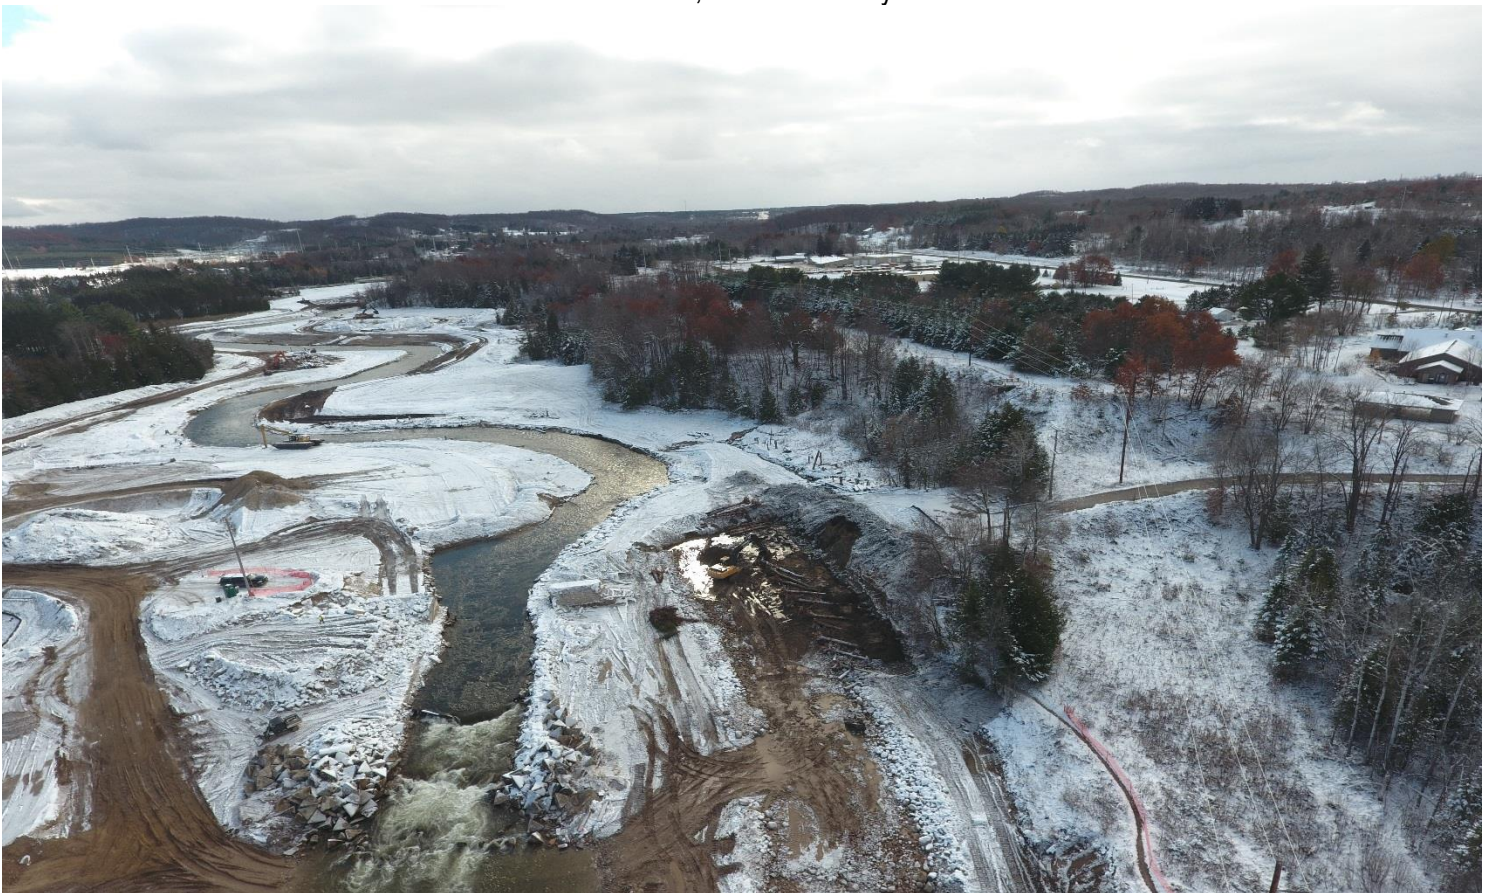
Aerial of Sabin Dam November 13, 2018. Photo by GTB Natural Resources.

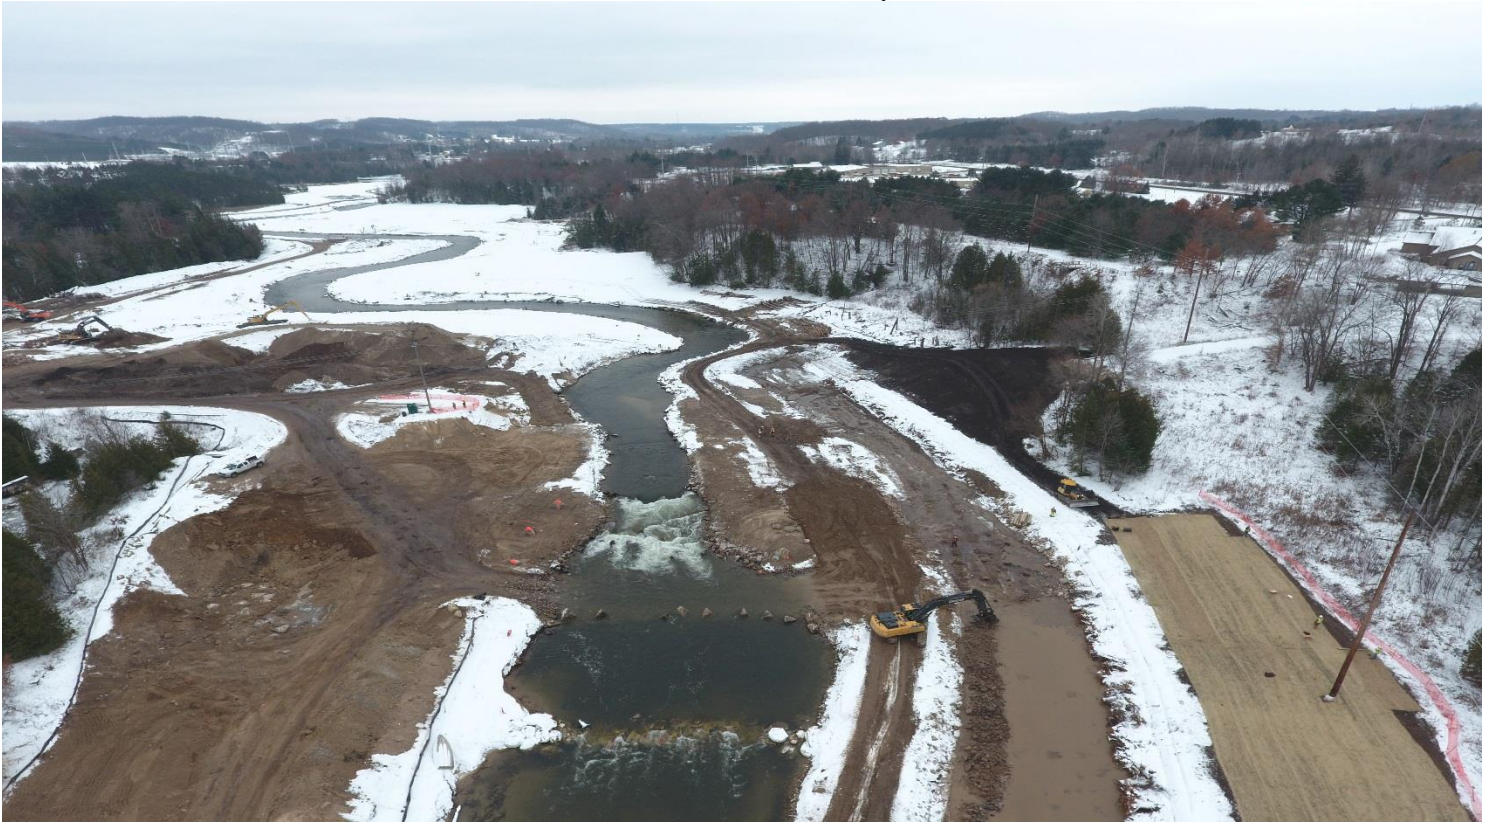
Aerial of Sabin Dam December 11, 2018. Photo by GTB Natural Resources.

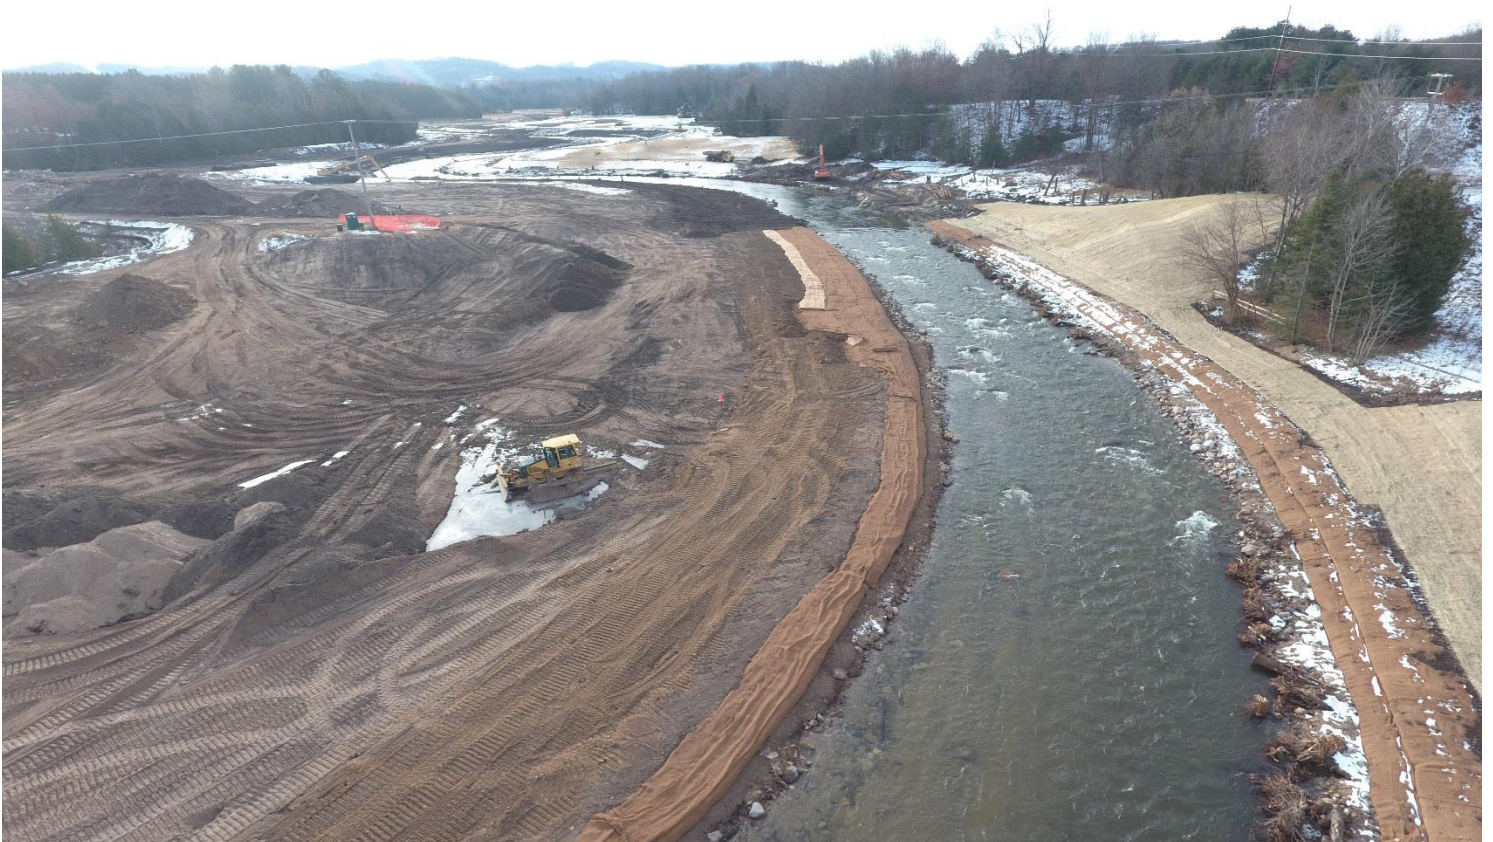
Aerial of Sabin Dam December 19, 2018. Photo by GTB Natural Resources.

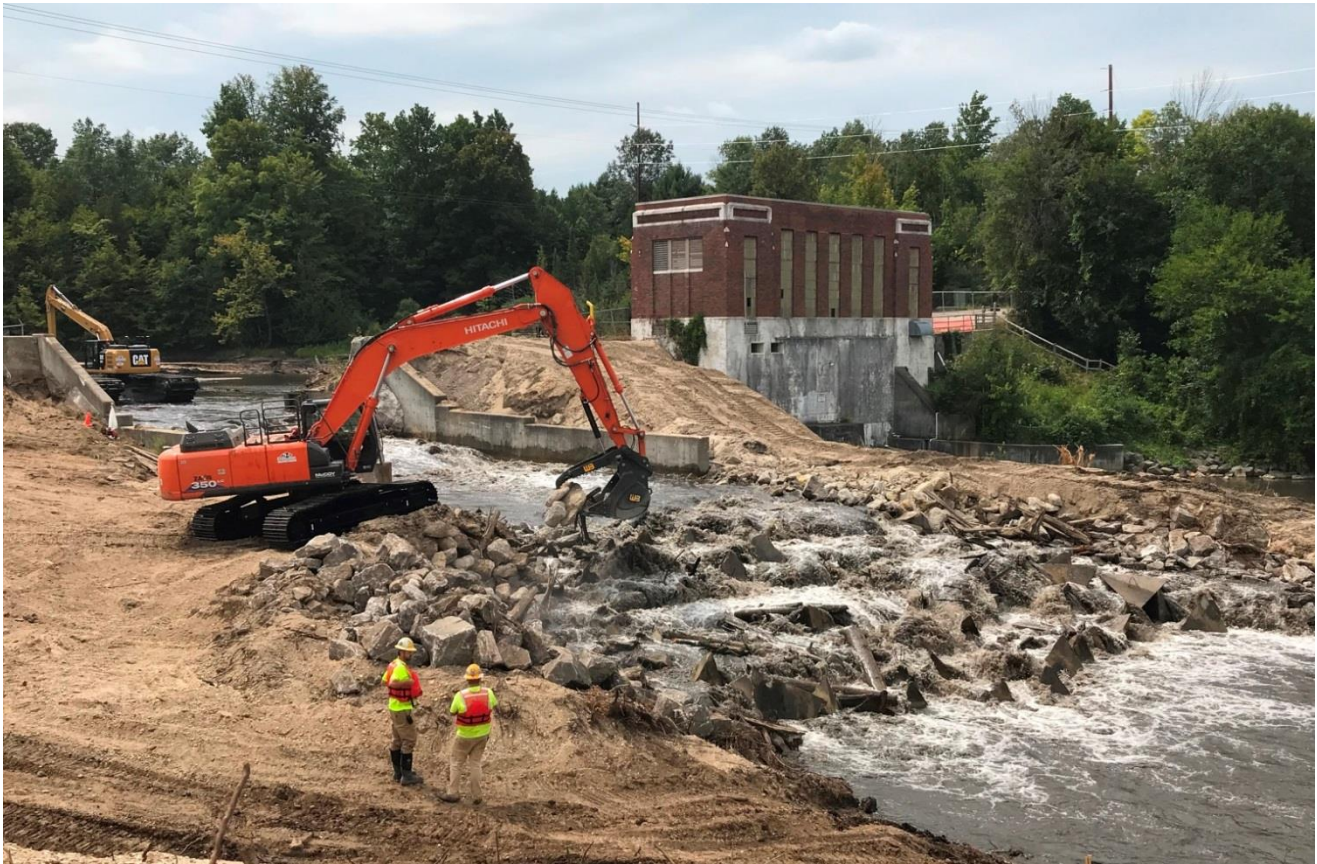
Spillway being broken apart & used as a water control structure to draw down Sabin Pond.

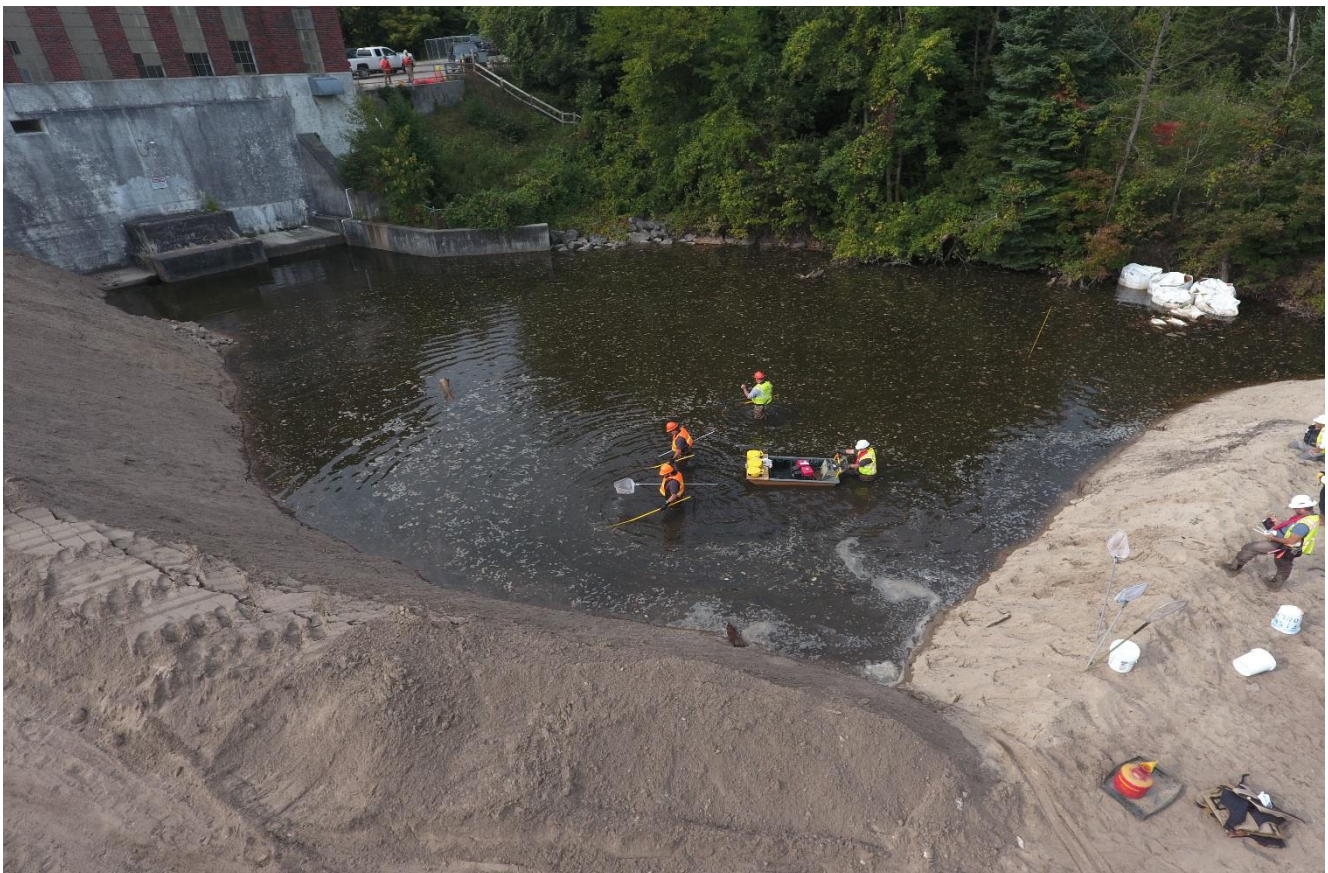
Fish rescue effort in isolated pool below powerhouse before demolition, GTB Fisheries staff, Aerial taken by GTB

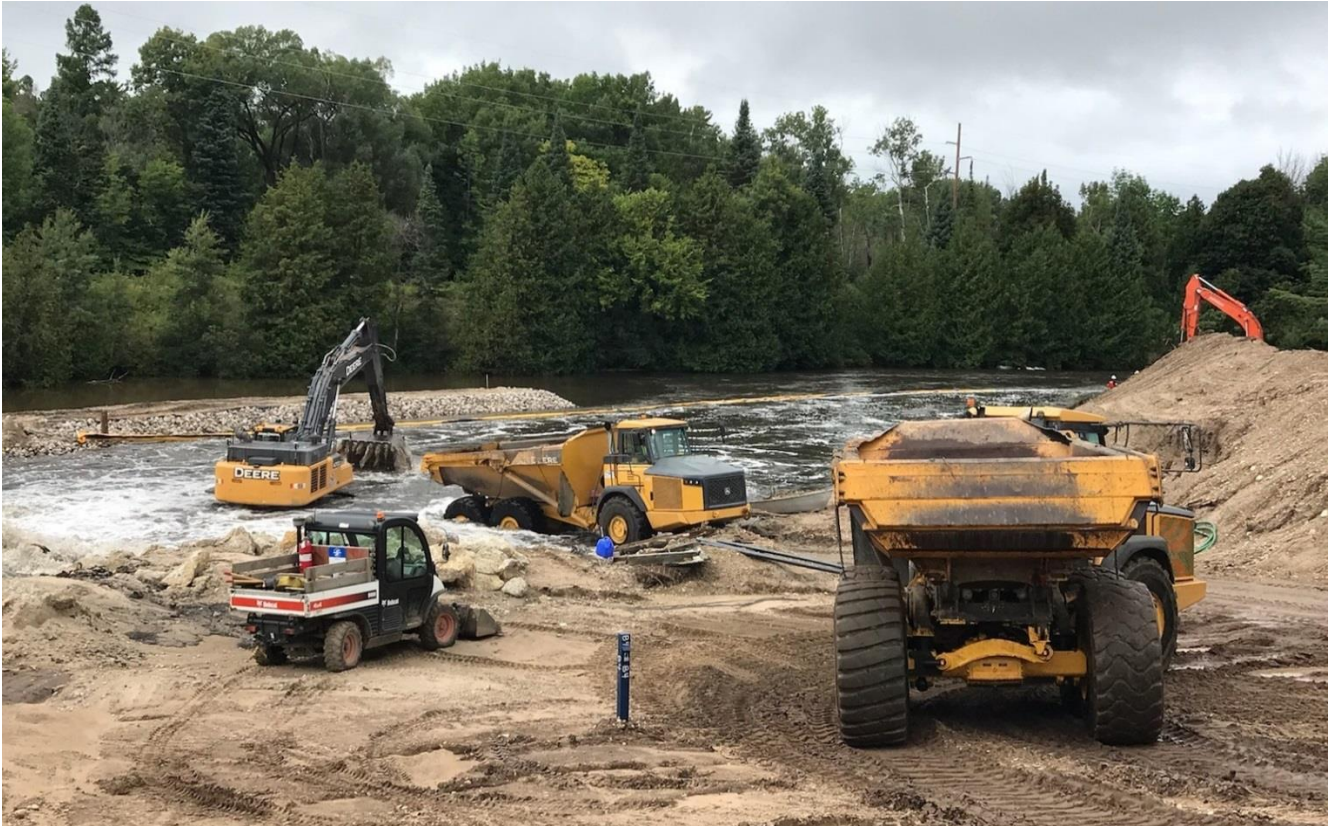
A series of 7 sediment traps were installed & are being maintained throughout the project area. Here, equipment operators remove sediment from downstream of the spillway.

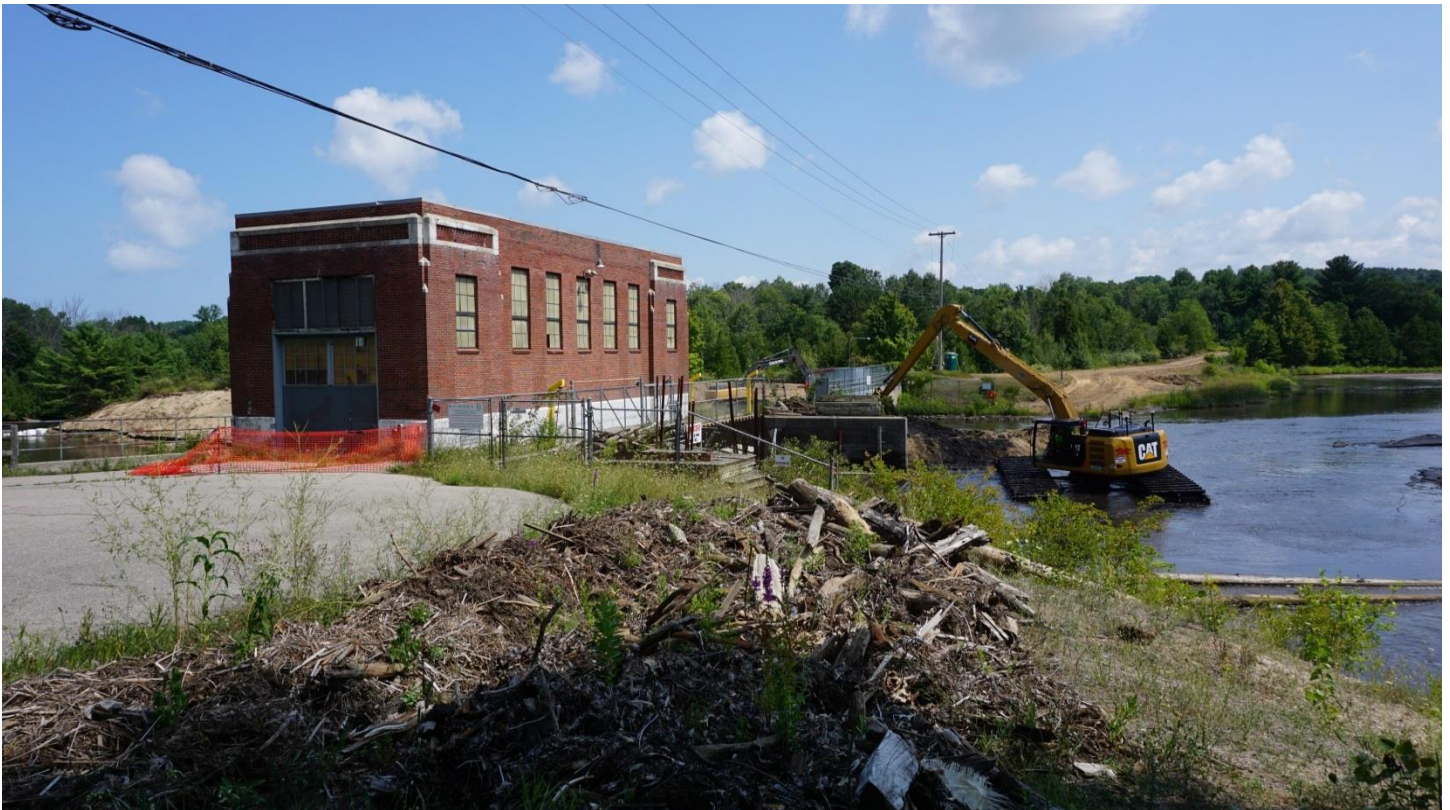
Sediment & accumulated fallen trees & branches that have floated down to the dam over the years are being removed in preparation for the powerhouse removal. The pond was dewatered 3' just from cleaning out this area so that water could better flow through the powerhouse & spillway.

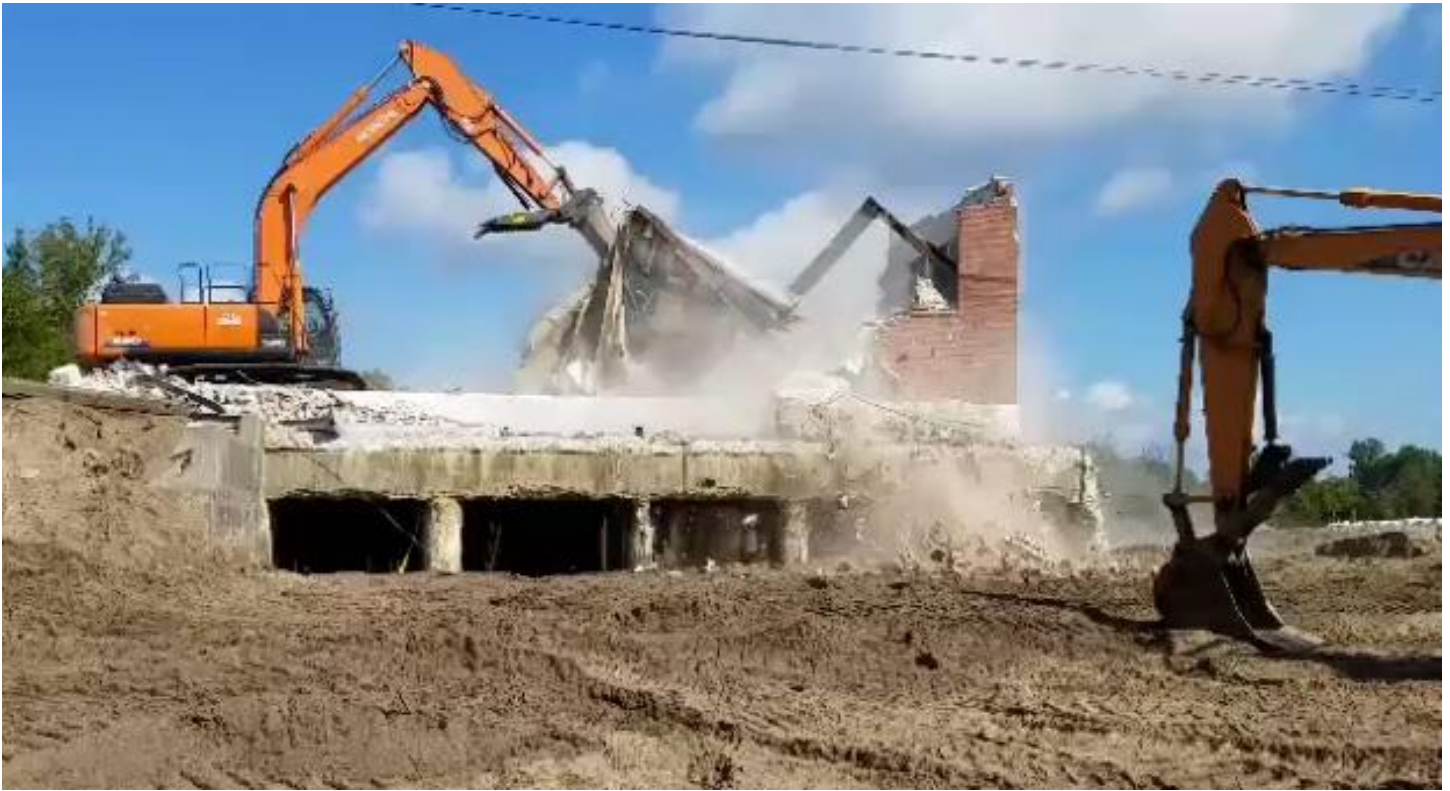
The above ground structure was demolished in less than 2 hours on September 25, 2018.

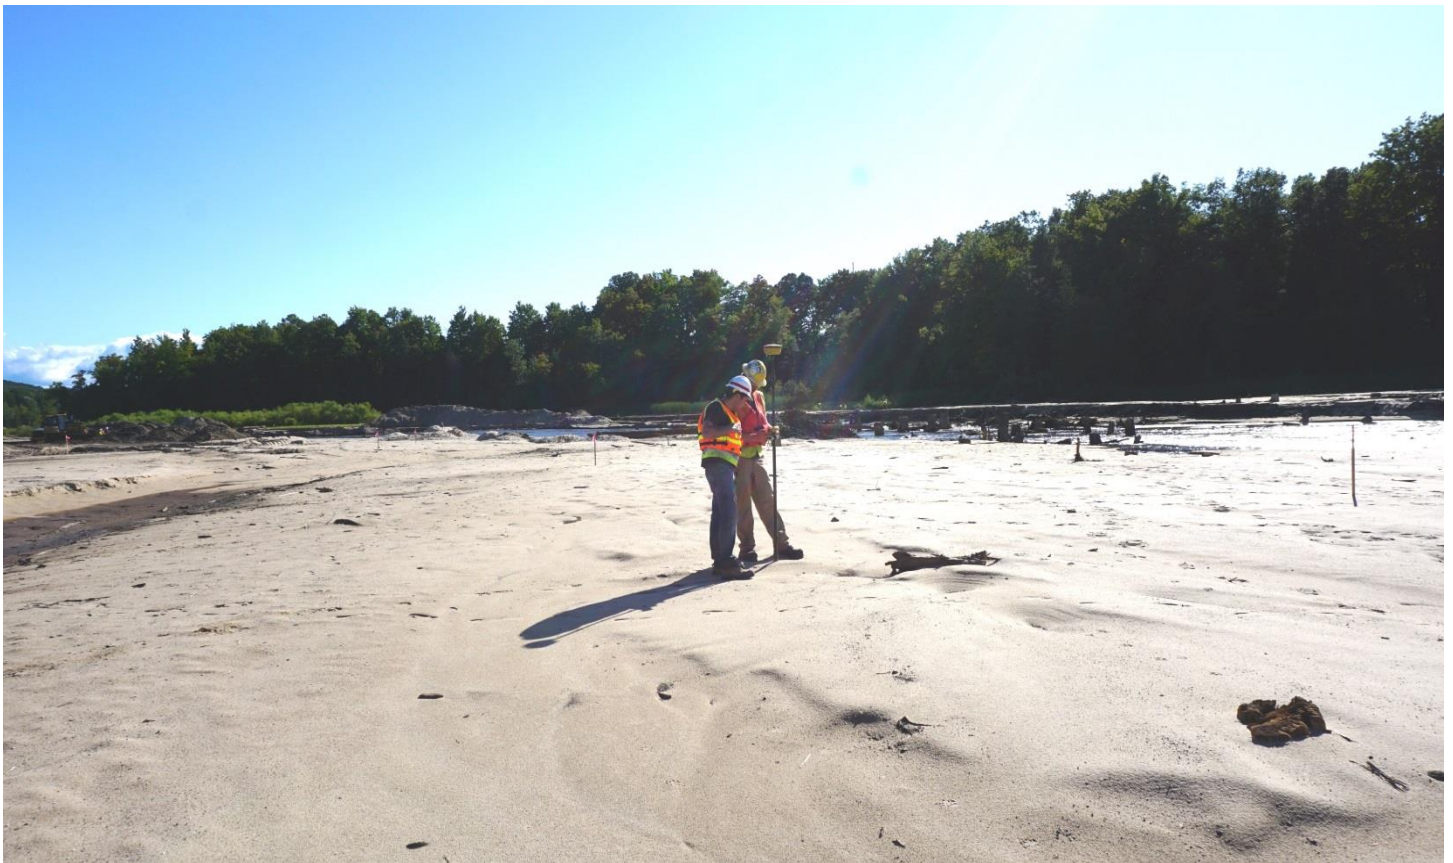
A moonscape. Engineer & contractor confirm location of planned river channel.

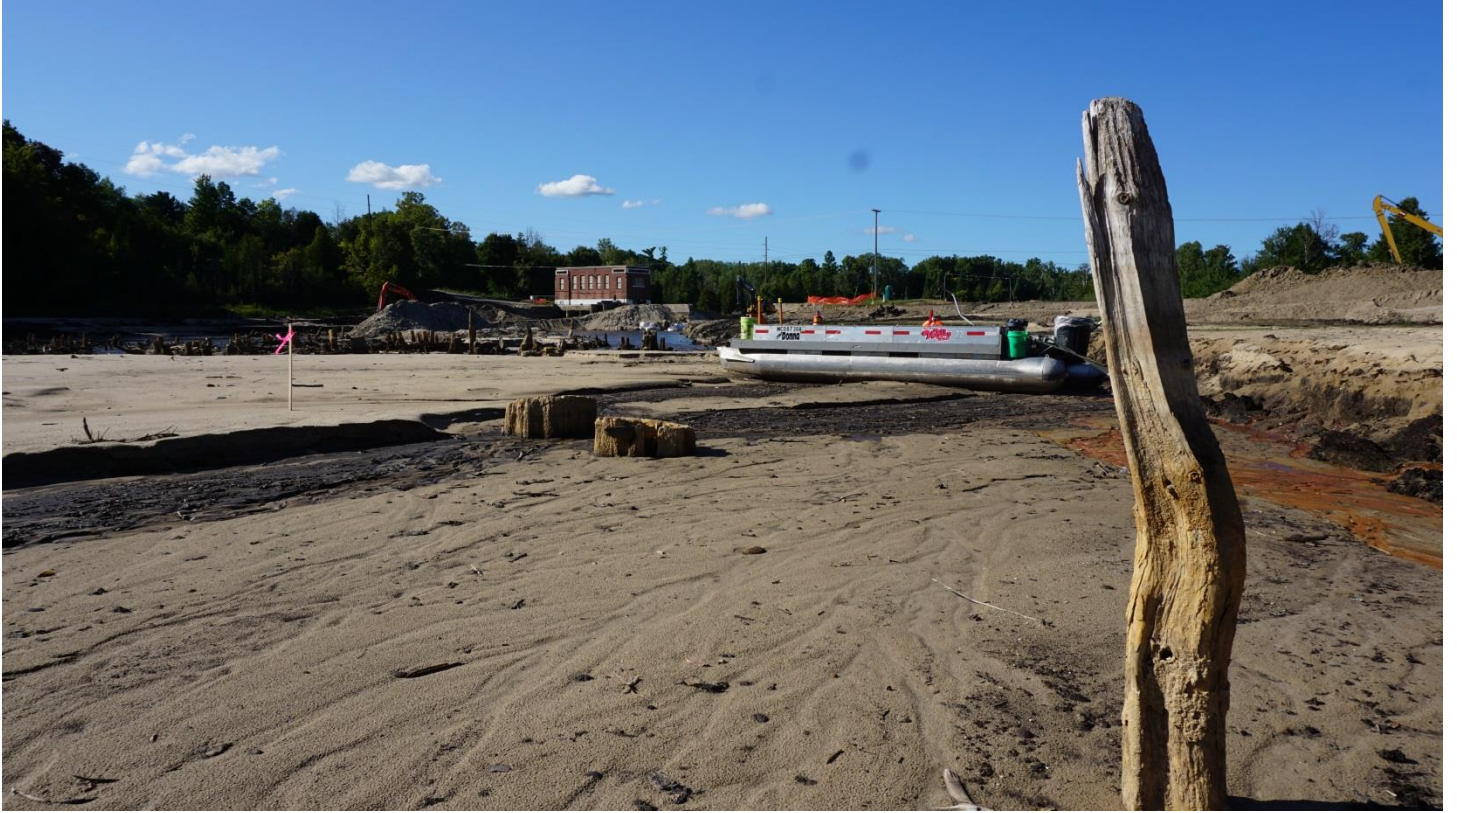
Tree stumps peek out of sand bars formerly under water & a pontoon boat staged by the contractor for potential safety needs sits high & dry. Seeps on the right are rust colored from the naturally occurring iron in the soils.

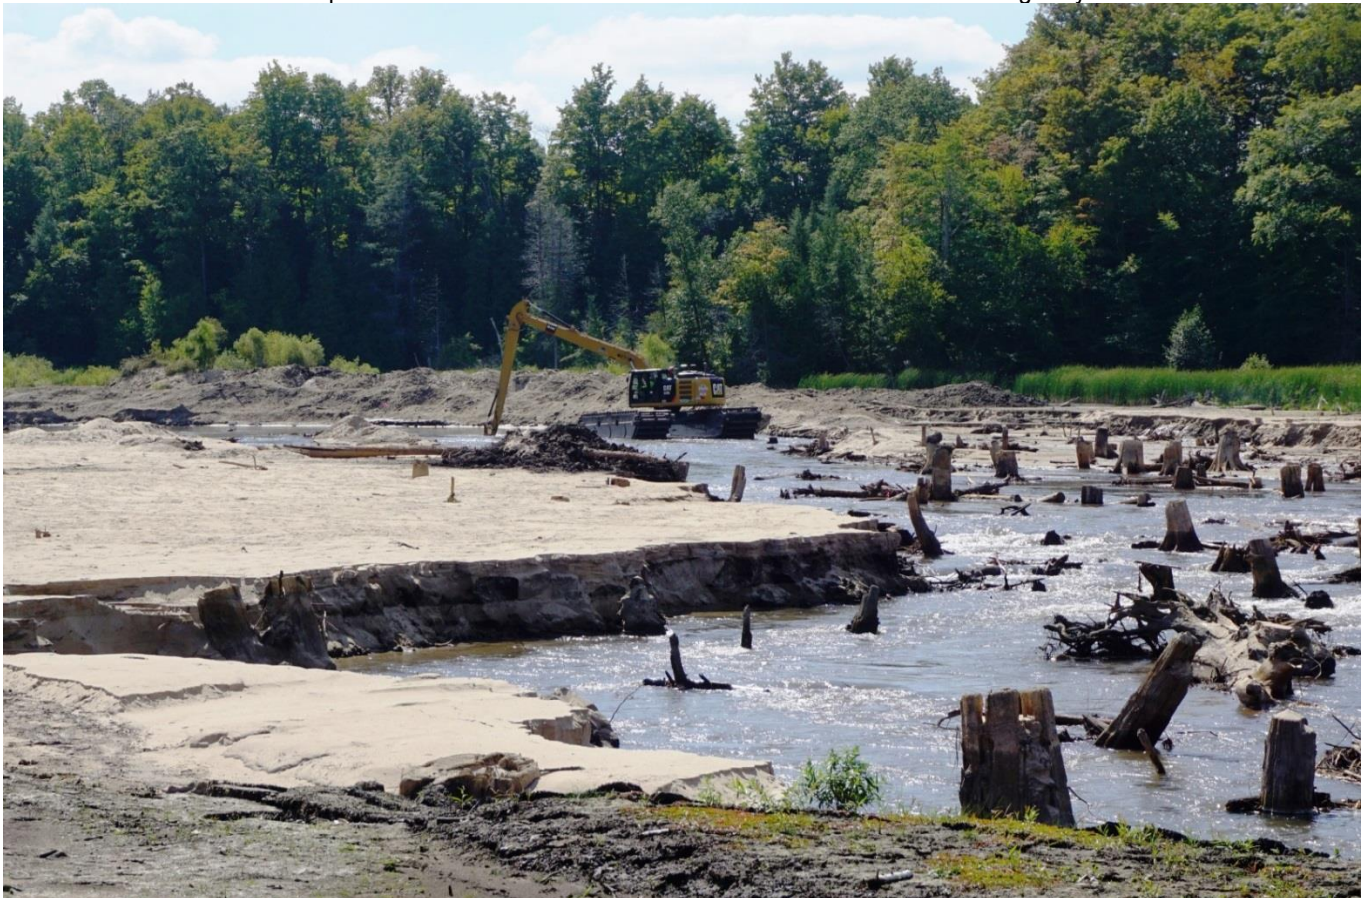
An amphibious excavator bails sediment out of the future river channel.  
A sea of tree stumps reminds us of the forest that once was before the dam was originally built in 1906.

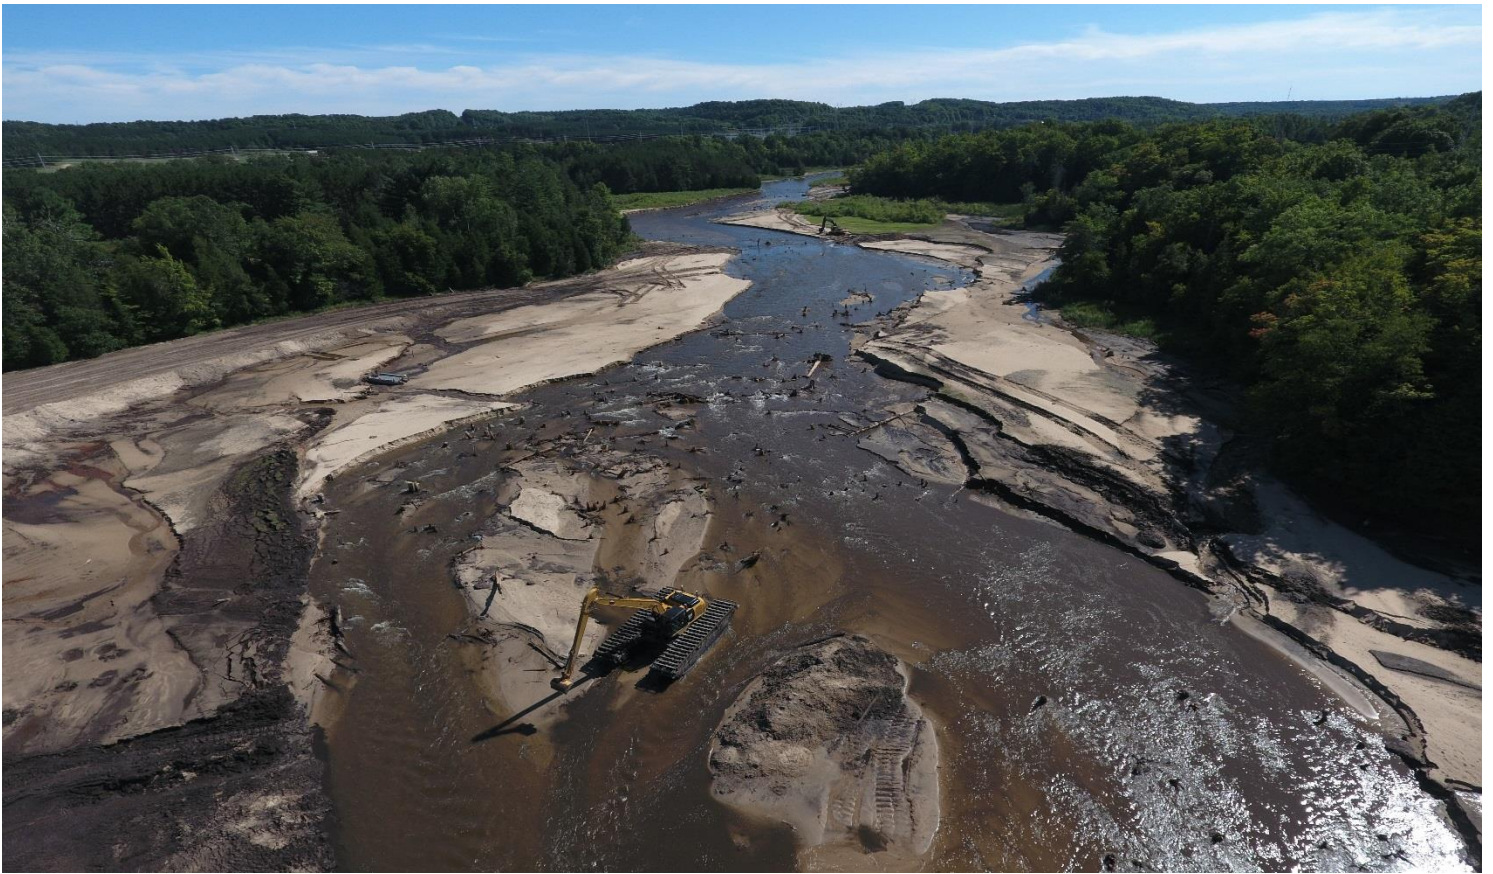
Aerial of channel excavation through exposed stump field, photo by GTB Natural Resources

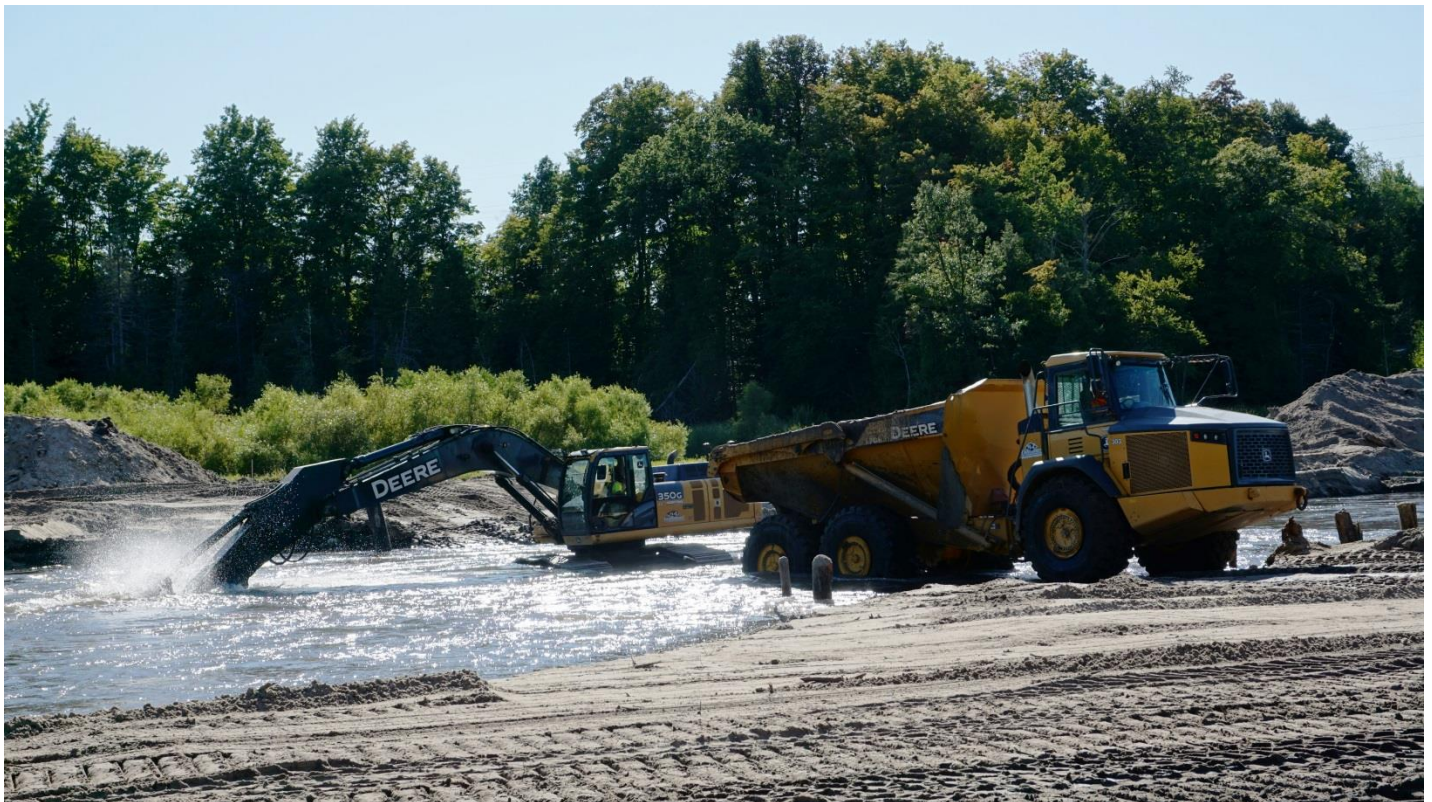
Off-road dump trucks with extra large tires back right into the water to collect sediment & haul it to a series of designated spoil areas that are outside of the reach of the future channel & floodplains.
