## Sabin Dam Removal & River Restoration Photo Report – December 2018

*(Unless noted otherwise, all report content was provided and prepared courtesy of Conservation Resource Alliance)*

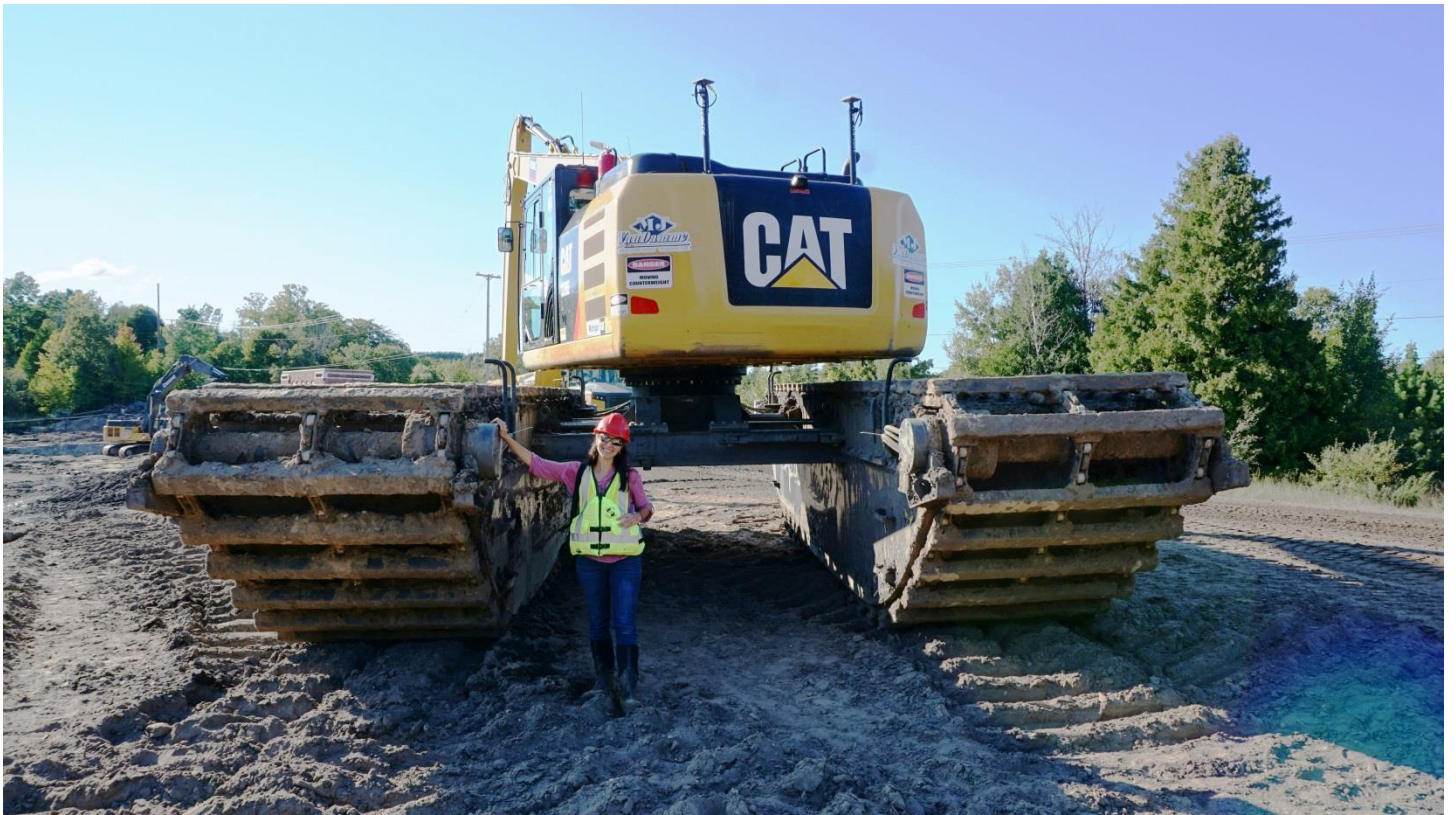
The amphibious excavator has extra wide & tall tracks that enable it to go into areas with soft soil & flowing water.

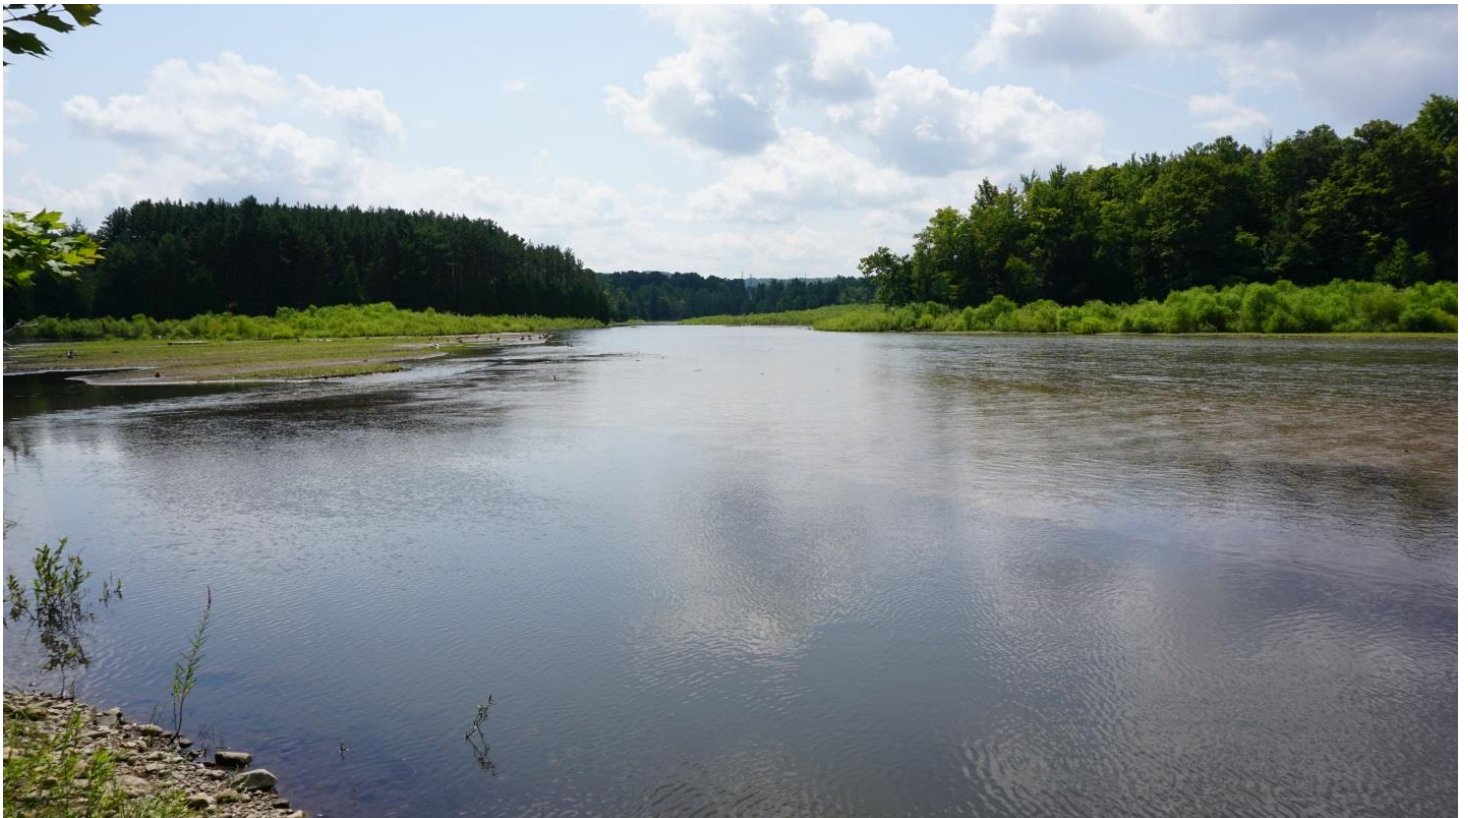
Looking upstream at the pond in August 2018. The pond was already drawn down 6' in 2012 for safety reasons & the bright green vegetation is what has taken hold on the fringes since then.

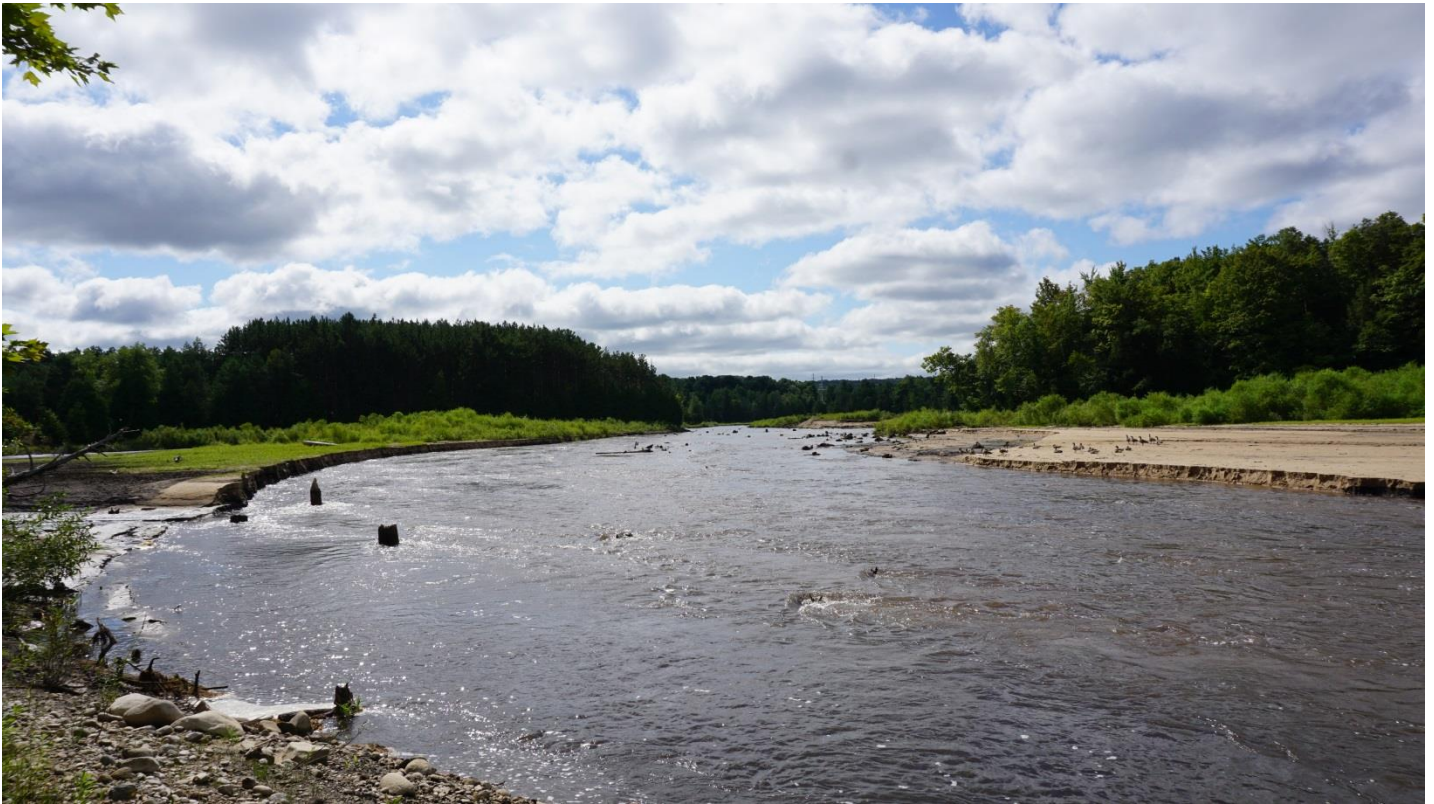
Looking upstream at the pond in early September 2018 after it has been drawn down 3'.

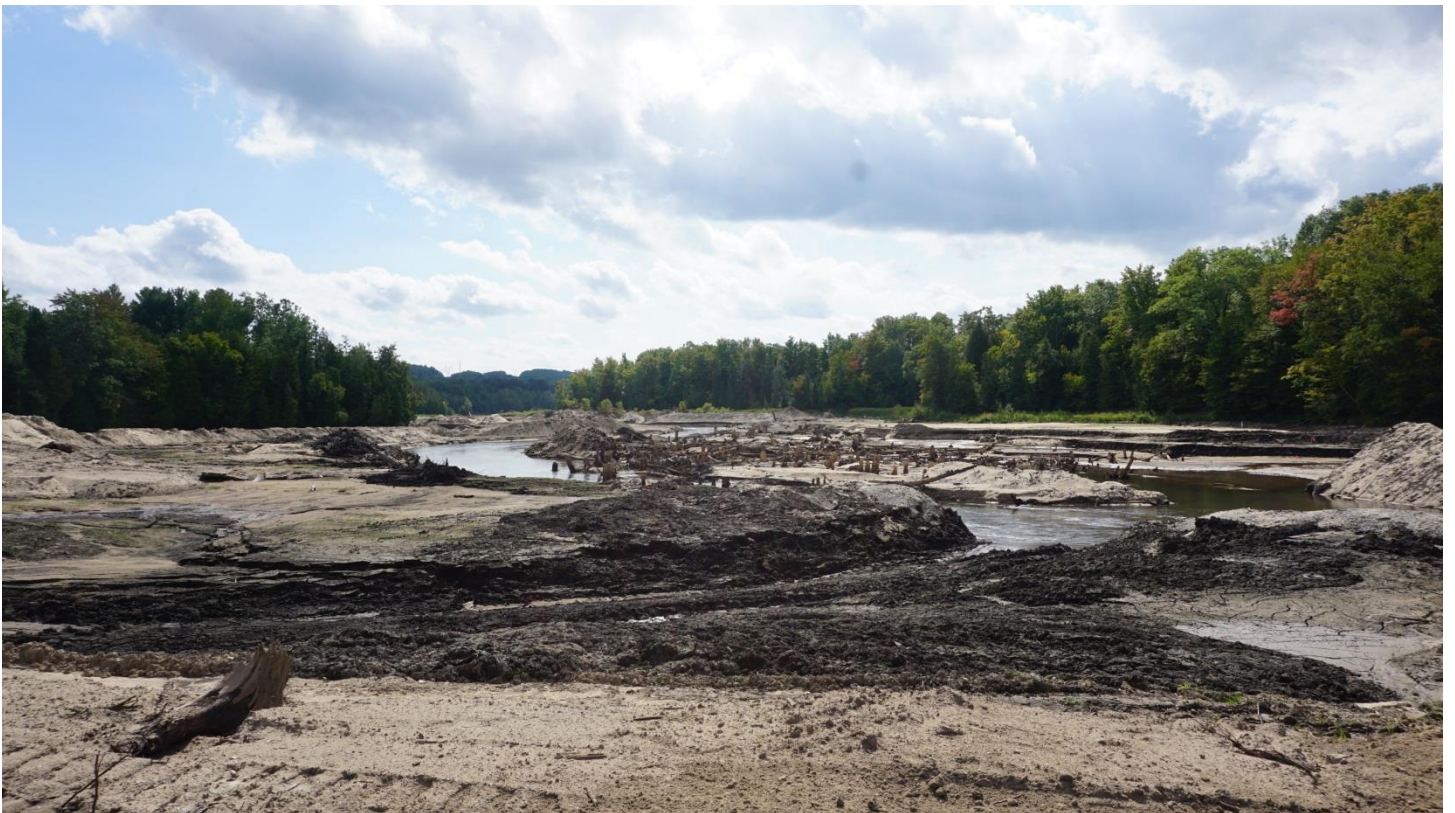
Looking upstream at the pond in late September 2018 after the pond has been drawn down 9'. Muck & sand flats remind us how dams built on ever flowing streams collect much more than just water. Muck forms from the breakdown of organic materials like trees, branches, leaves, & by-products from fish, wildlife & insects.

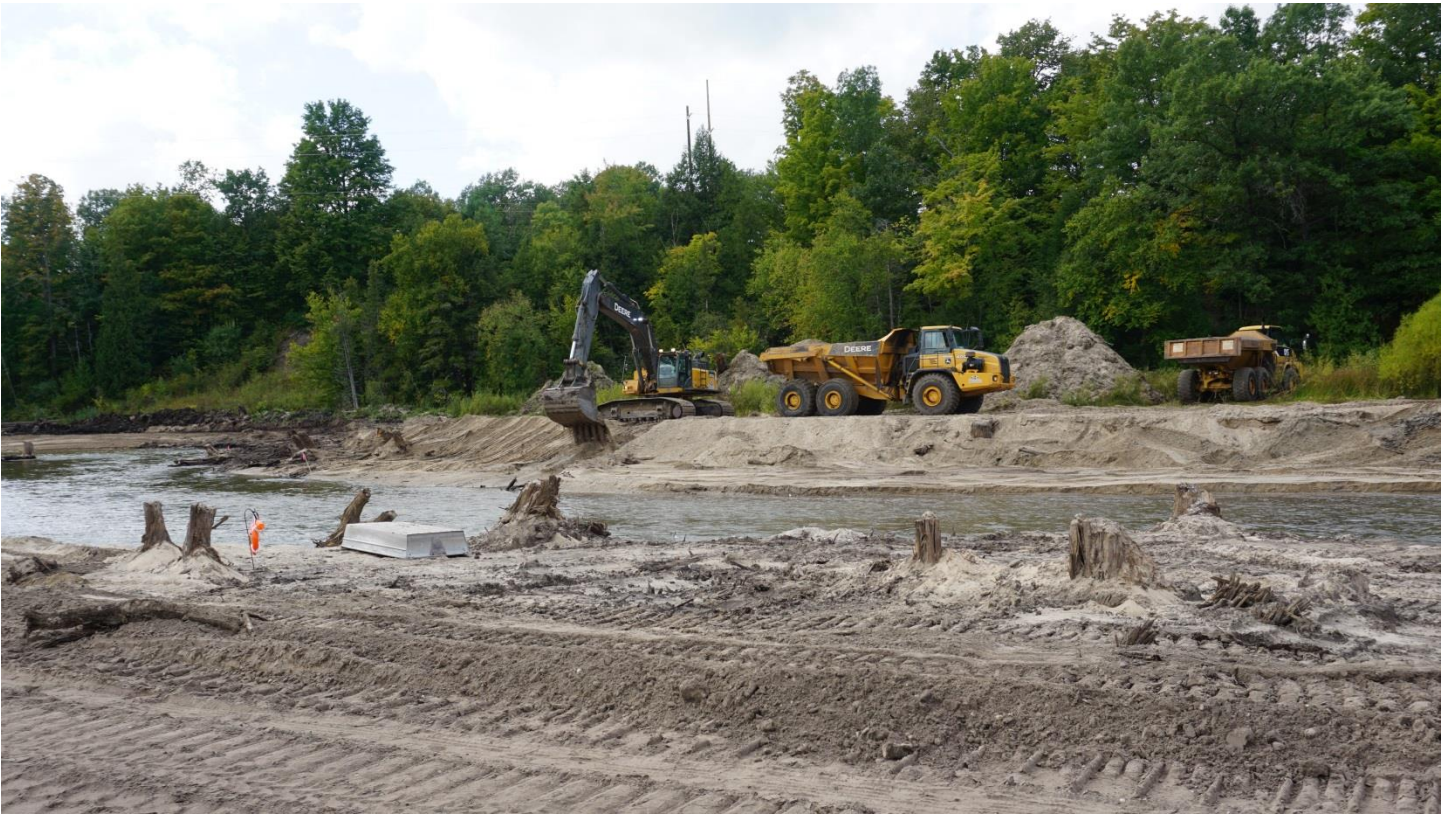
Building a river. Equipment operators start sculpting the adjacent floodplains needed for a stable river channel.

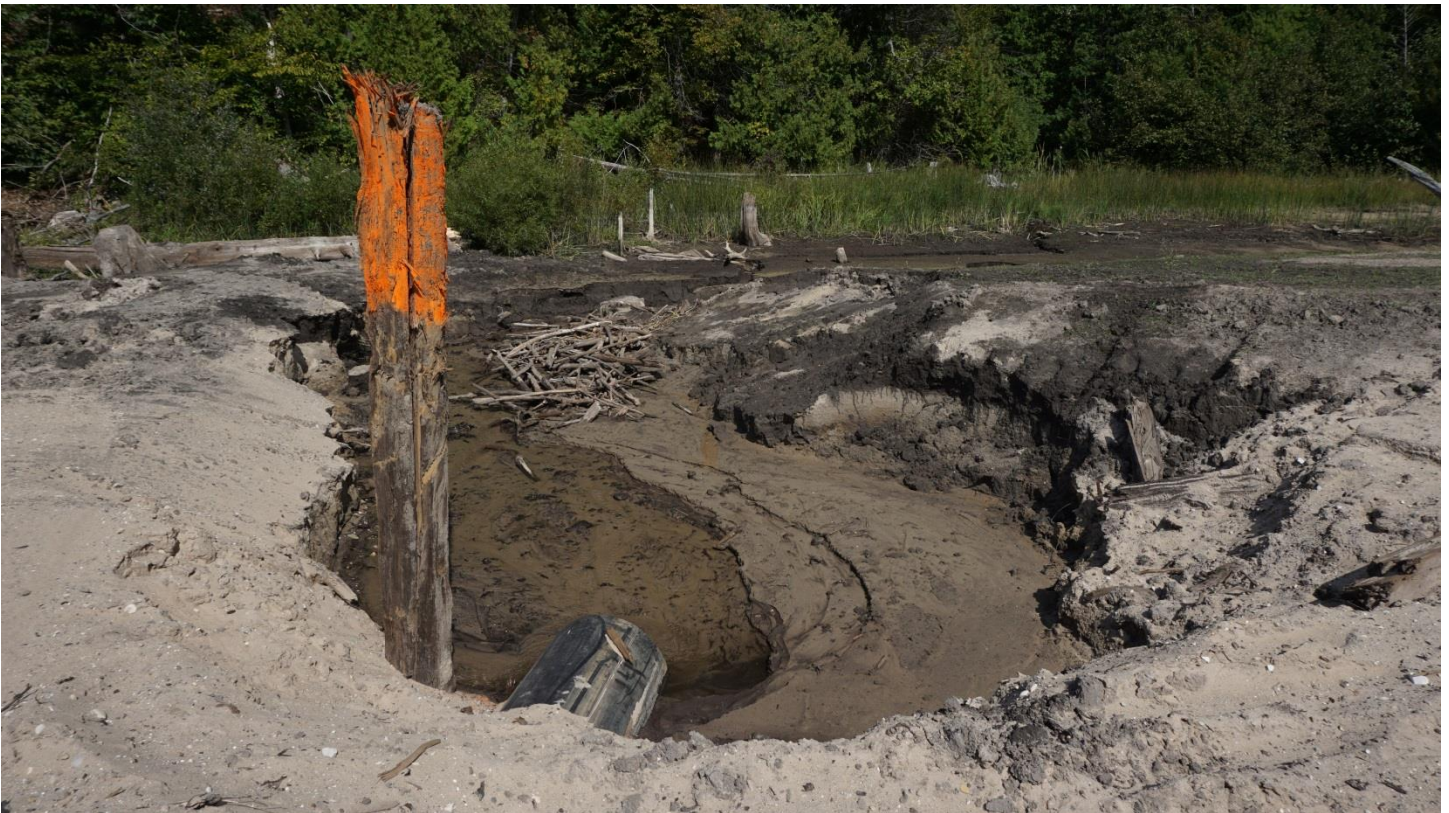
Finding creeks. With the former pond being 50 acres, some small feeder streams were also buried. These areas will be graded out & restored. Meanwhile, a sprayed log & a culvert allow equipment operators to travel over these creeks.

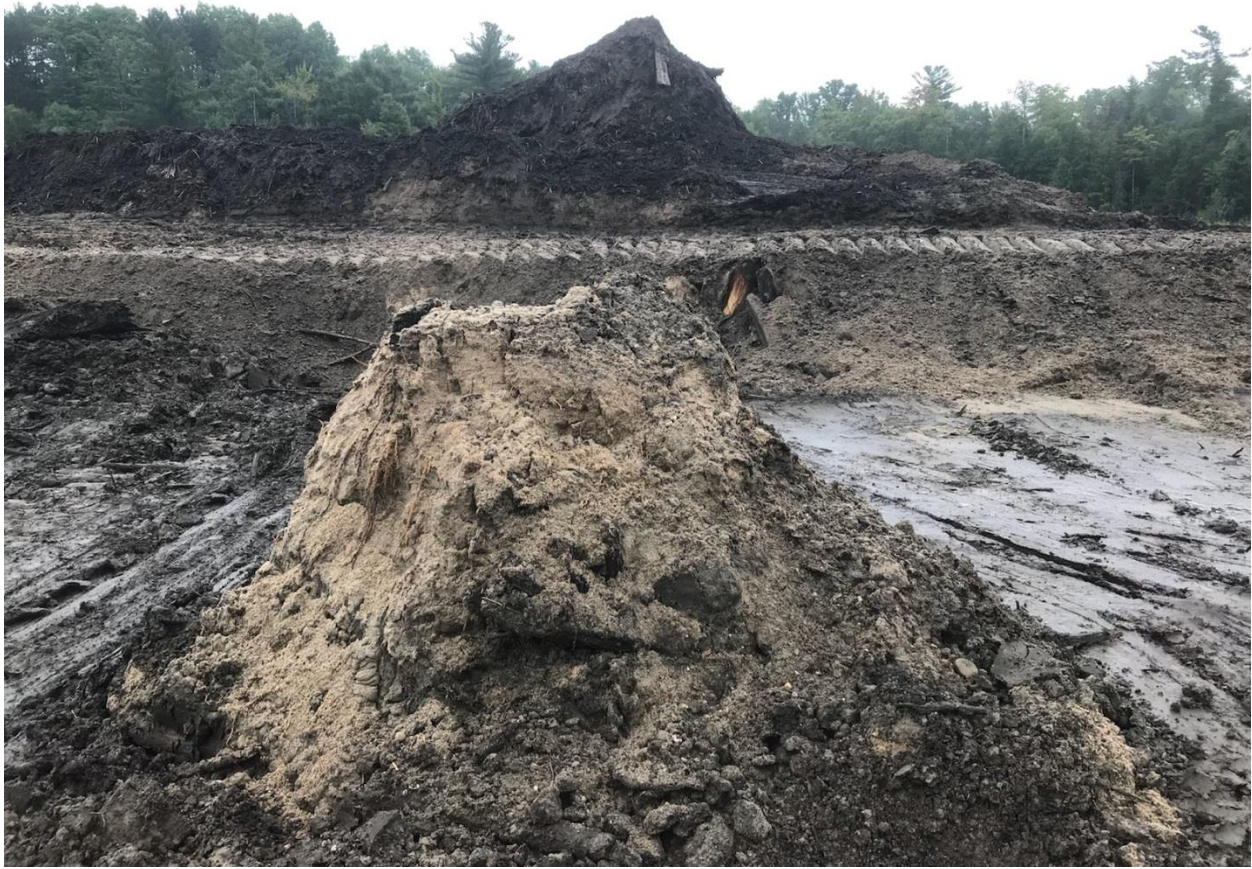
A large pile of muck in the background waits to be smoothed out. In the foreground, a tree stump is hidden in a pile of sand. Equipment operators leave these stumps intact & use them as indicators of what once was upland.

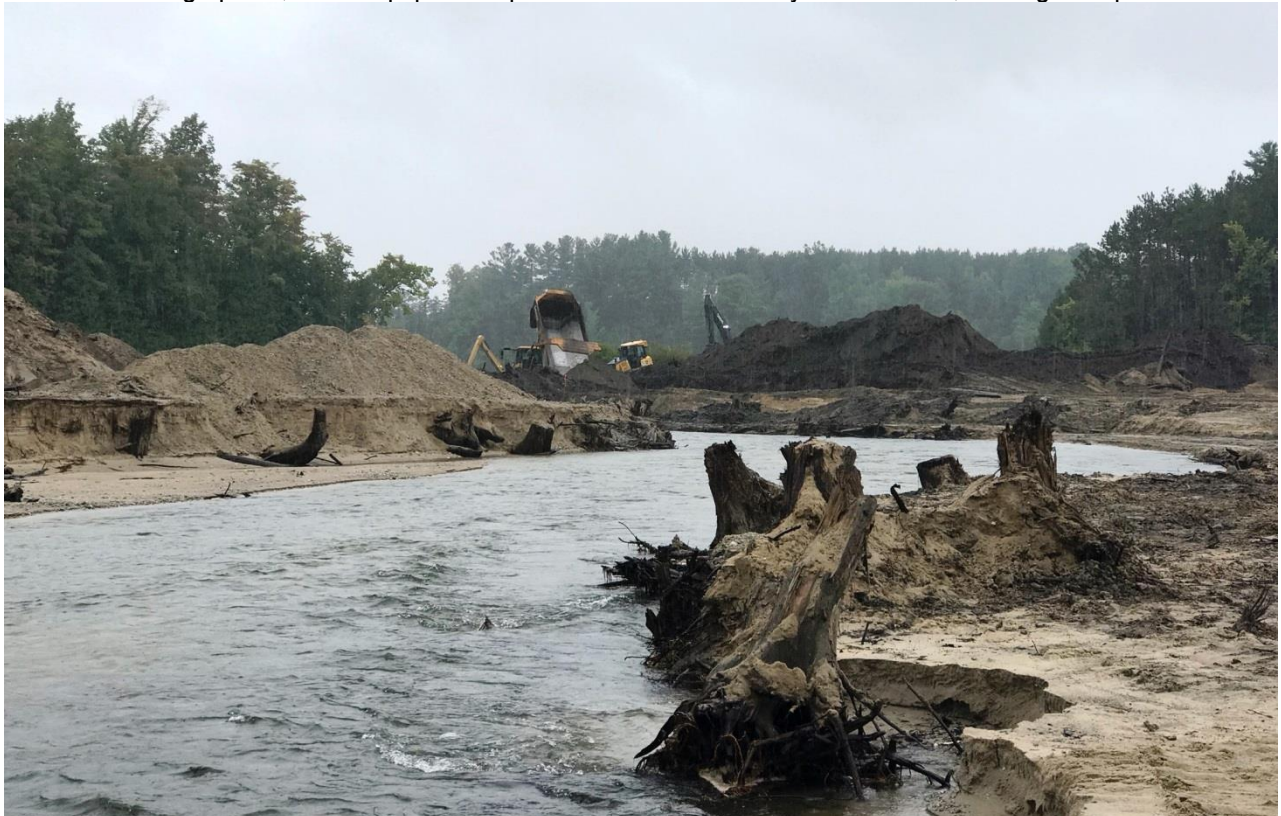
Nailed it. Leaning tree stumps on either side confirm that engineers found the original channel in the design plans, & the equipment operators worked carefully to uncover it, leaving stumps intact.

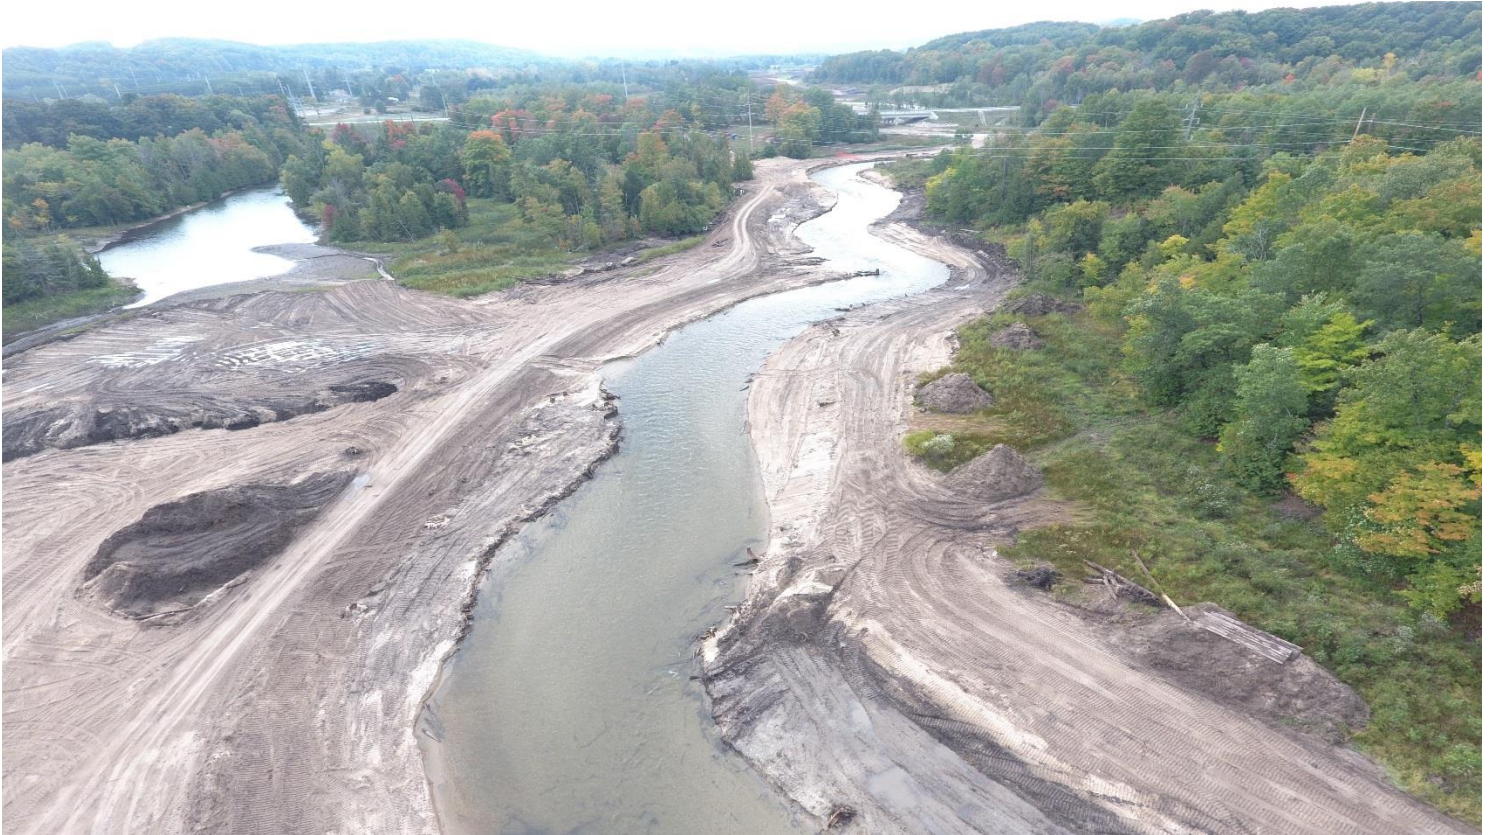
Aerial view of “relic” channel settling back into its comfortable pattern. Note the stumps along the banks signaling the design indeed brought the river back from the past. Photo taken by GTB Natural Resources.

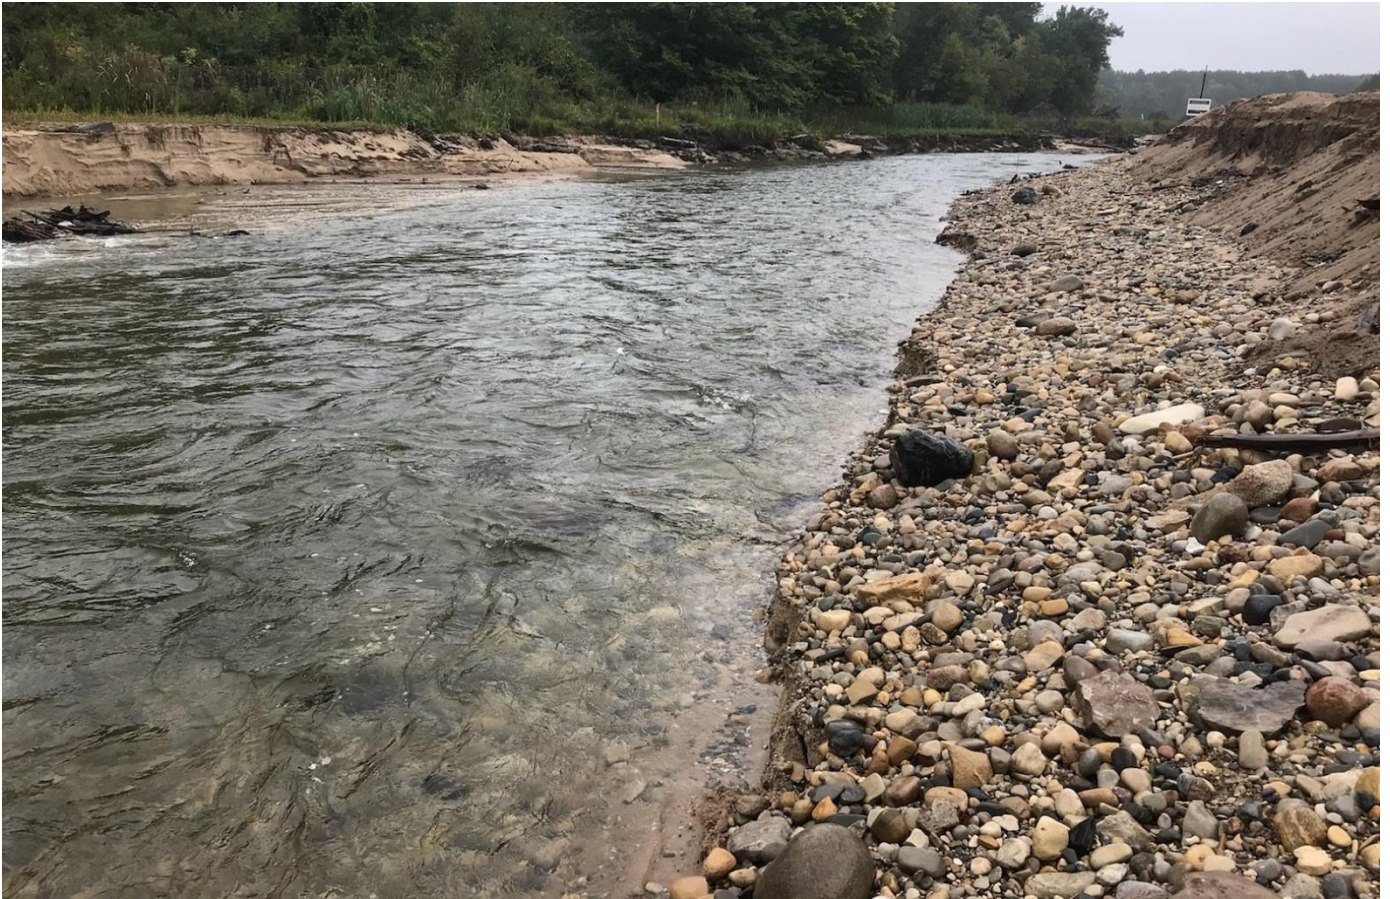
Rivers in Northwest Michigan often have gravel & cobble. The Boardman River though, is a superstar when it comes to having beds of this throughout its channel. Aquatic insects need these rocks to attach to & these bugs provide the base of the food chain for fish & aquatic wildlife. Fish need these beds to lay their eggs.

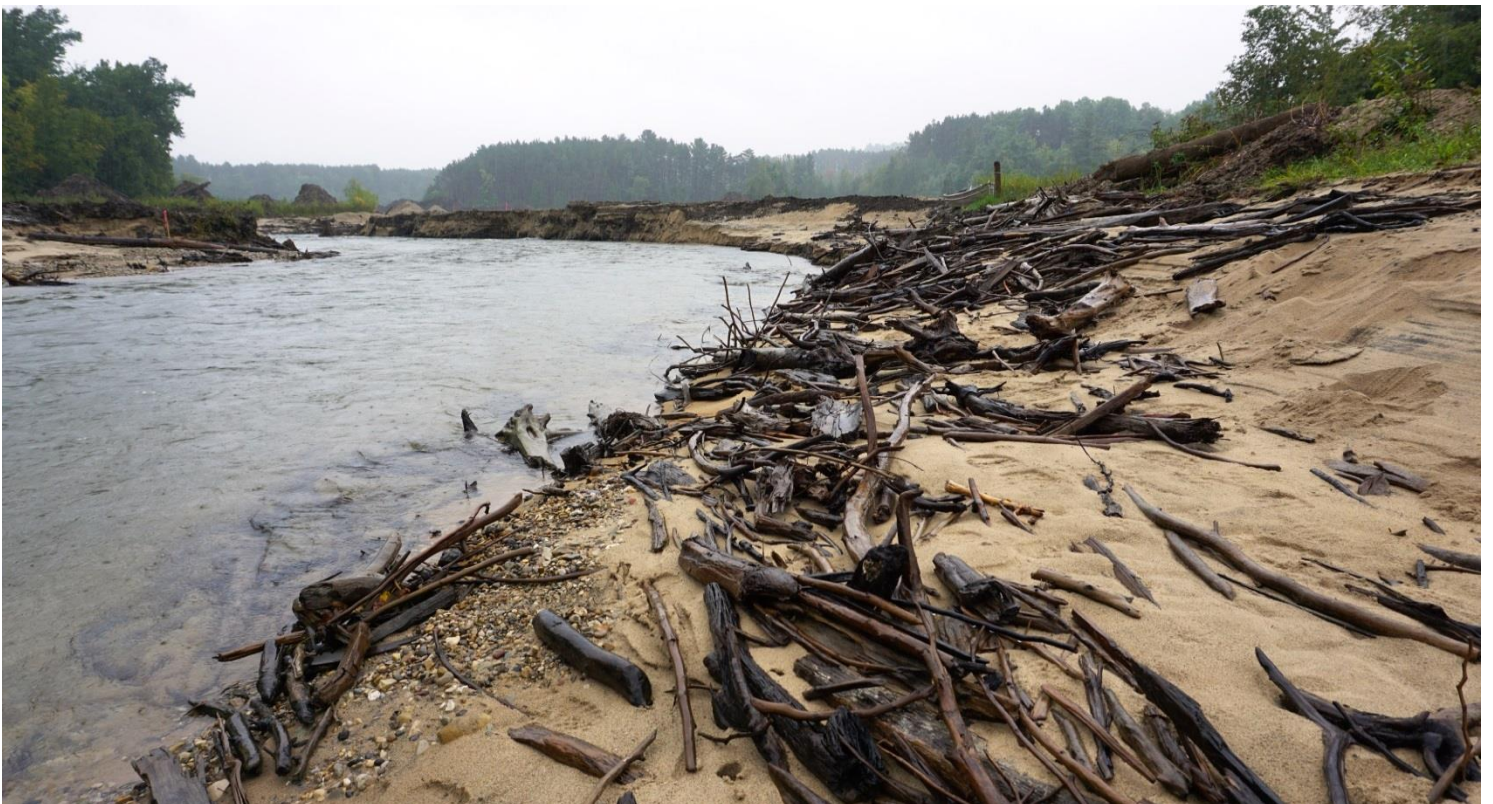
Dams impound woody debris – fallen trees & branches that float through a river system.
