Jordan River Chestonia Bridge Project Photo Report

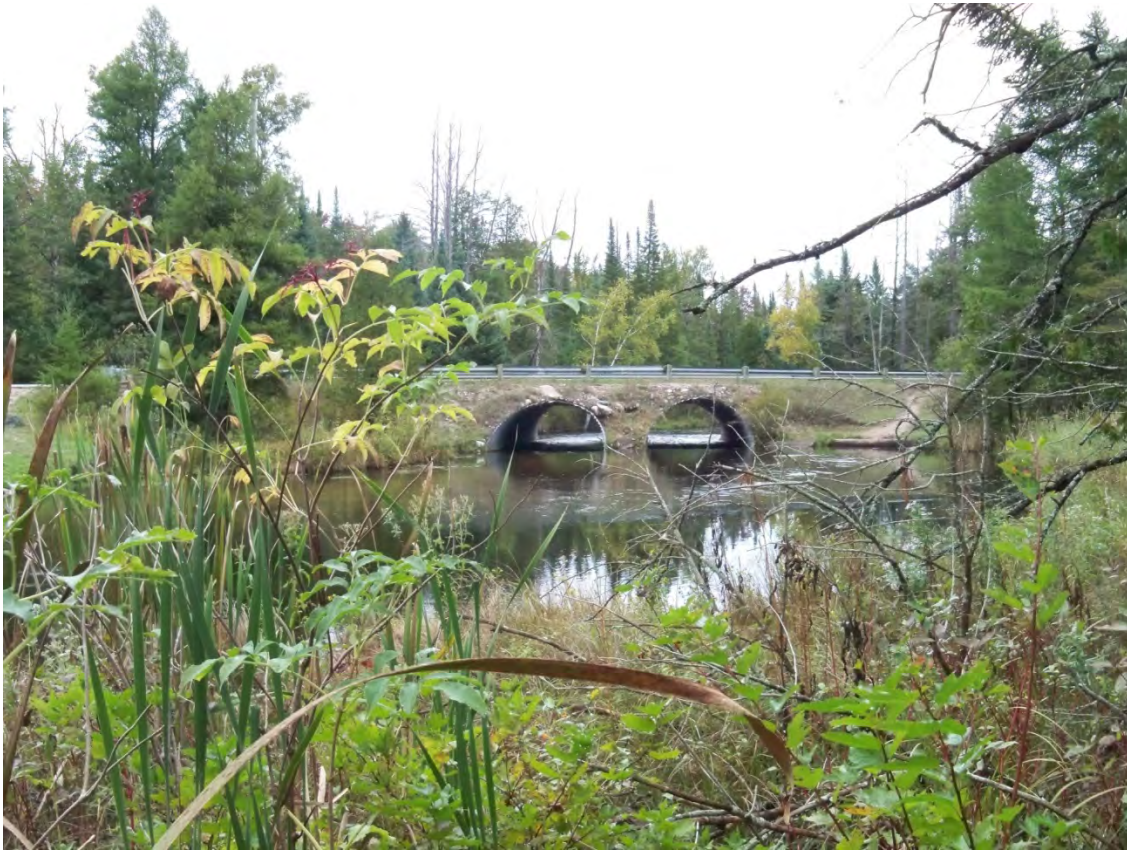
Before - Inlet, 16' wide culverts funneled the 50' wide river under the road. The design survey showed that the culverts were sitting 2' above what was the original stream bottom elevation.

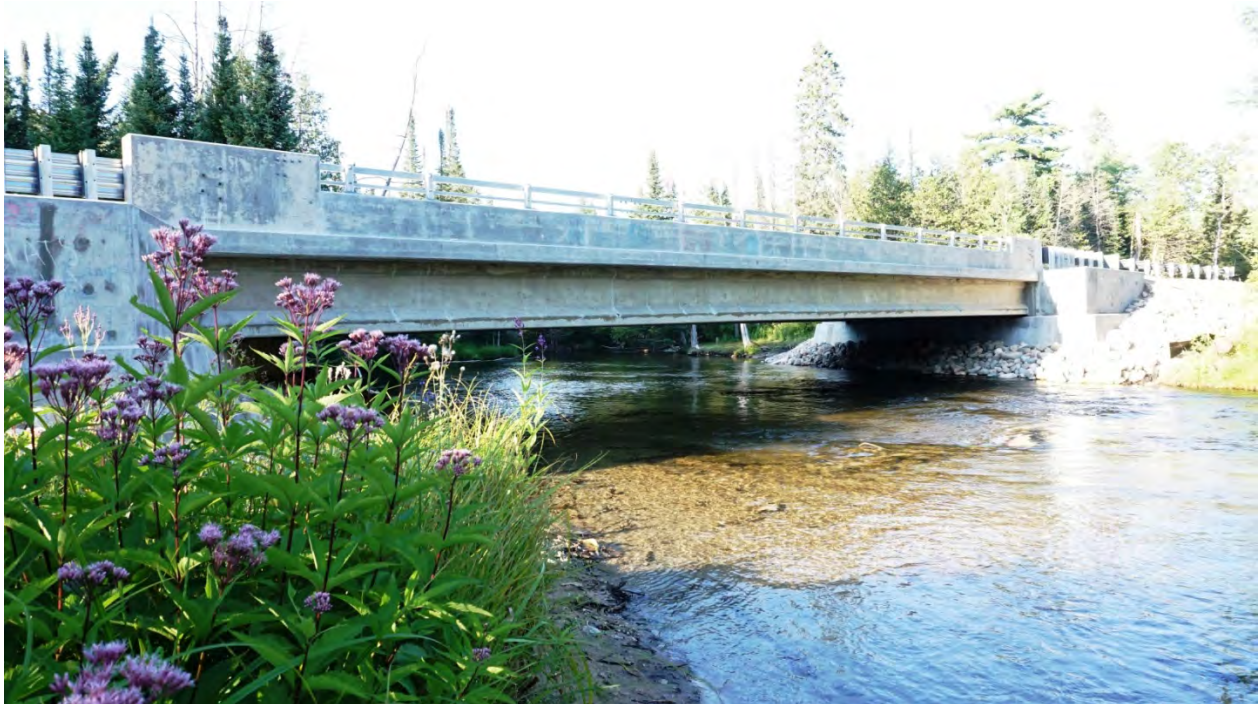
After – Chestonia Bridge! A 90' span concrete bridge allows for the natural flow of the river during high water events & for the movement of fish, wildlife, aquatic insects at all life stages.

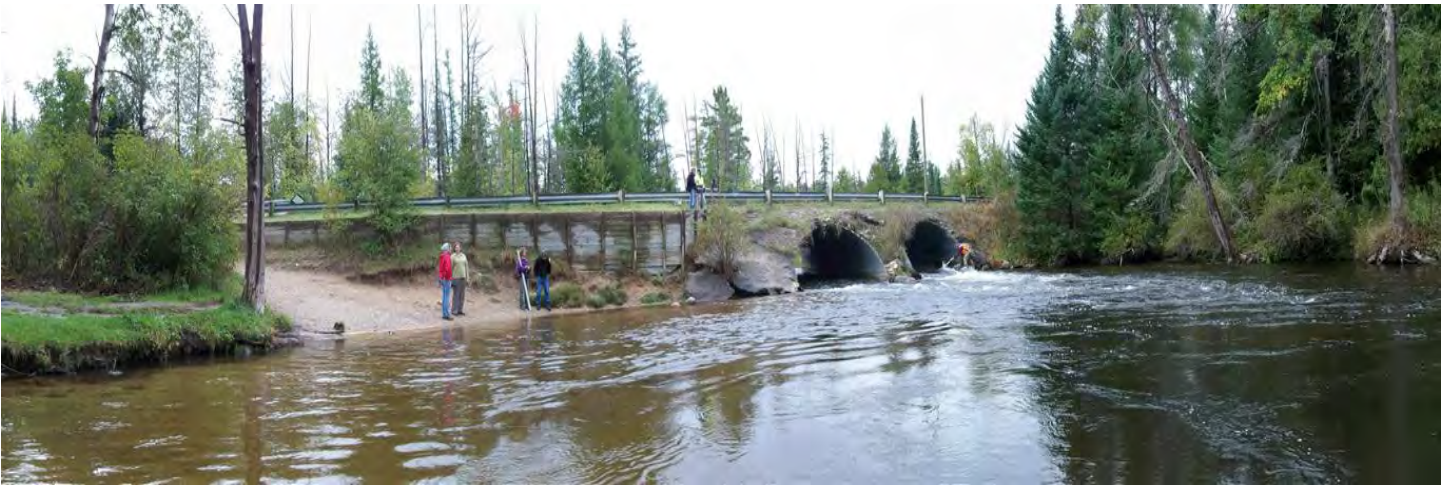
Before – Culverts caused major pool formation at both the inlet & outlet, giving water a chance to warm & sand to build up over time. This is not ideal instream habitat.

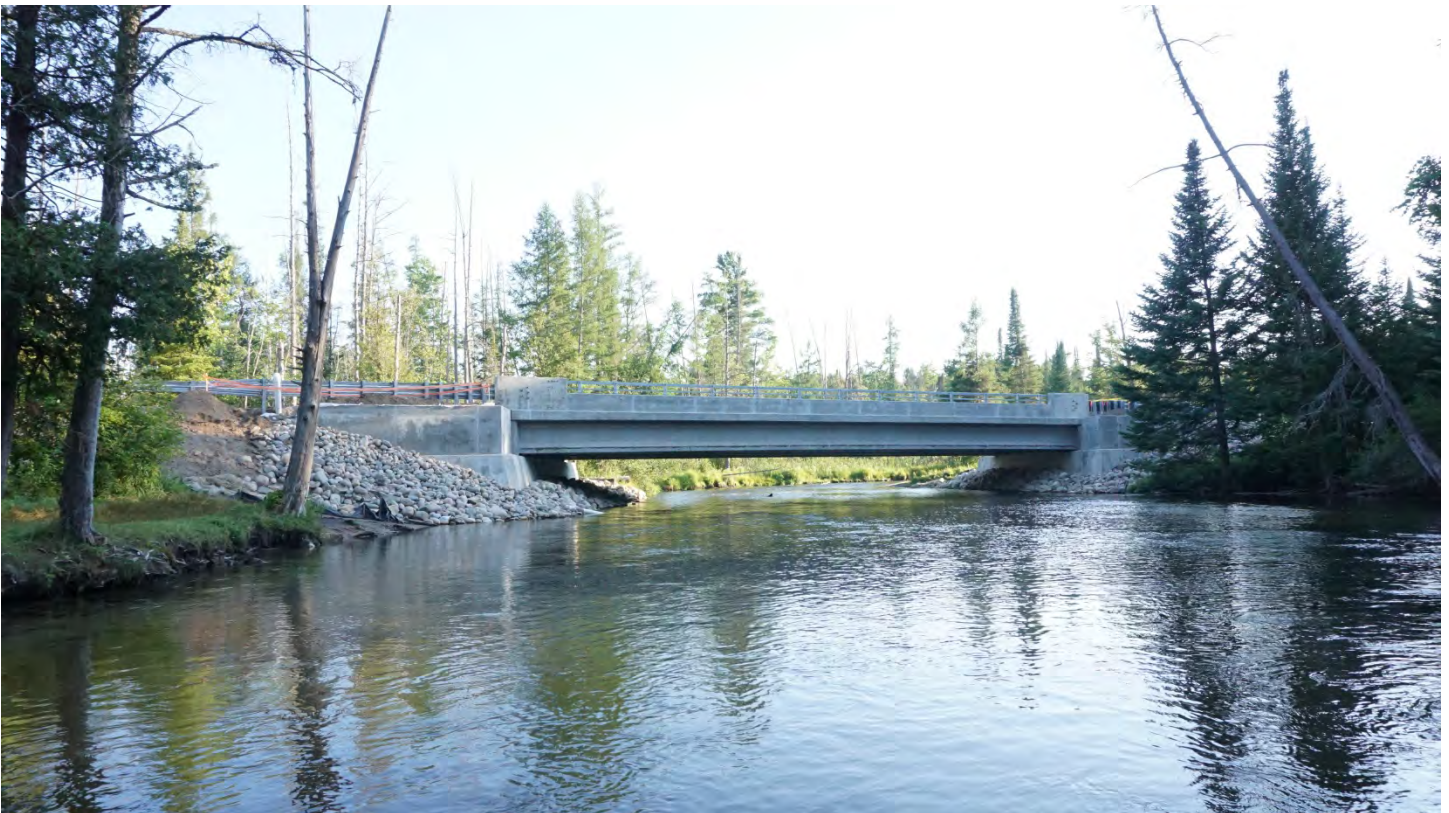
After – Bridges are the preferred structure for mainstem crossings; they allow for a natural stream bottom & the movement of fallen trees, branches, leaves. This is also safer for paddlers.

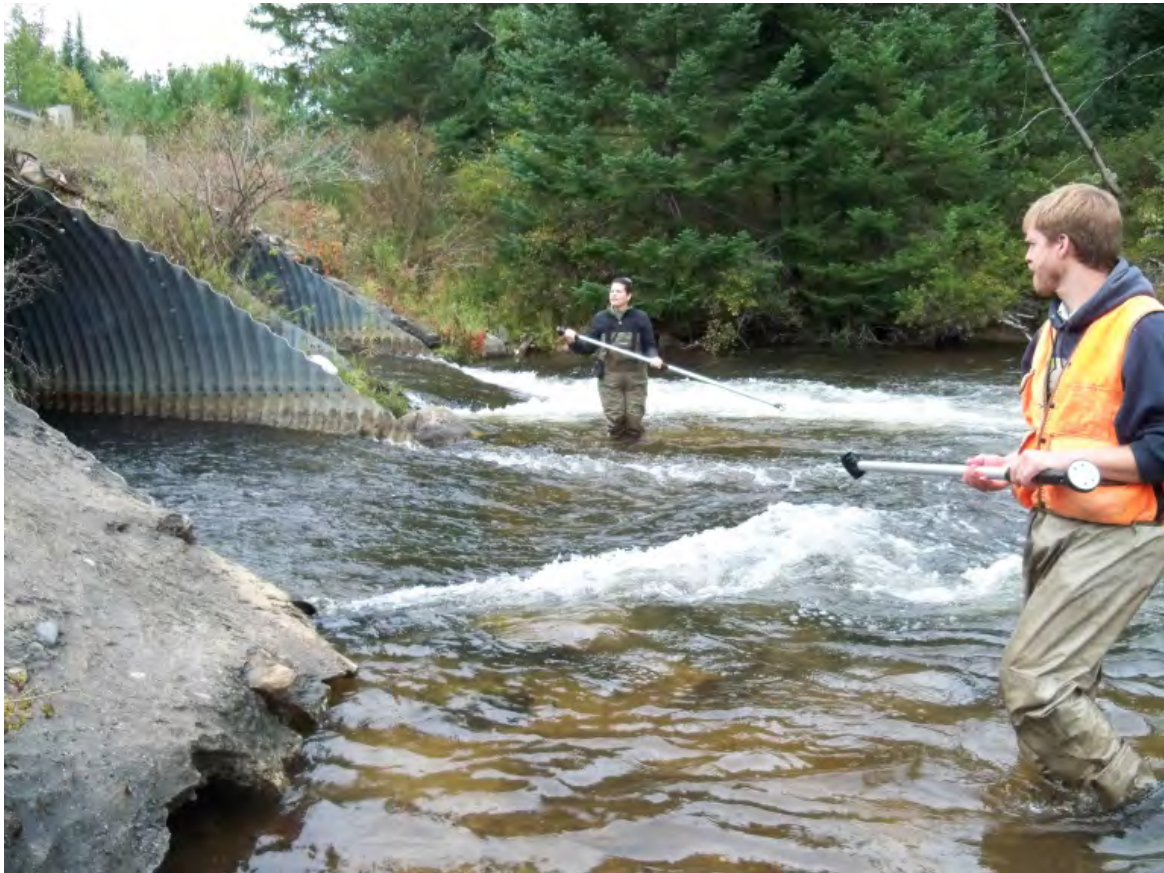
Before - Stream velocities approached 11.5 feet/second, over 5 times higher than what they should be (further upstream it only measured 2.2). The day we took these measurements the river was flowing at 195 cubic feet/second (cfs). For comparison, heavy rain in October 2017 caused the river to spike to 780 cfs. Typical rain events can increase flow to 400 cfs. Imagine a young fish trying to swim upstream through these.

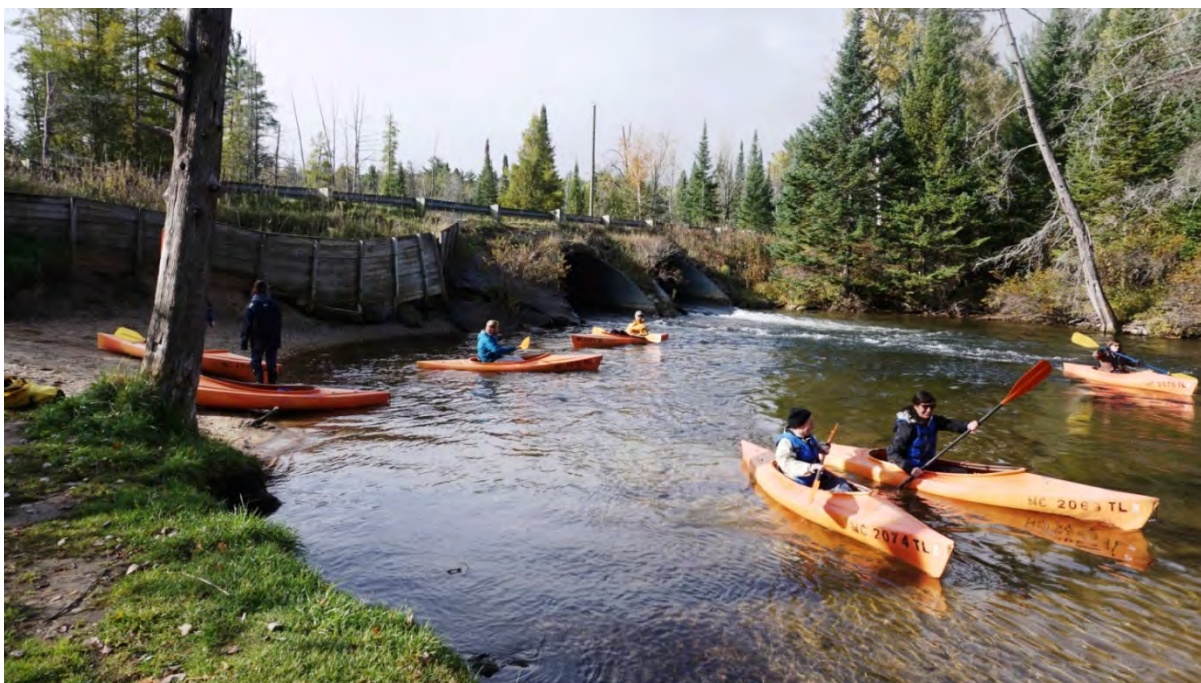
Before - Recreational use at the outlet was heavy; the illicit “driveway” down to the river caused bank erosion and reached out of the road-right-of-way onto private land where 12’ of riverbank had washed away over the years.

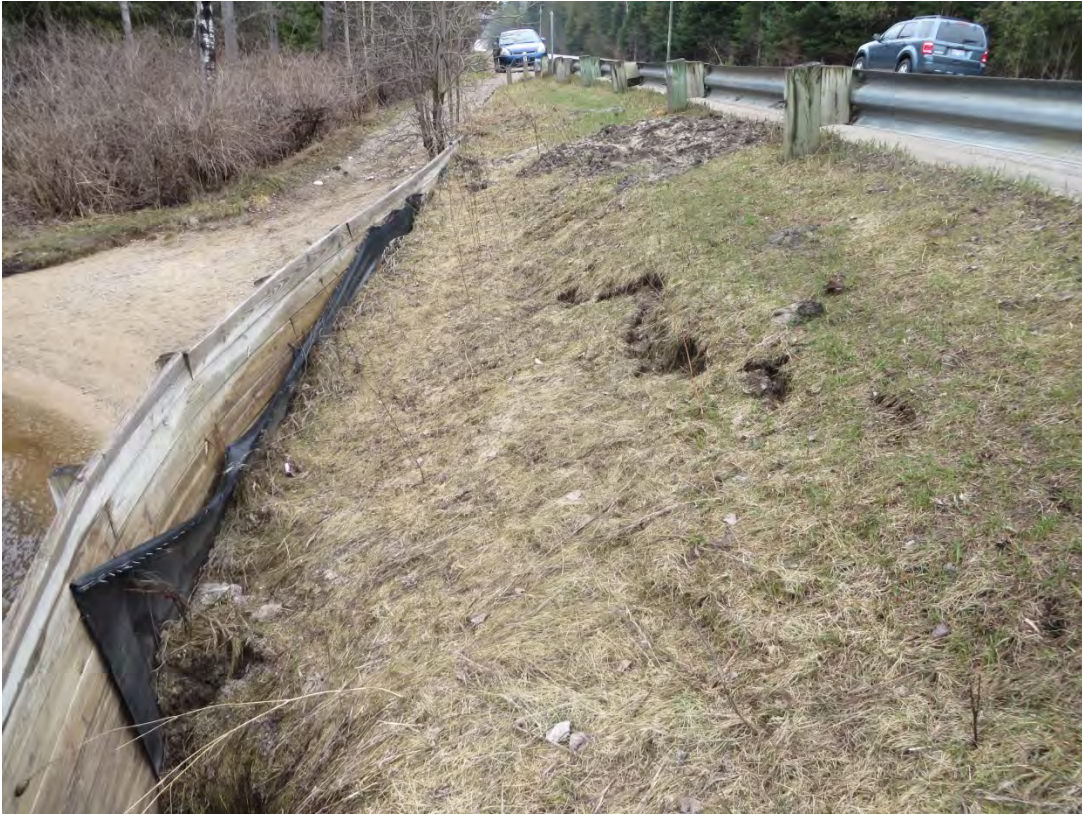
The road embankment was supported by a timber retaining wall that was leaning & close to failure.

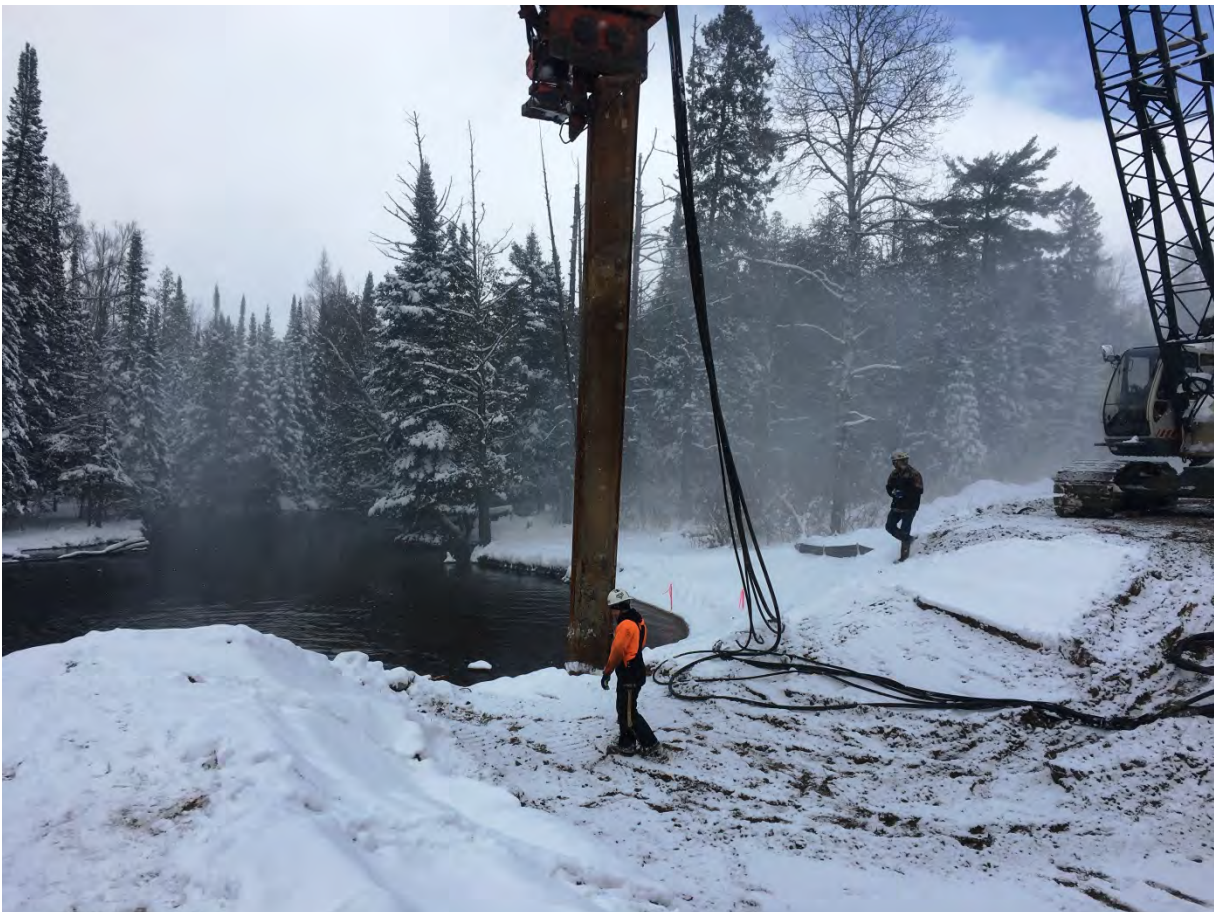
February 2017-Getting started! Driving sheet pile east of the culverts to re-route water & dewater the construction zone.

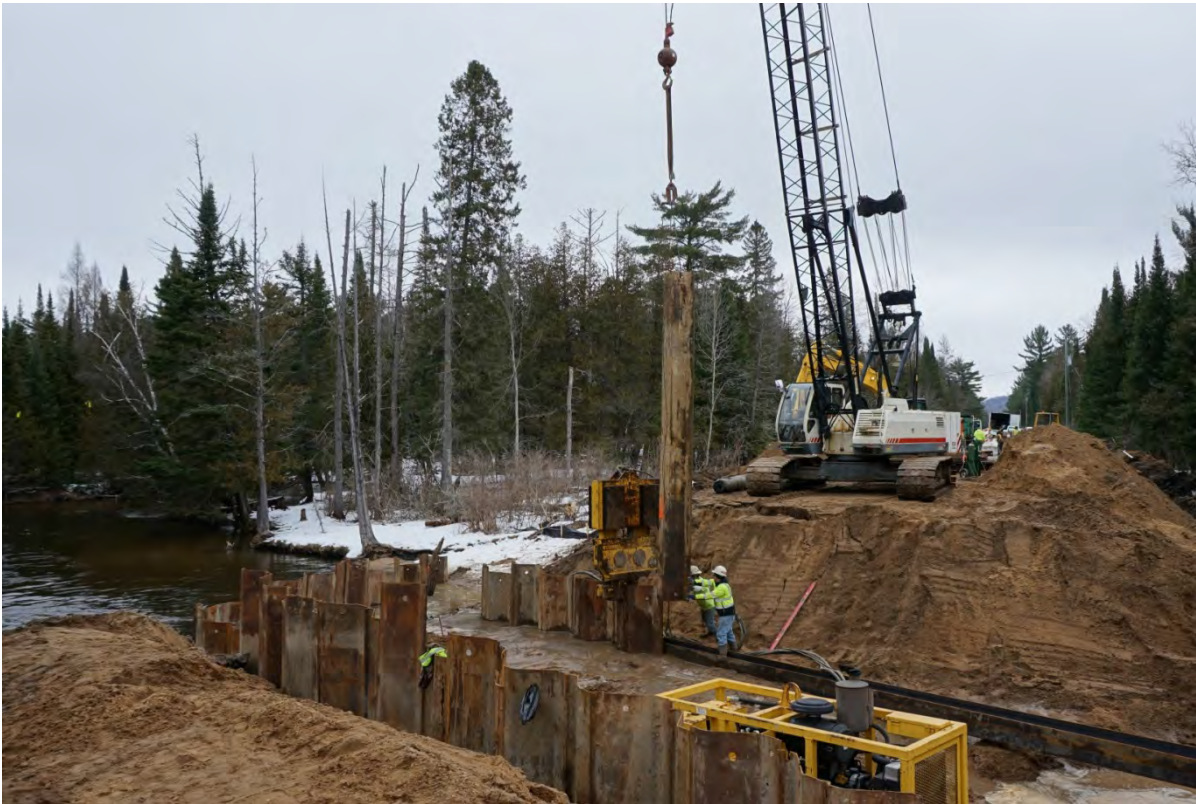
Sheet pile work continues & provides a channel for the river to flow during construction so that the support structure of the bridge can be built in the dry.

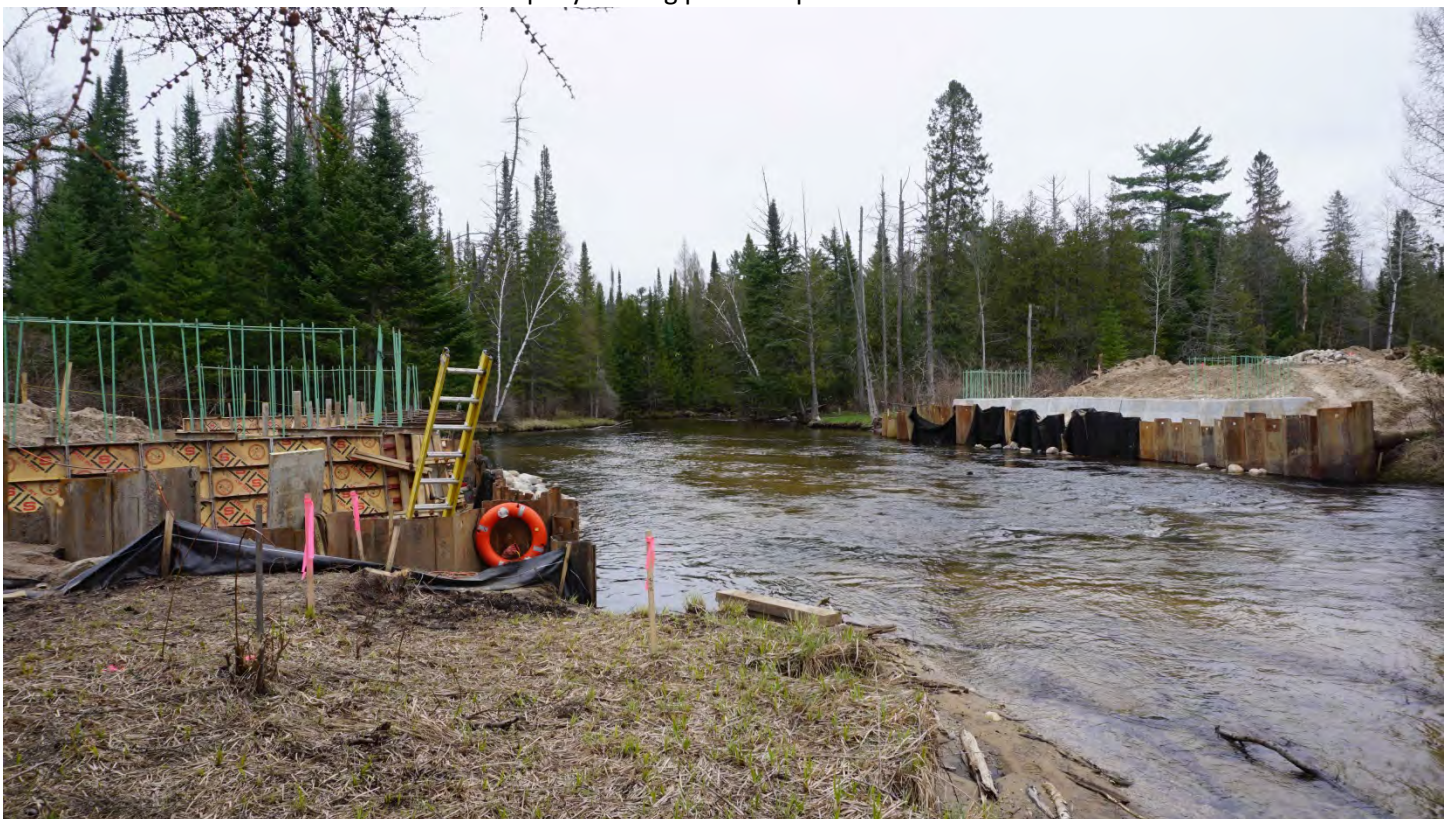
East footing constructed with concrete poured & cured. The “forms” for pouring the concrete are comprised of frames made of green epoxy coated steel rebar & plywood. The rebar provides the “skeleton” & the epoxy coating prevents possible corrosion.

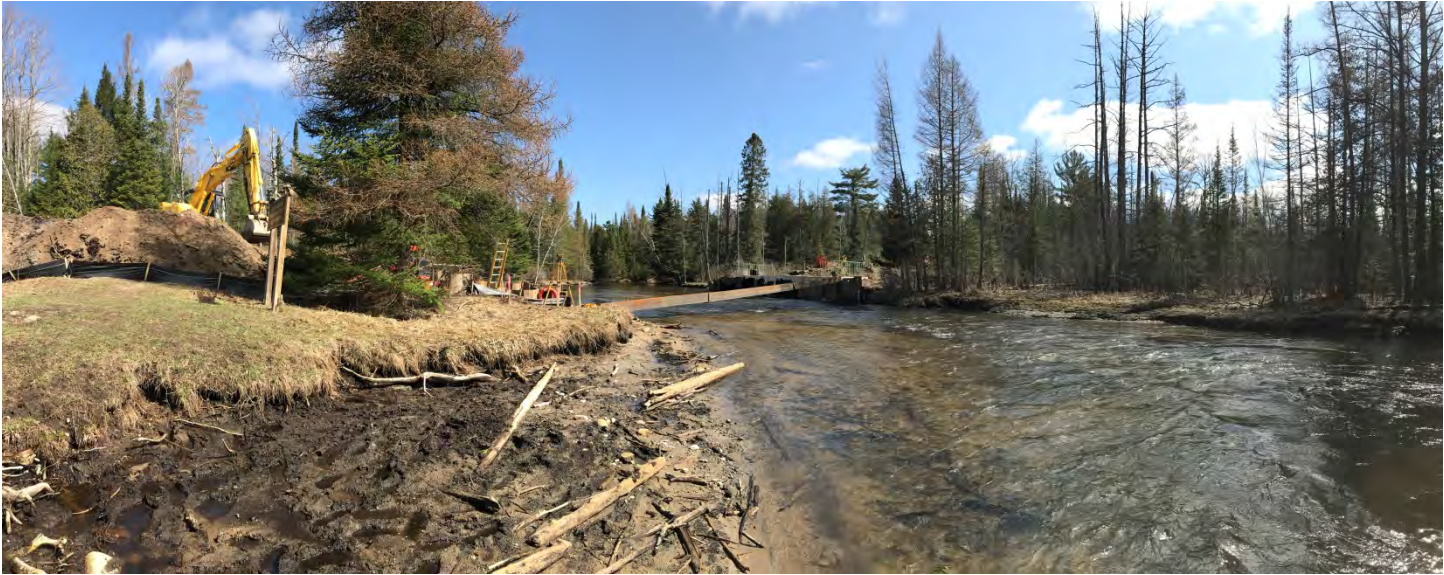
Removing the culverts allows the river to “breathe.” Note the area in the lower left corner that was previously submerged.

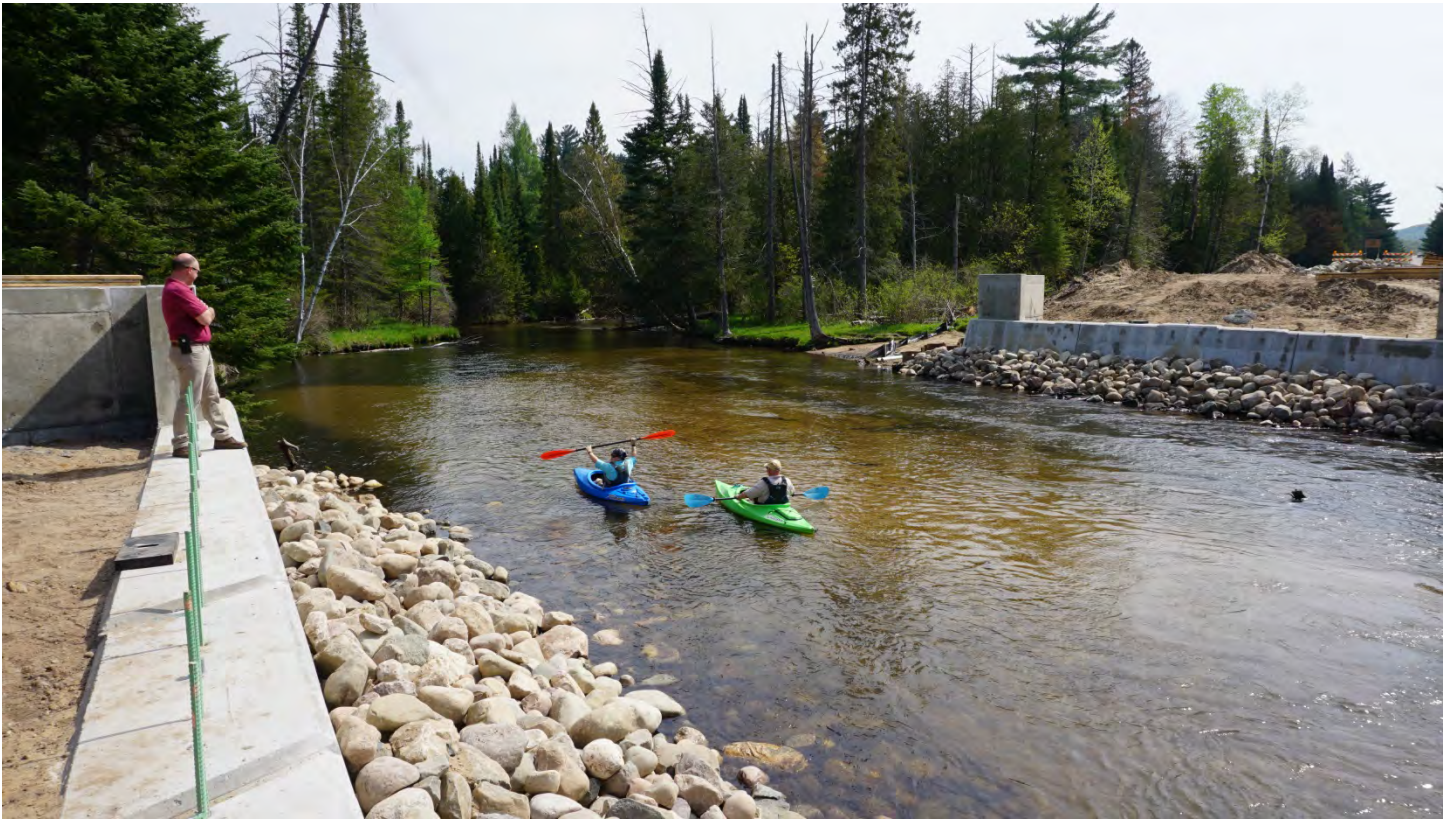
Footings & wingwalls are constructed. Kayakers enjoy the free flowing river, one of them paddling the Jordan for the first time. Road Commission Engineer-Manager, Burt Thompson, looks on.

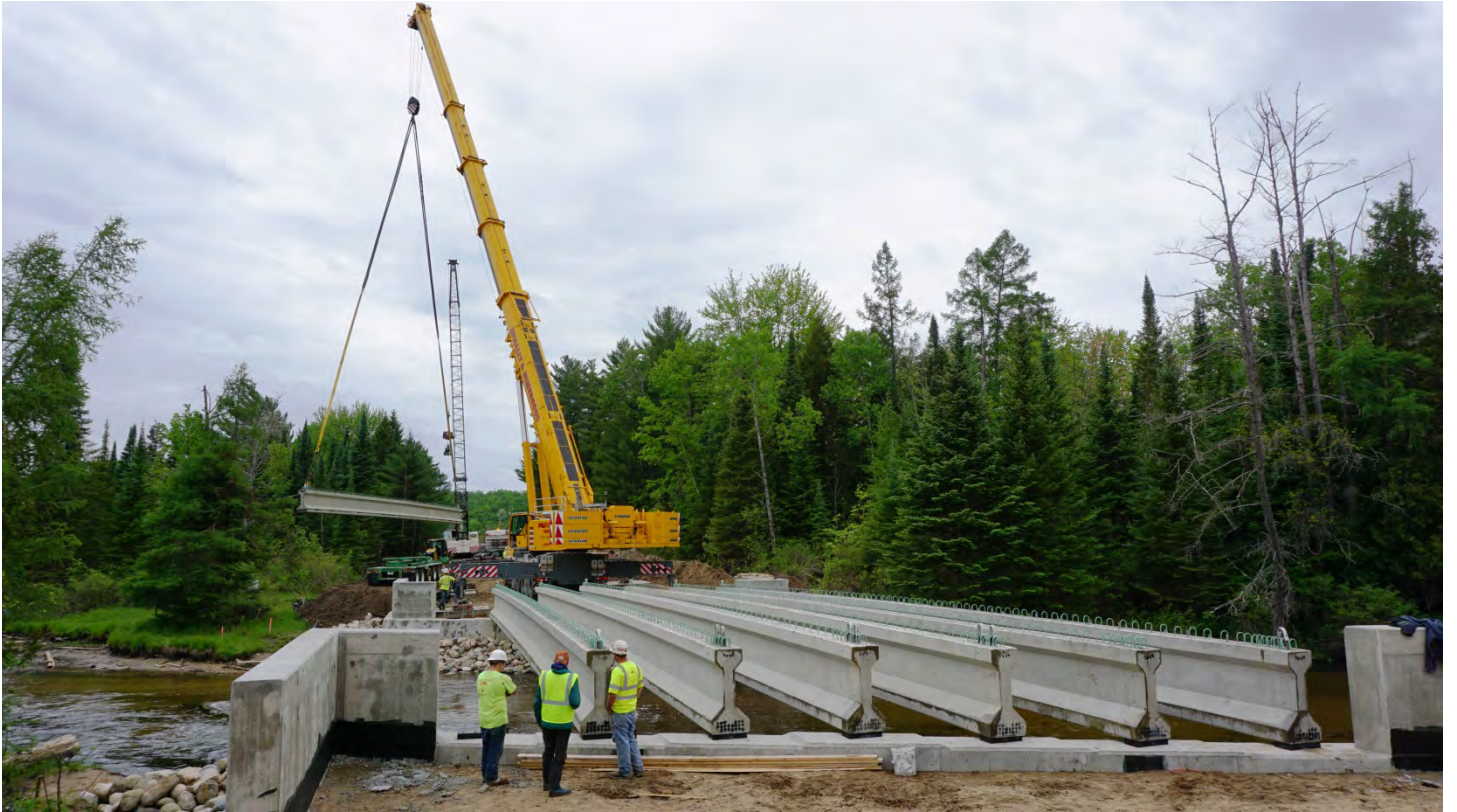
Beam day! Seven concrete I-beams weighing 26 tons each, measuring 88' in length were set to comprise & support the deck.

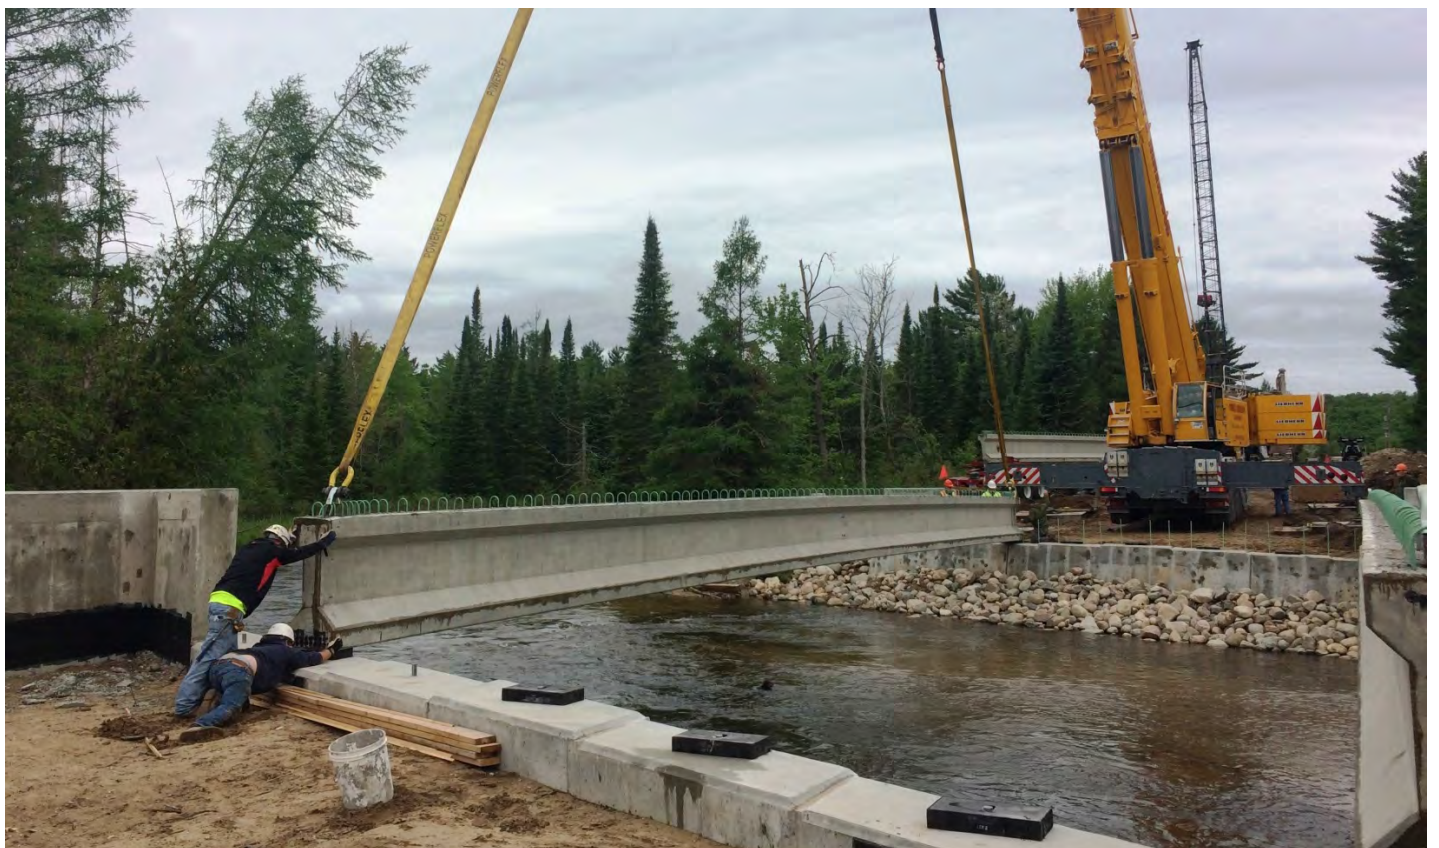
Because of their size, beams were trucked individually up from Kalamazoo where they were cast. Semi-trucks backed almost a half mile down the road from the highway to the site, where a crane took it from there.

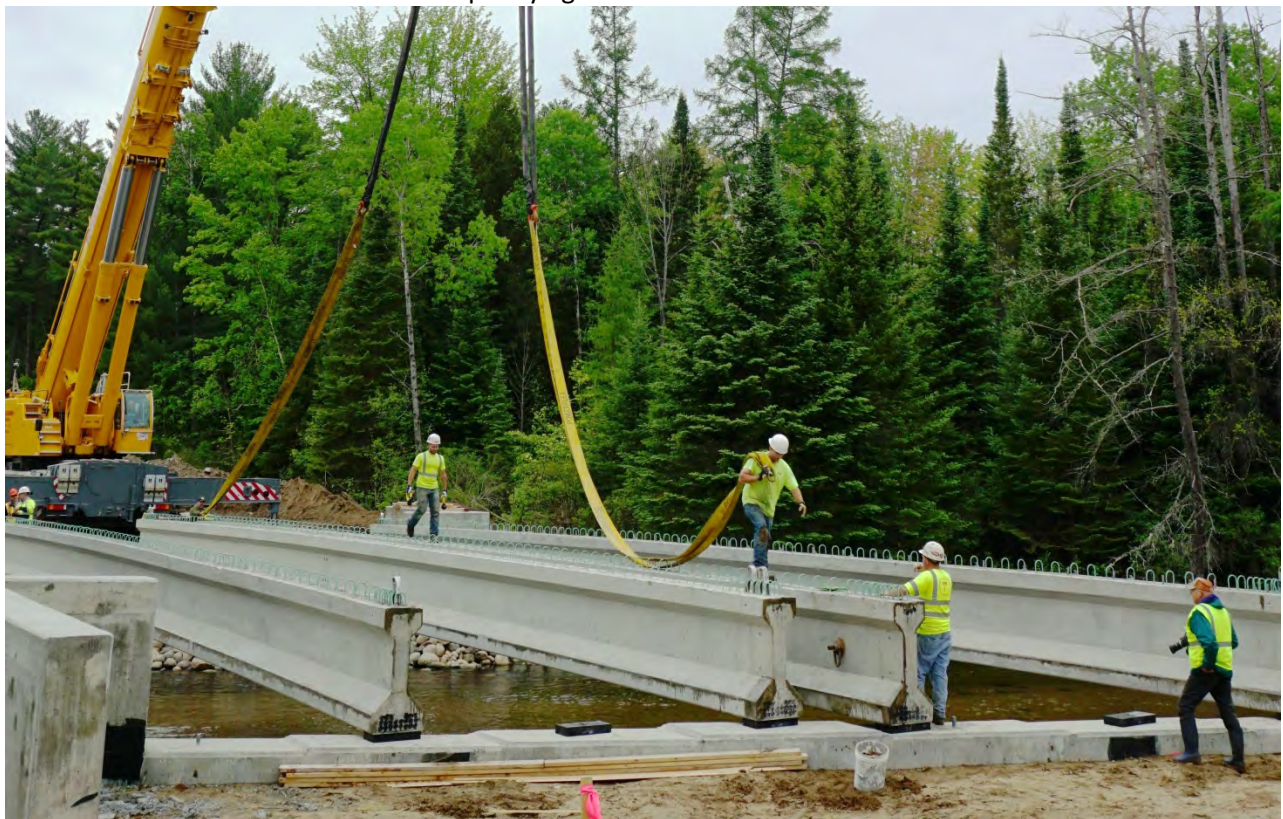
Workers have to be pretty agile & able to balance for this beam work.

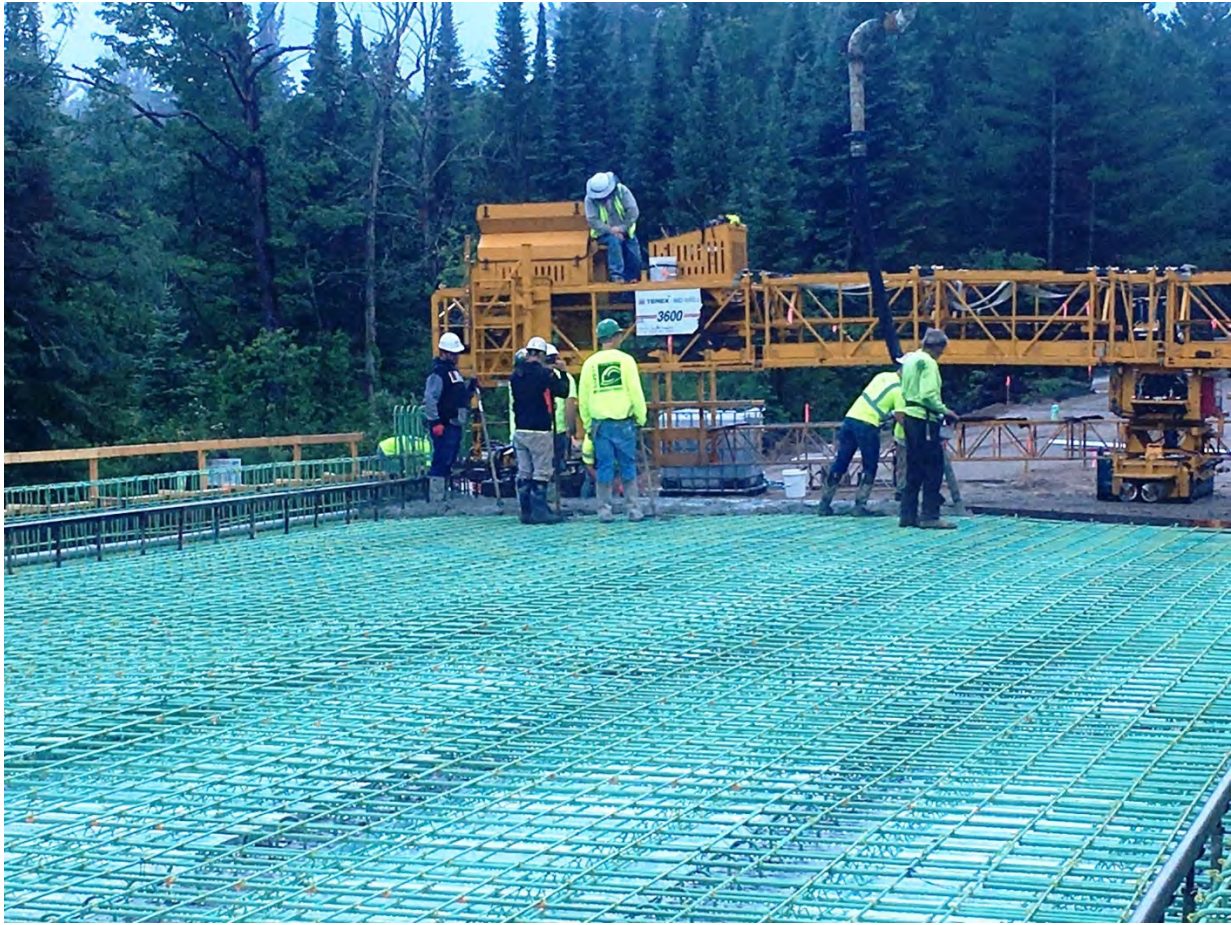
Pouring the concrete deck! Looking at the concentrated steel rebar form for this, you know it will be sturdy.

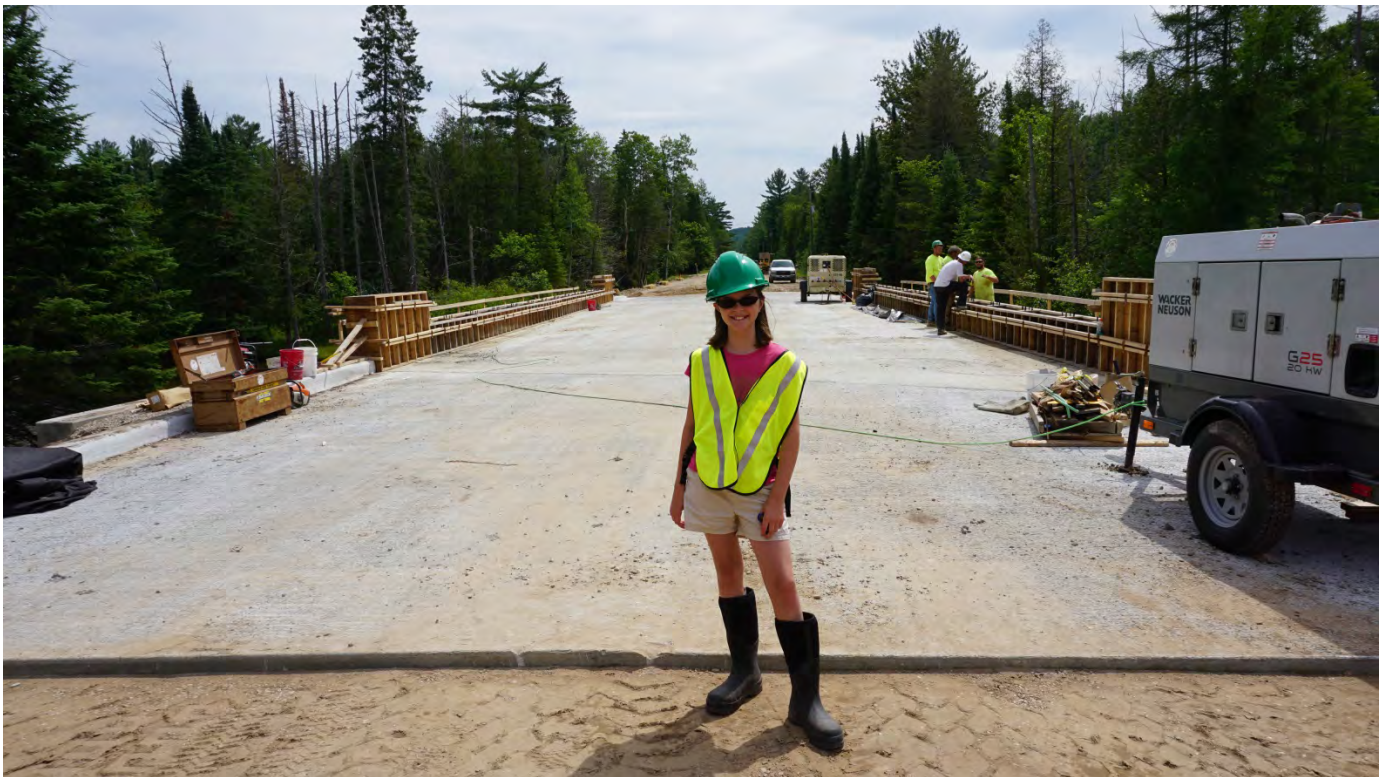
Bridge deck looks awesome & accommodates two 6' wide shoulders & two 11' wide vehicle lanes for a total width of 34' versus the former 25' width.

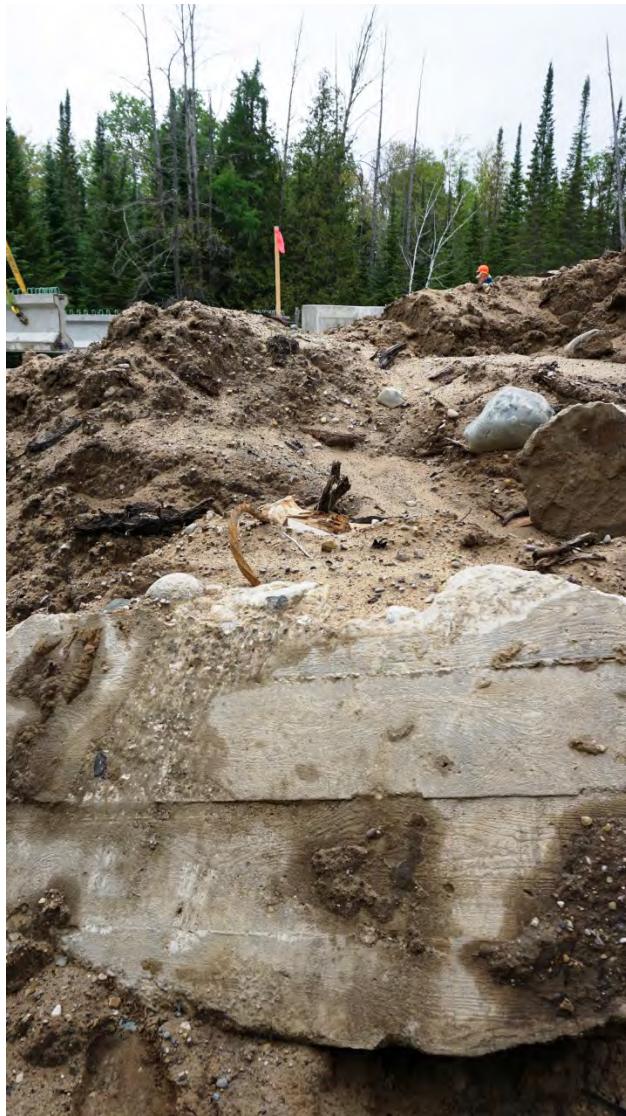
Replacing old with new. There was originally a bridge at this site before the culverts were installed in the 1960s. An old bridge concrete abutment was excavated during construction. Note the wood grain impressions from the form used to pour & set it.

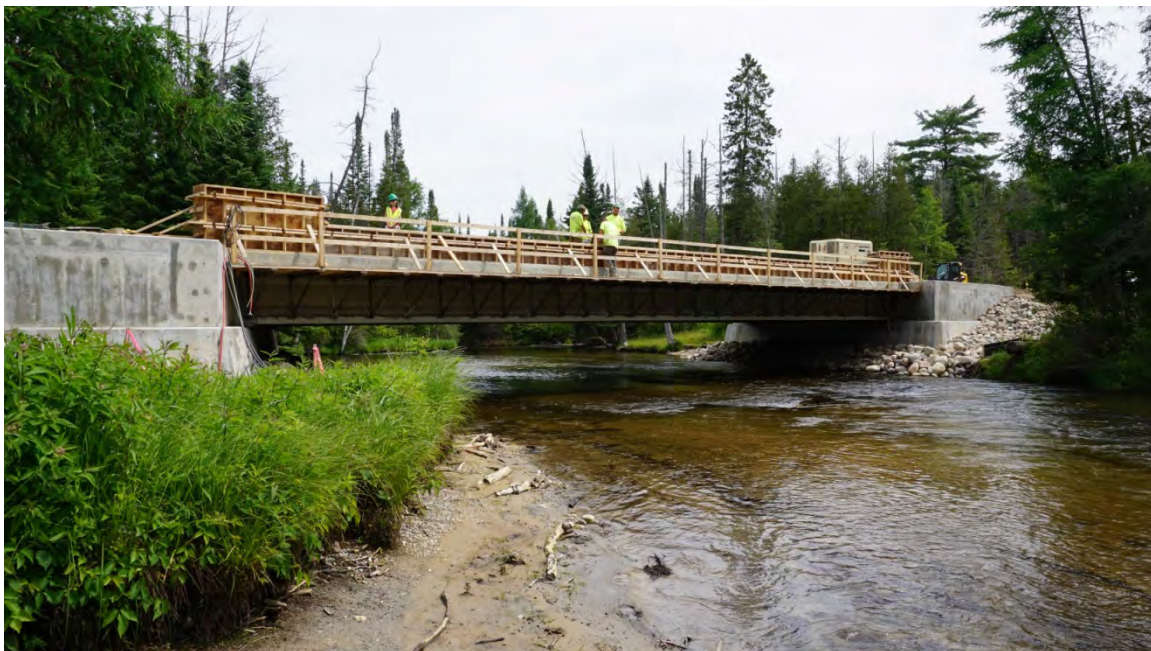
Getting ready to pour the end sections & side walls of the bridge rails.

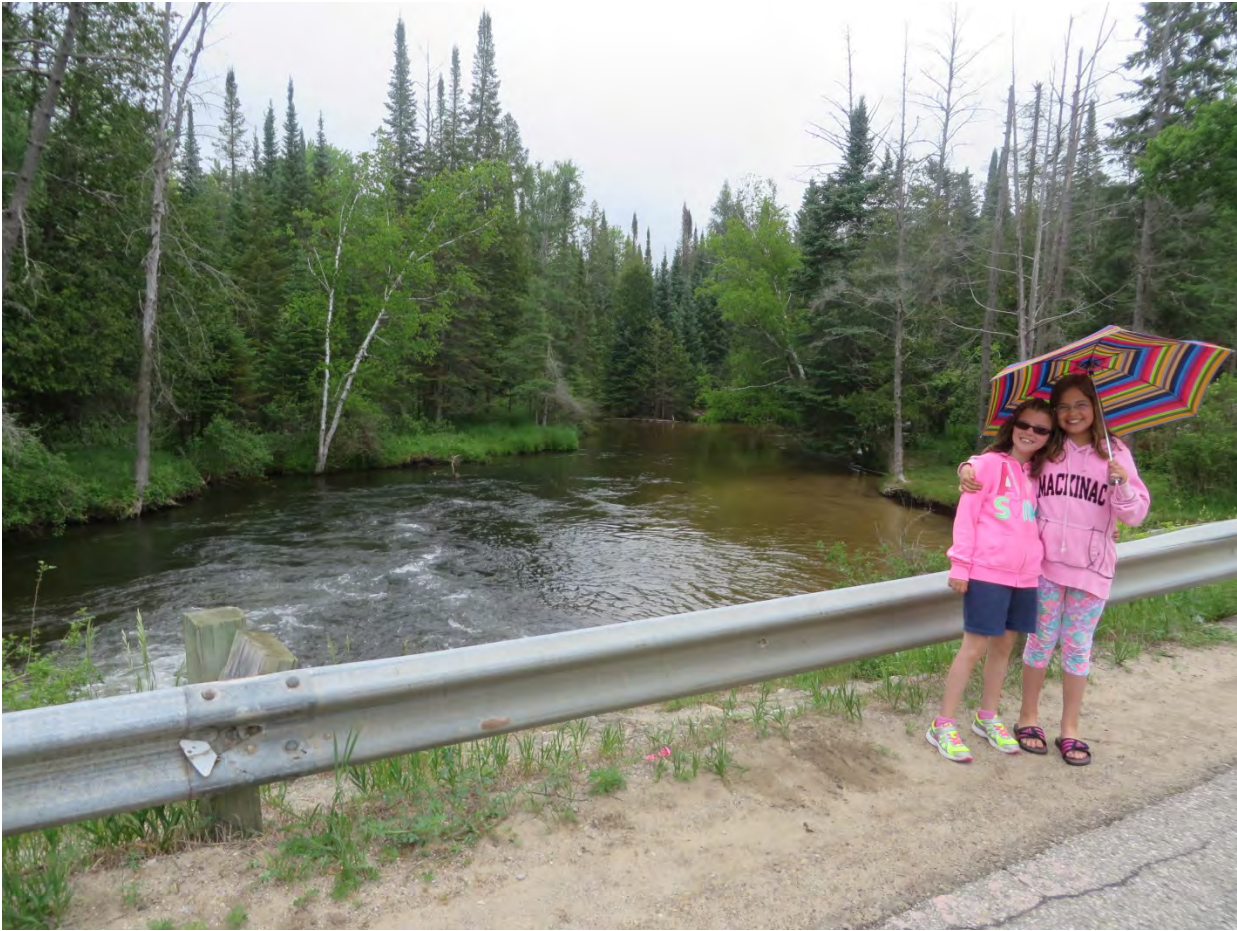
Before – The old guardrail & sandy road shoulders weren't ideal.

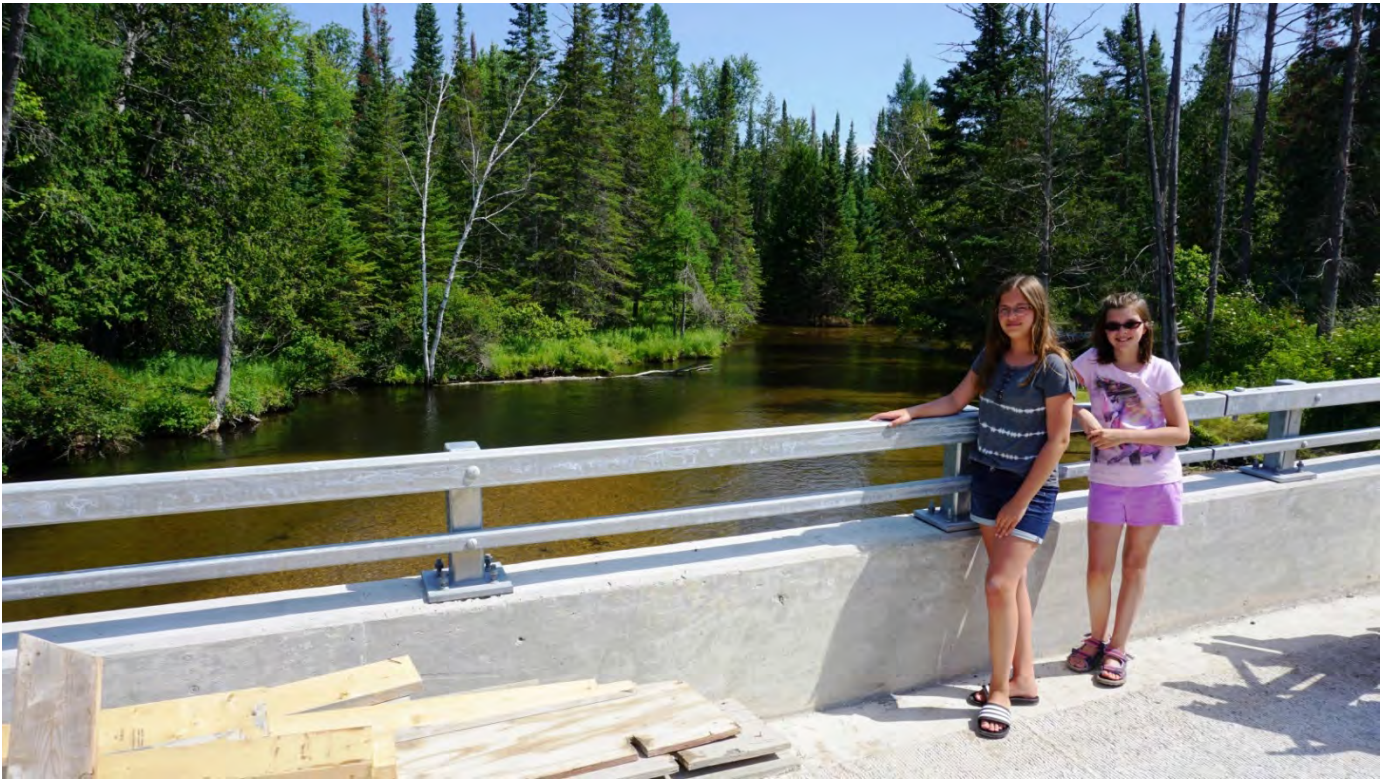
After - Bridge rails are 54" high & have parapet tubing; they are safe for both pedestrians and vehicles.

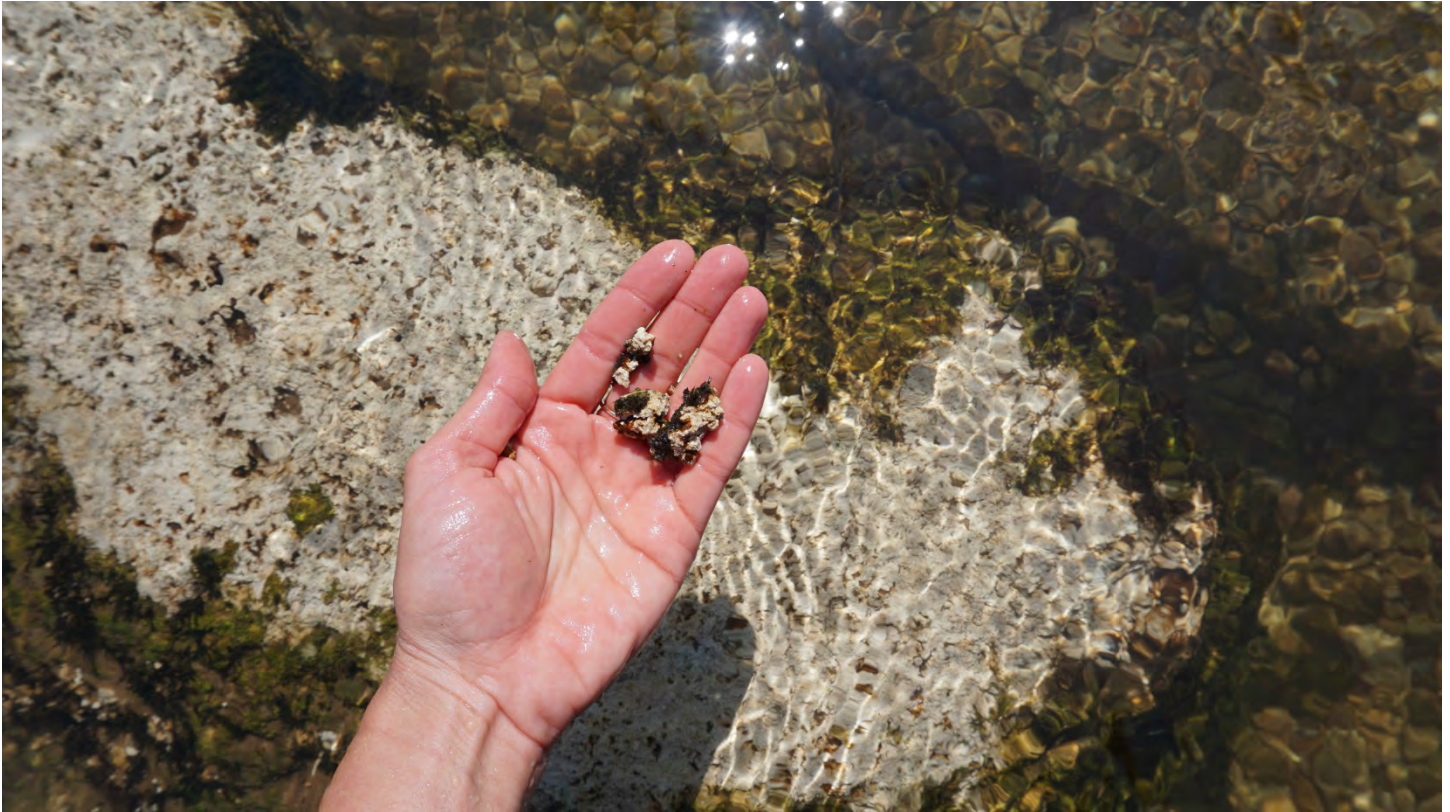
For the last 50+ years the undersized culverts caused marl to build up as hard formations at the inlet reaching 800' upstream. This will gradually wash away over time to reveal the natural stream bottom.
