Jordan River Chestonia Bridge Project Photo Report

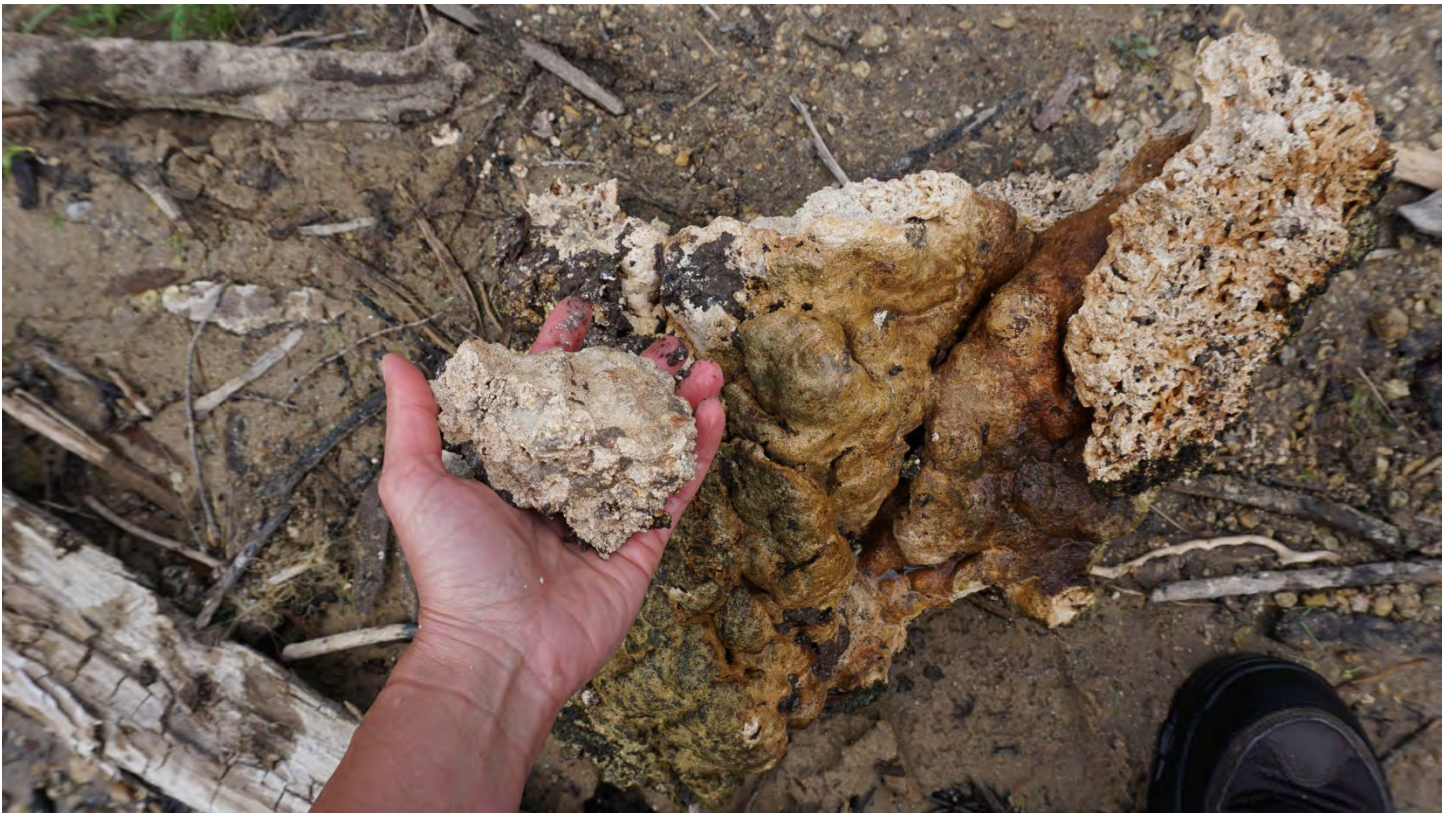
Marl formations are sizeable and actually pretty interesting; rust color shows the presence of iron in the water. Some of it was chipped away for paddler safety, most of it will have to wash away over time.

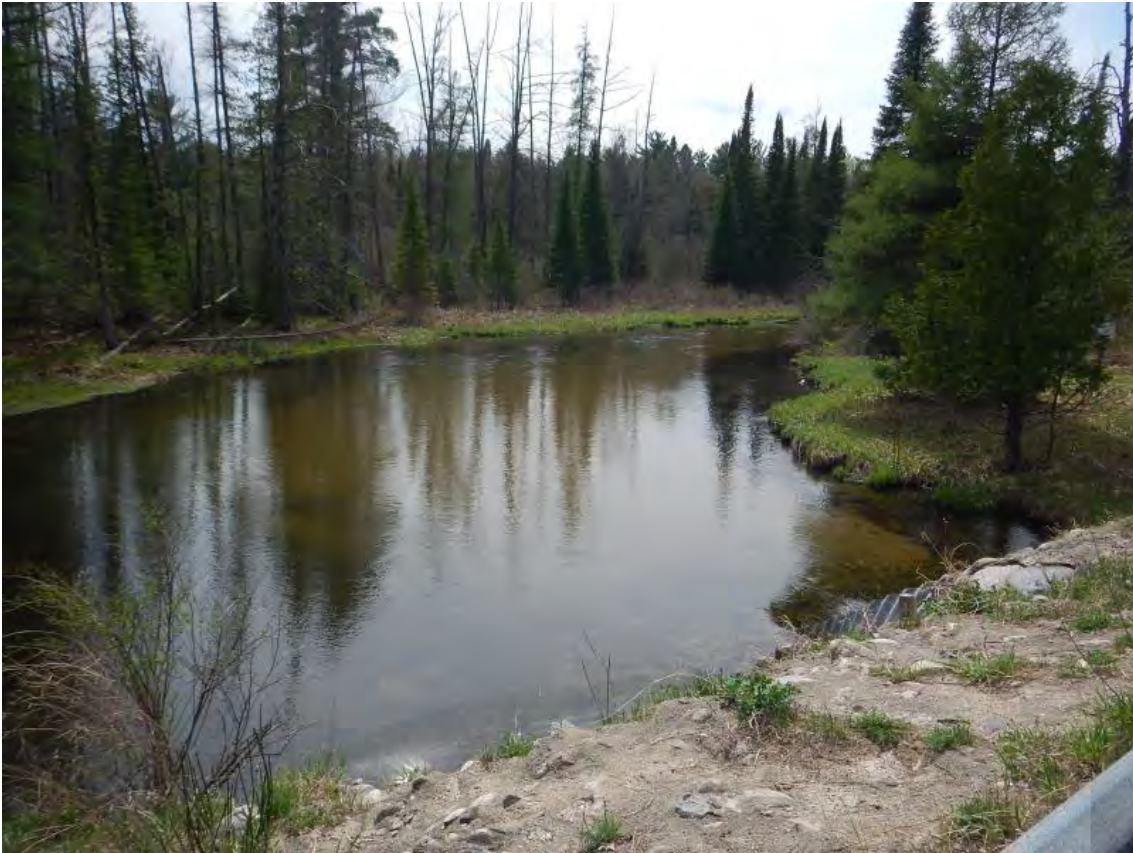
Before – Looking upstream from the crossing; the river was slow & wide. Areas like this can get warm & shallow, not ideal habitat for fish & aquatic insects. The embankment above the culverts was continually eroding.

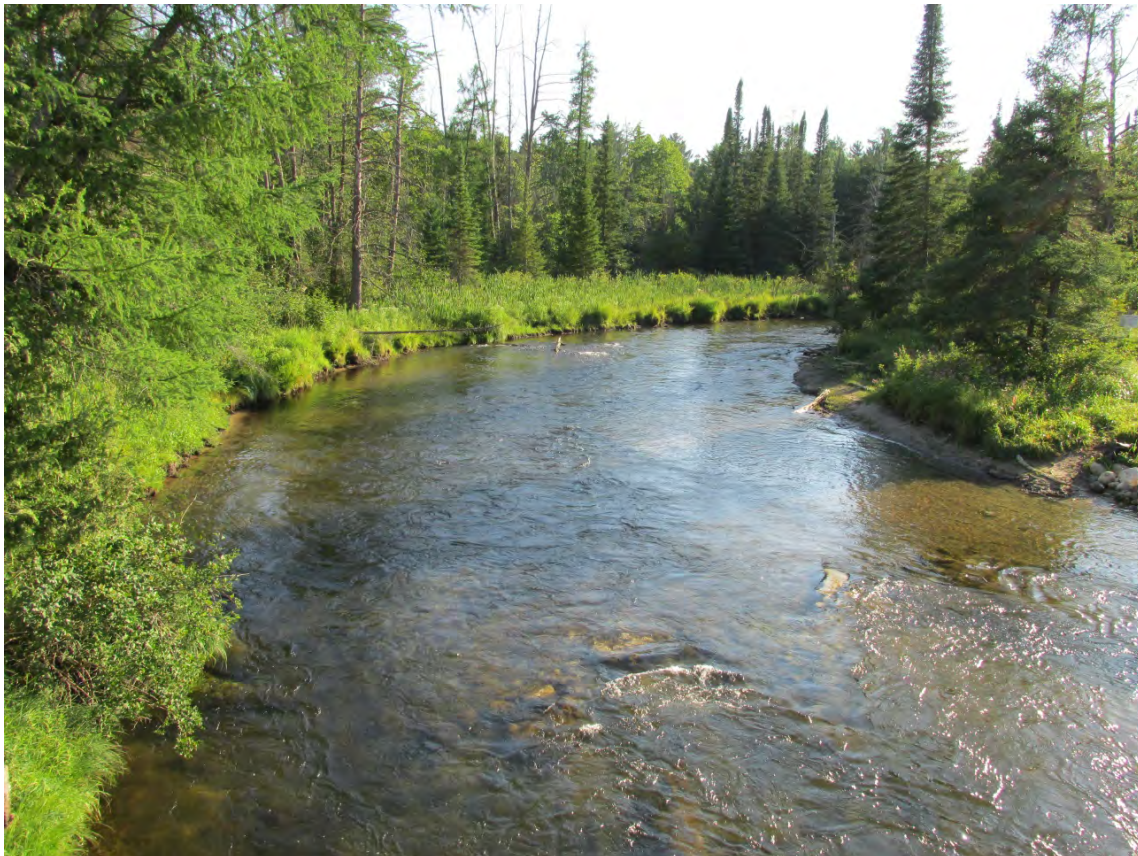
After – The same view, note how the current is fast & river has narrowed. No more eroding embankment to be concerned with either.

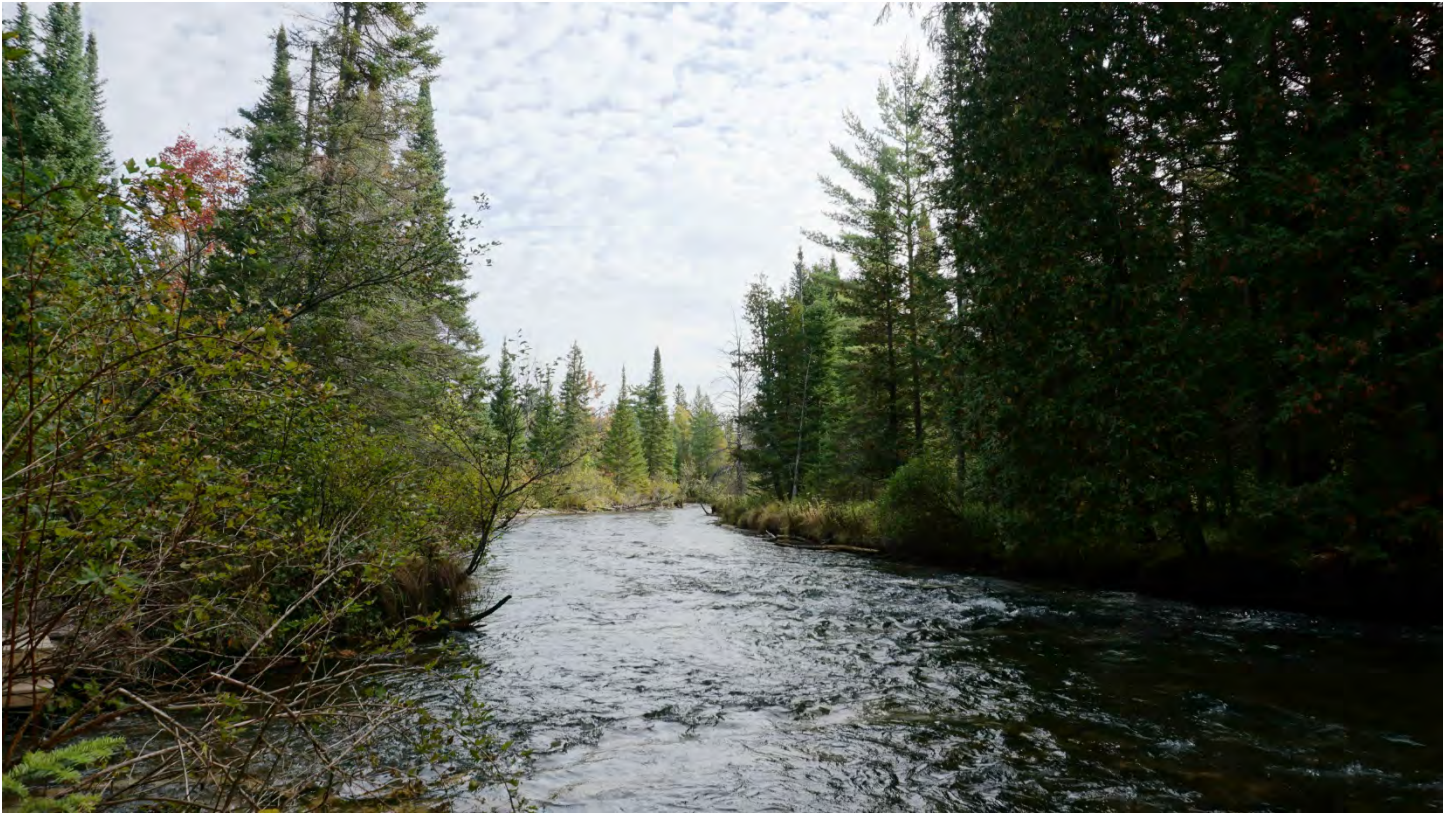
After – About 800' upstream of the crossing, the Jordan River is a model of a healthy Great Lakes stream corridor, attesting to why it is important to resolve anthropogenic disturbances before they get even worse.
