Boardman River Dam Removal, River Restoration & Cass Bridge - Project Photos

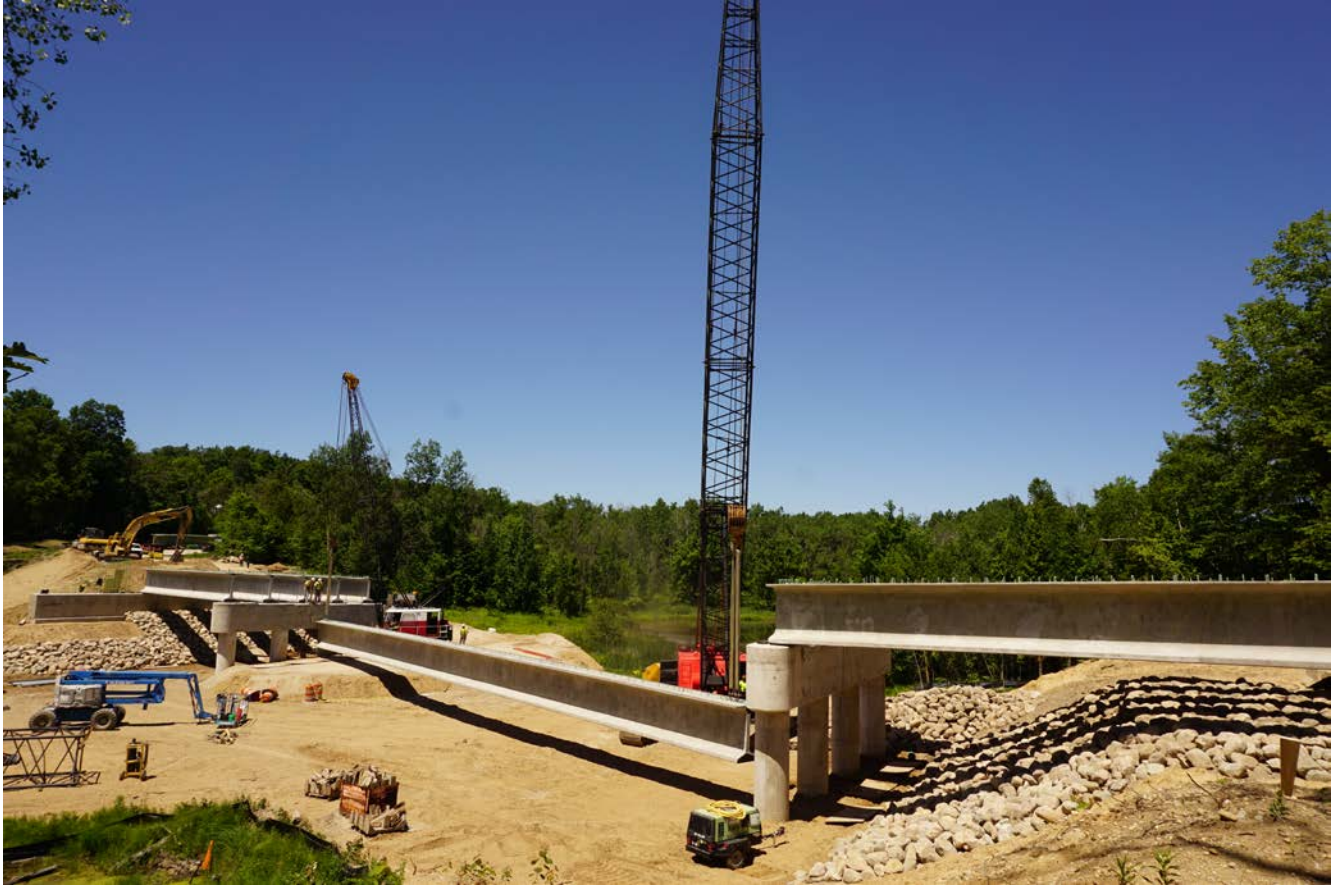
June 2016 - Cass Road Bridge project underway with 135' center beams being set

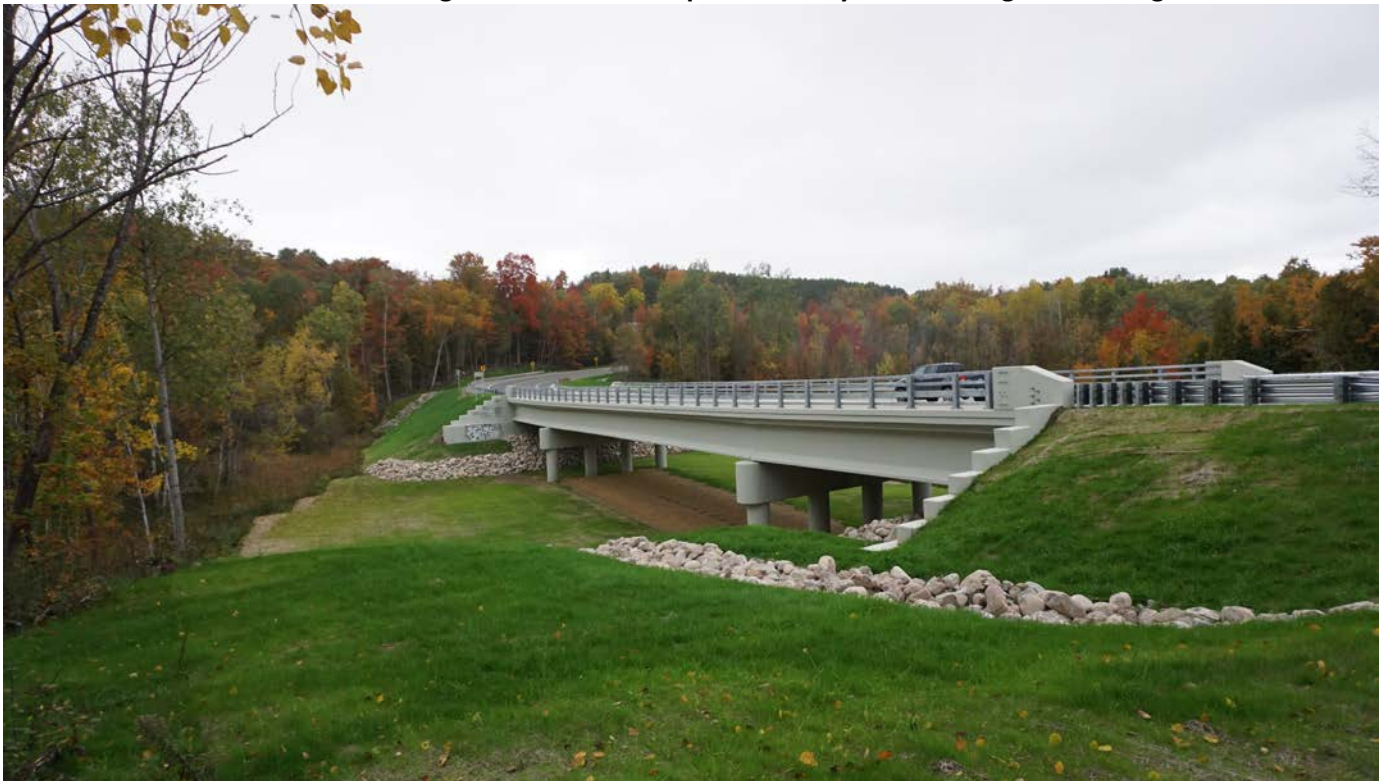
October 2016 – Cass Road Bridge construction complete & ready for returning river to original location

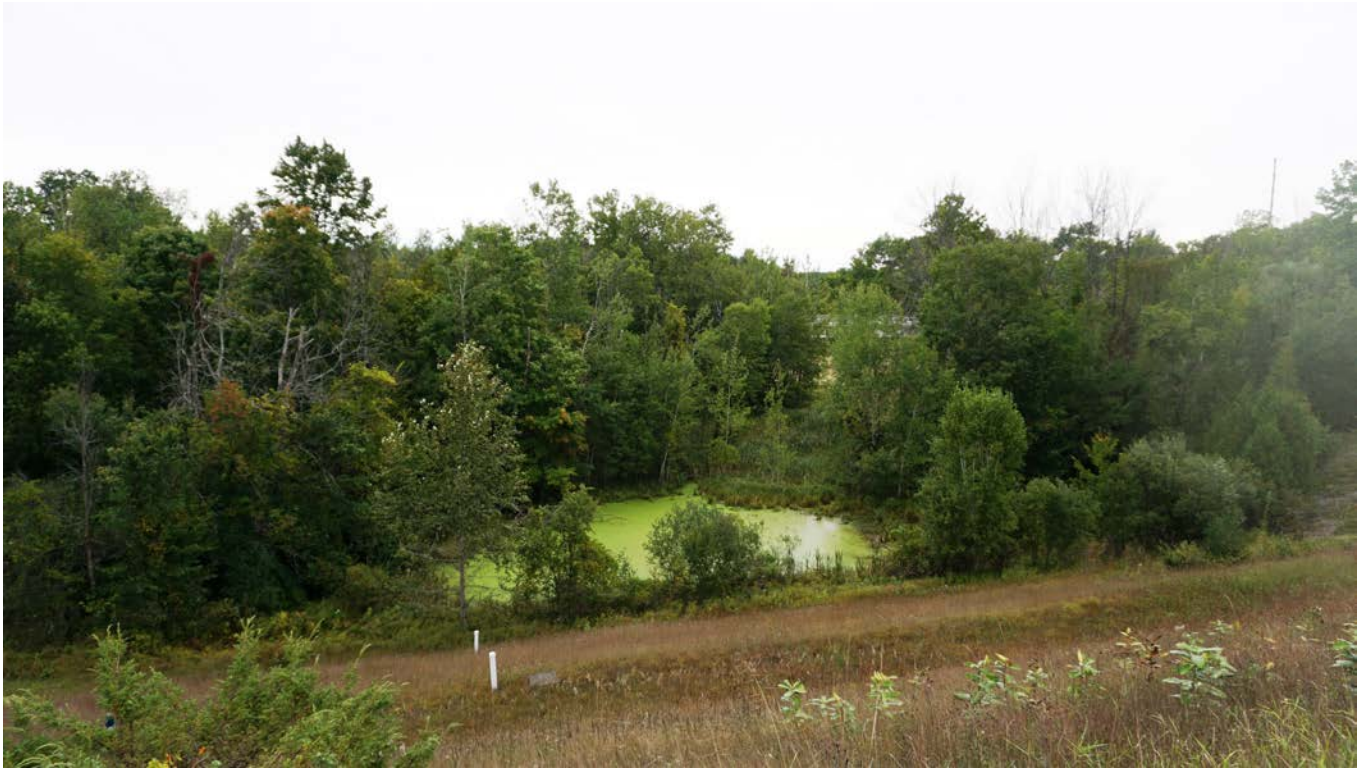
October 2016 – Standing on Boardman dam earthen embankment/concrete wall looking downstream to Cass Road Bridge, barely discernible behind trees. Standing water is evidence of seeps from original river channel.

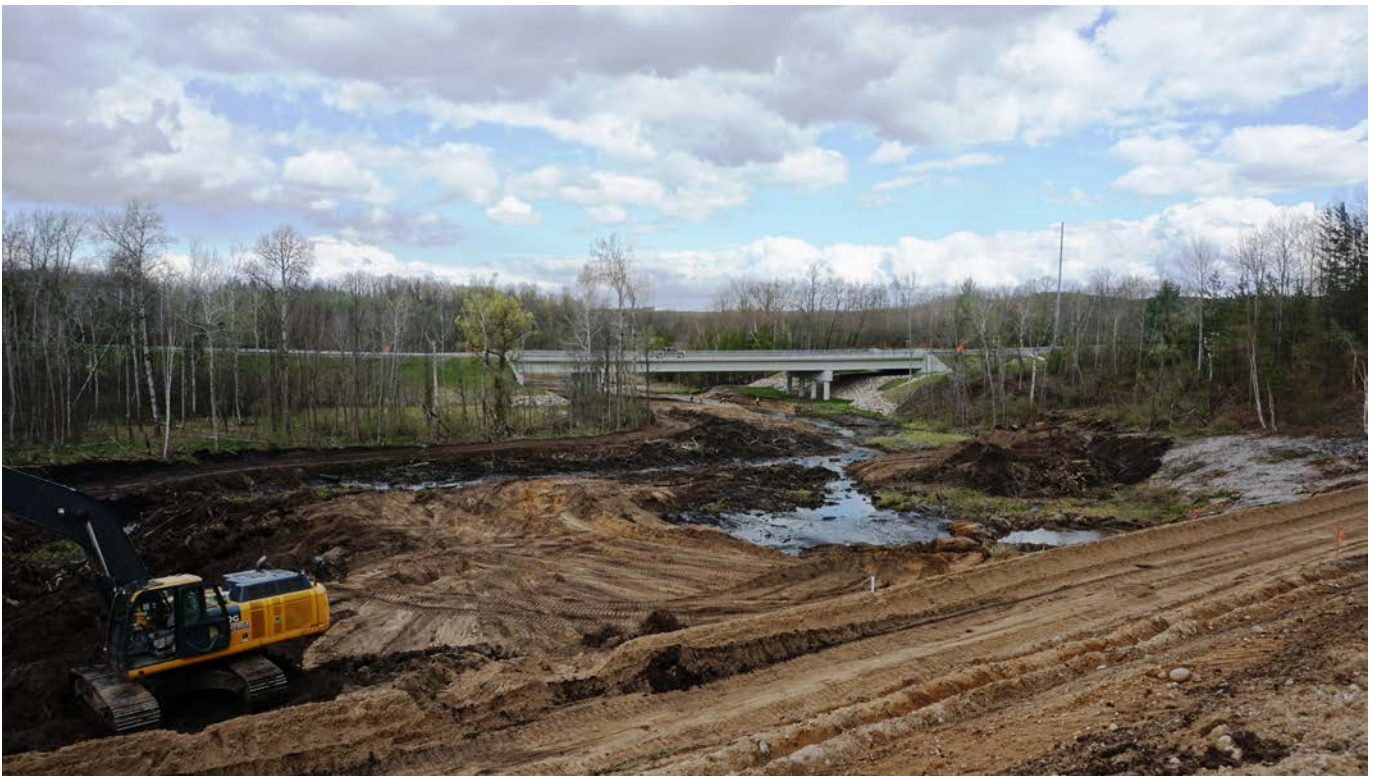
April 2017 – Getting ready to return the river to its original streambed; building the channel.

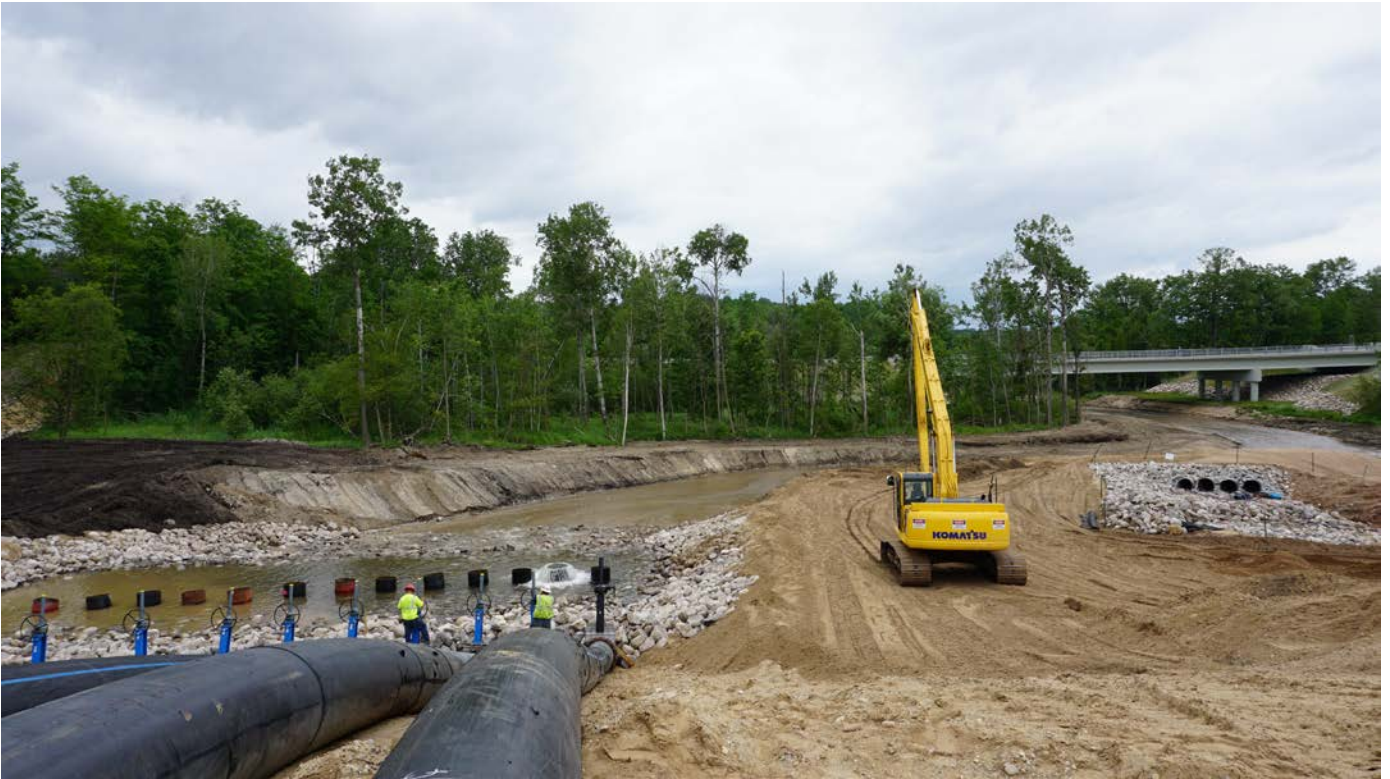
June 2017 – Siphons to drain the impoundment are being tested & auxiliary channel to the right is being built.

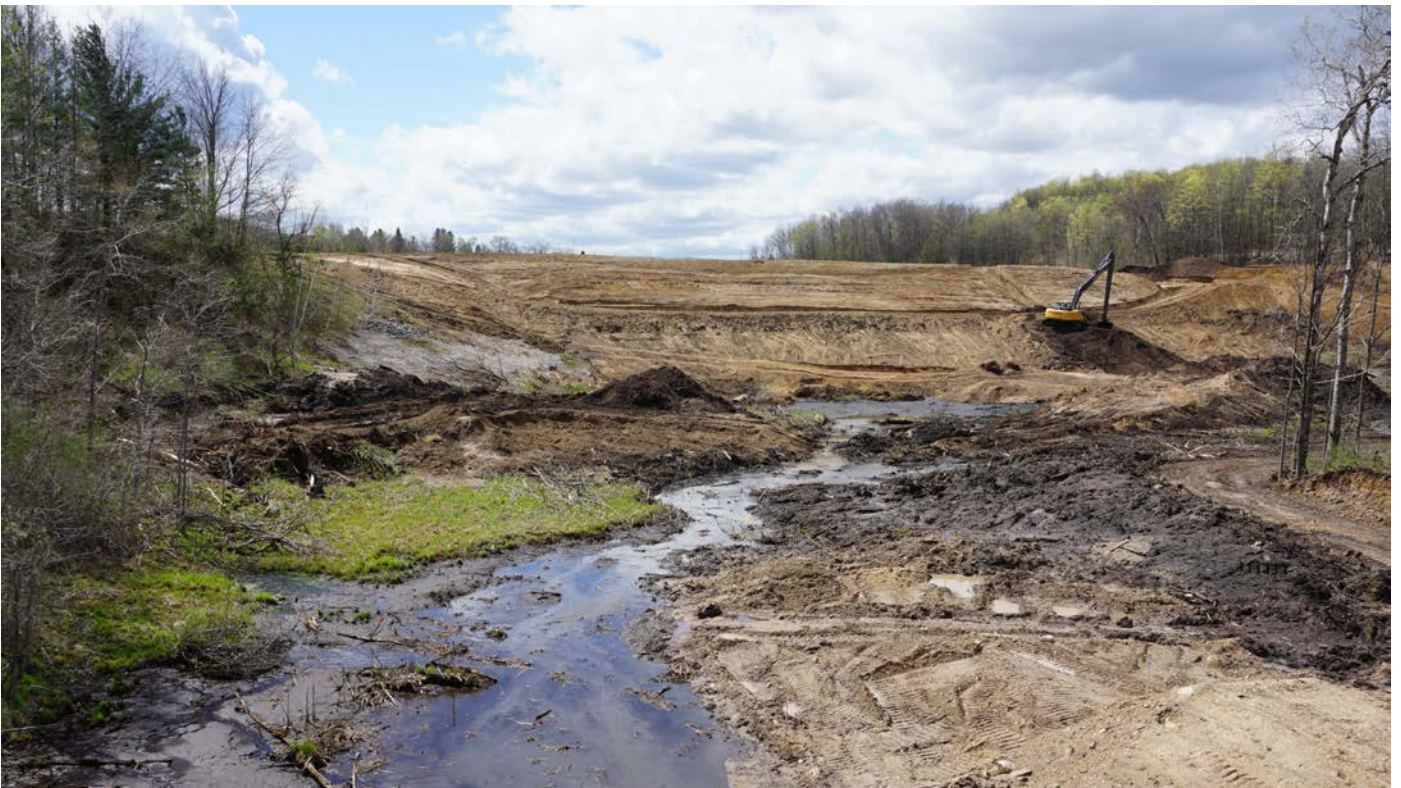
April 2017 – Looking upstream at earthen embankment/concrete wall of Boardman Dam as it is starting to be removed & a river channel created. The 78 acre impoundment is behind this wall.

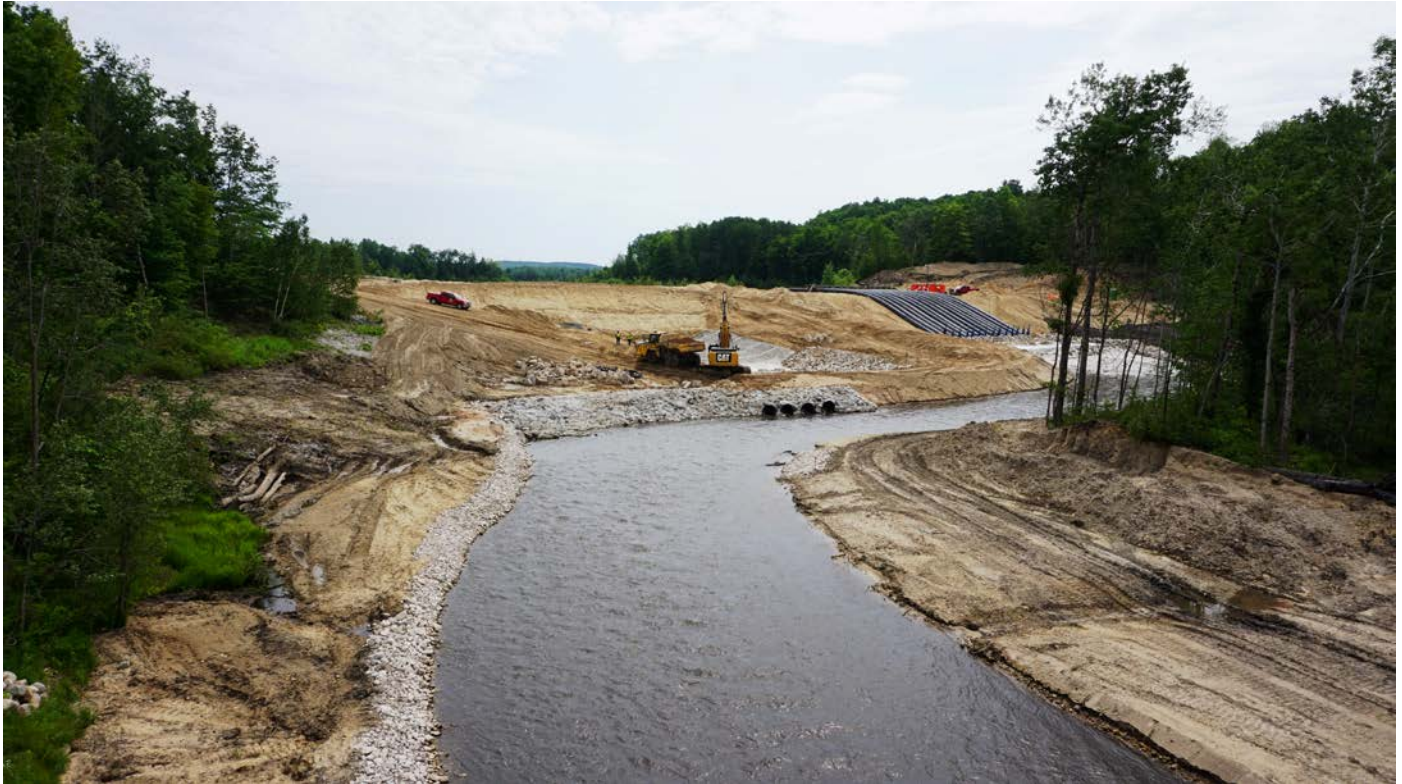
June 2017 – Looking upstream at dam; siphons are in full operation draining the impoundment & auxiliary channel being constructed. Once the gravity fed siphons have drained the pond as far as they can go, the rest of the impoundment will be drained by the auxiliary channel while the siphons are removed & the river channel is finished being built in their place.

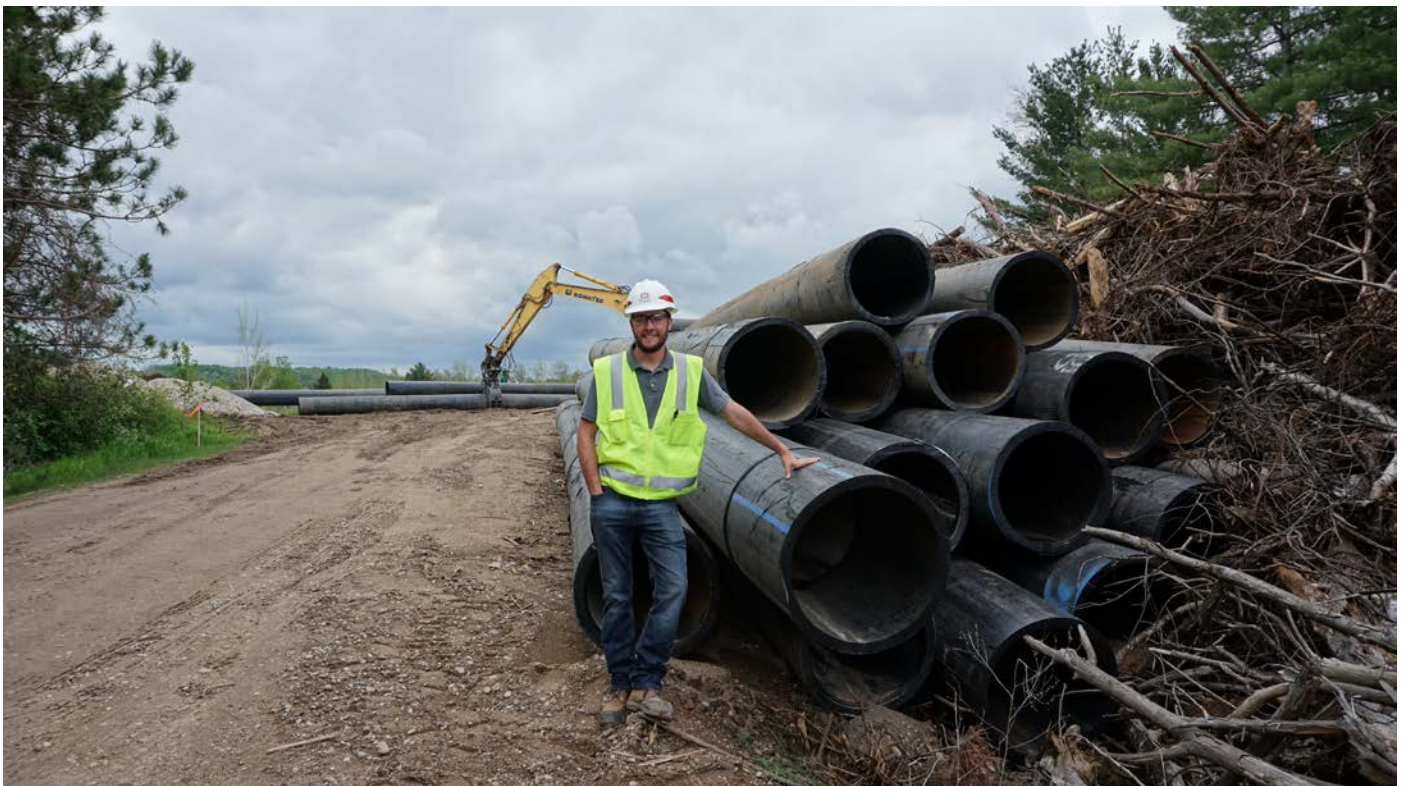
May 2017 – Siphons are comprised of 30' diameter pipes fused together to make 300' lengths.

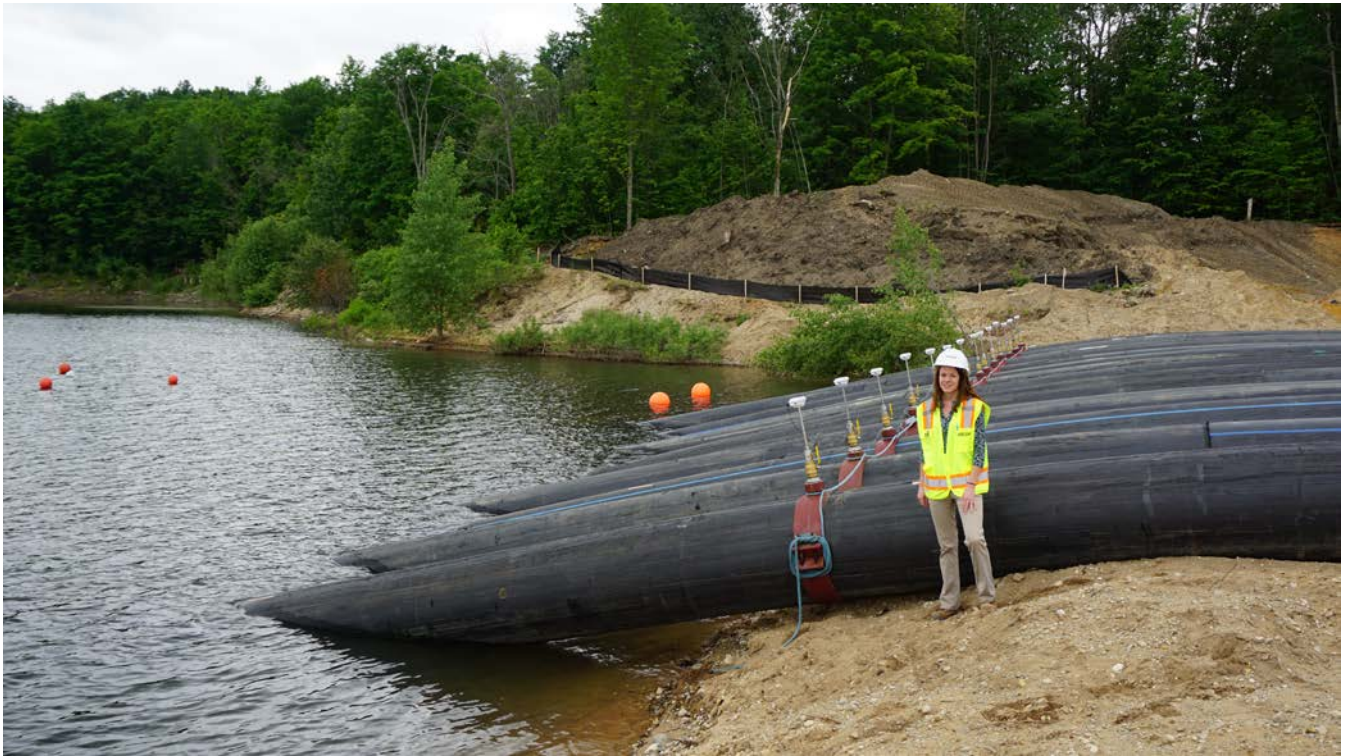
June 2017 – Siphons were primed and gravity fed; 14 siphons were individually operated 24 hours a day at varying capacity and amounts according to stream flow and rain events so that the impoundment was drawn down between 6"-12" per day.

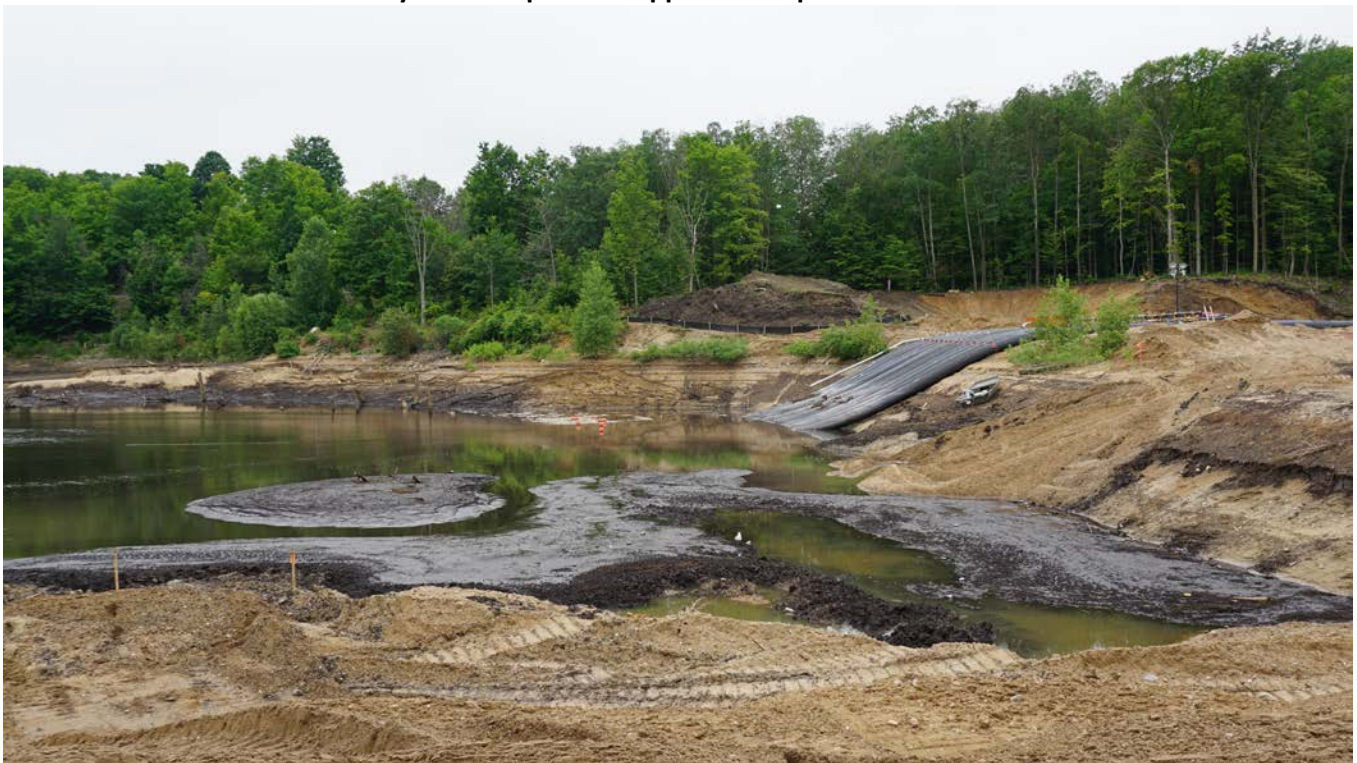
July 2017 – Siphons dropped the impoundment 21'.

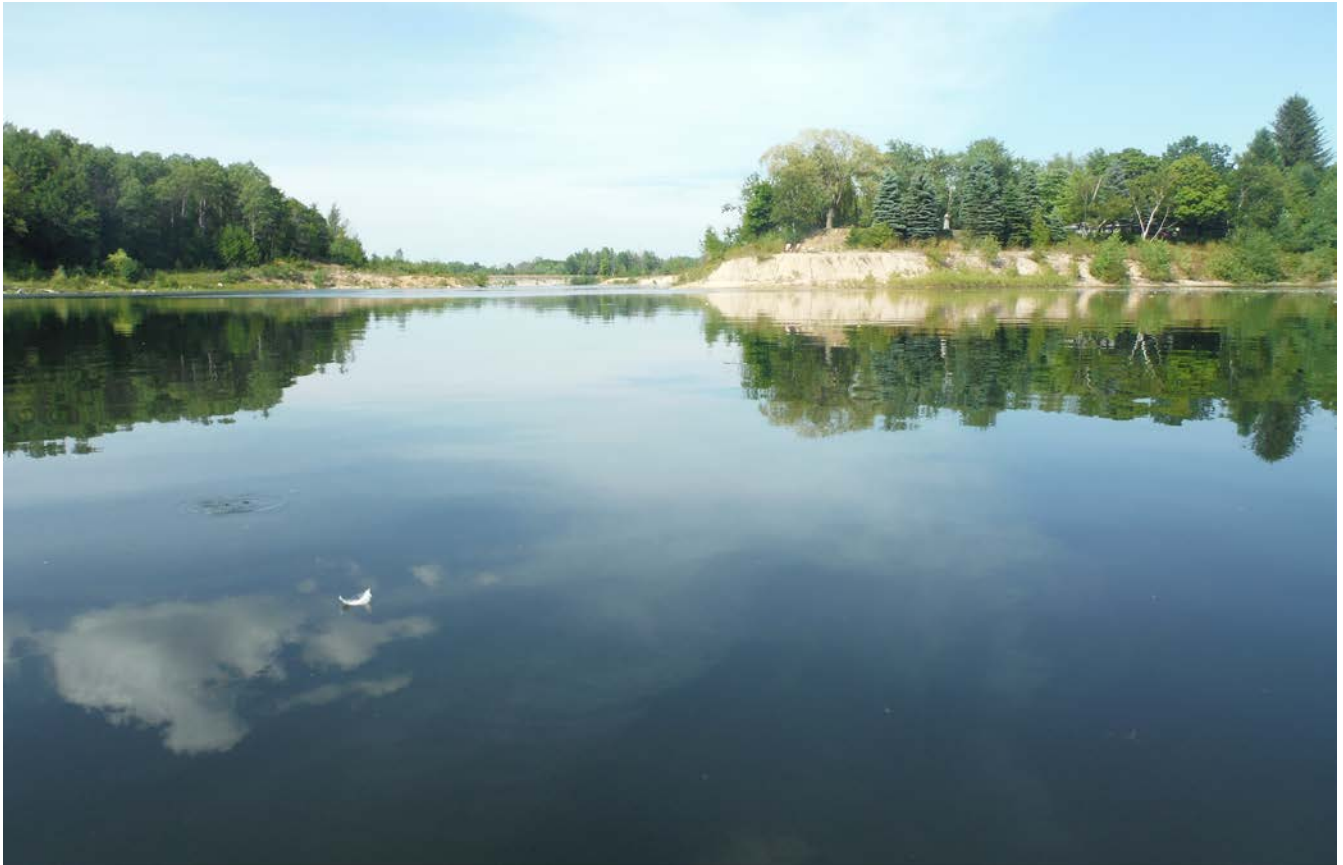
August 2015 – Boardman Pond used to be 104 acres until MDEQ required it be drawn down 16’ due to structural insufficiency of the spillway. Then the pond became 78 acres.

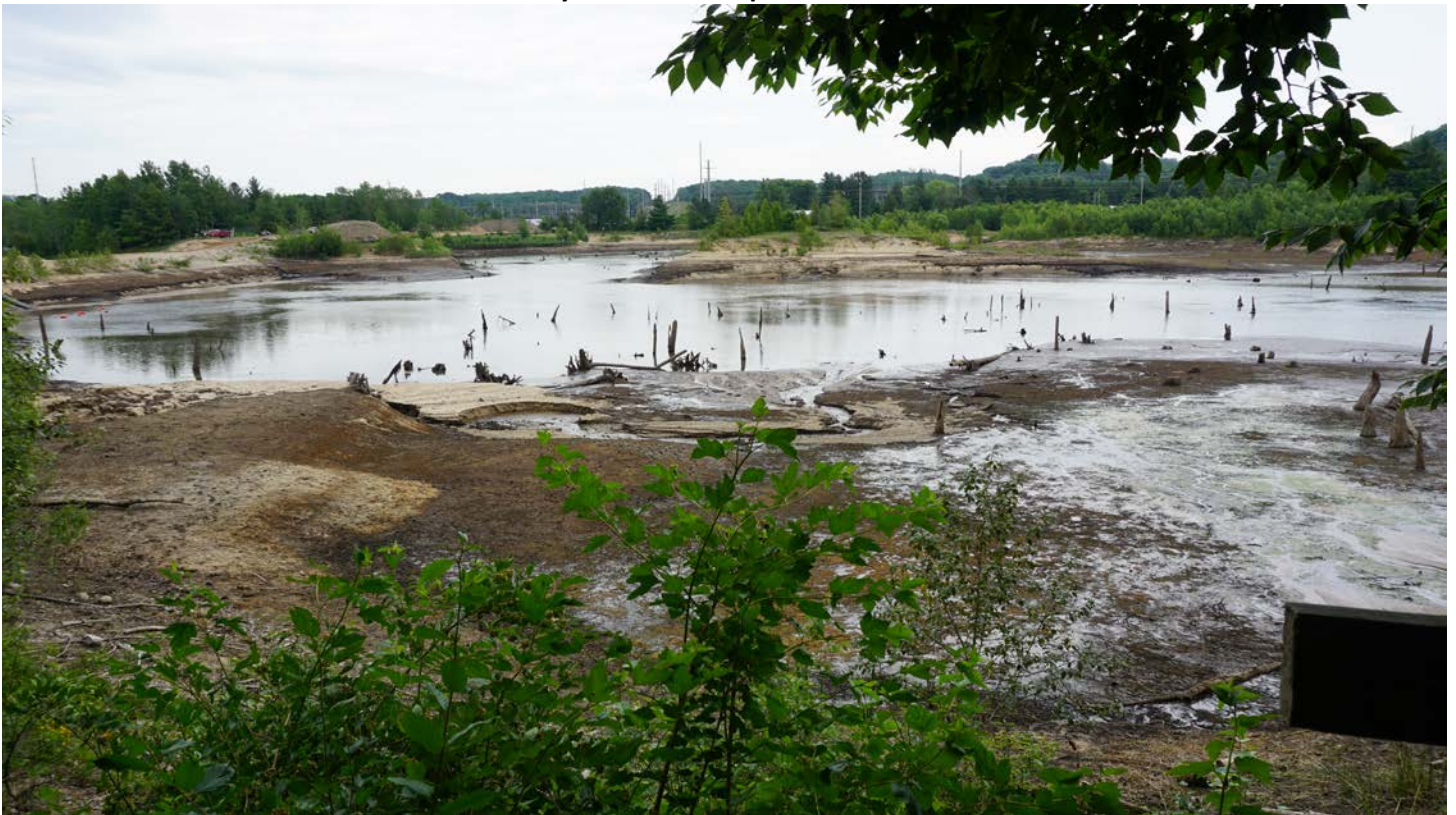
July 2017 – Drawdown efforts uncover the accumulated sand, muck & tree stumps that were concealed by the former impoundment.

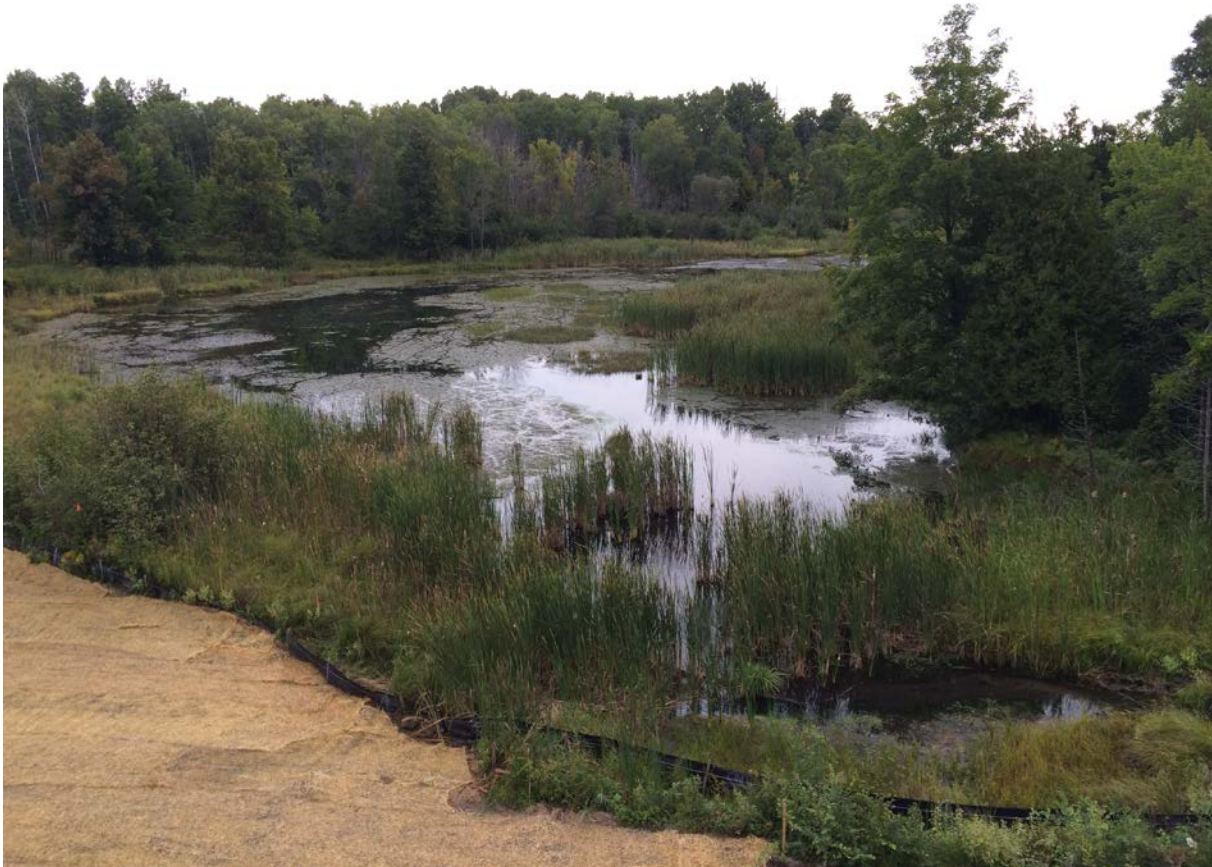
September 2016 – Downstream of the new Cass Road Bridge, this ponded area is a result of beavers damming the natural seeps from the original riverbed that have continued to flow in spite of both Boardman and Sabin Dams.

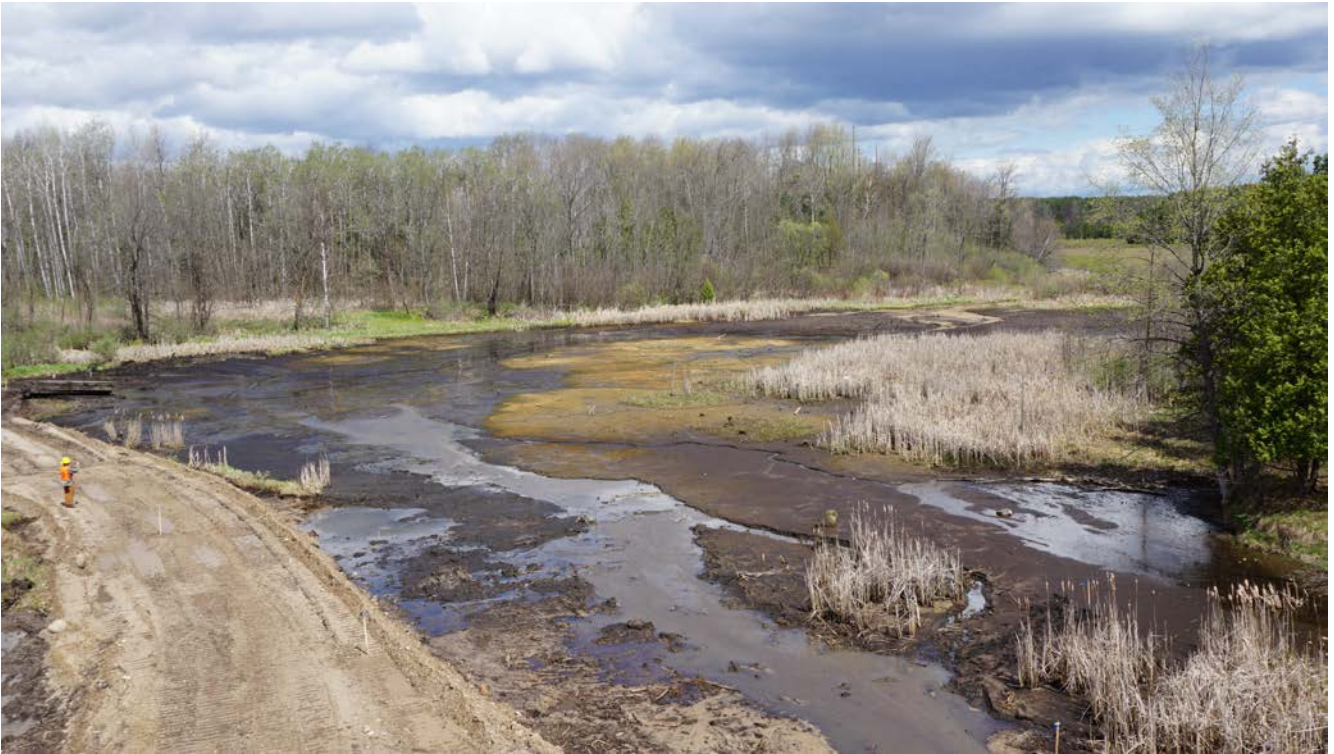
April 2017 – Getting ready to return the river; an access road is built on the left bank.

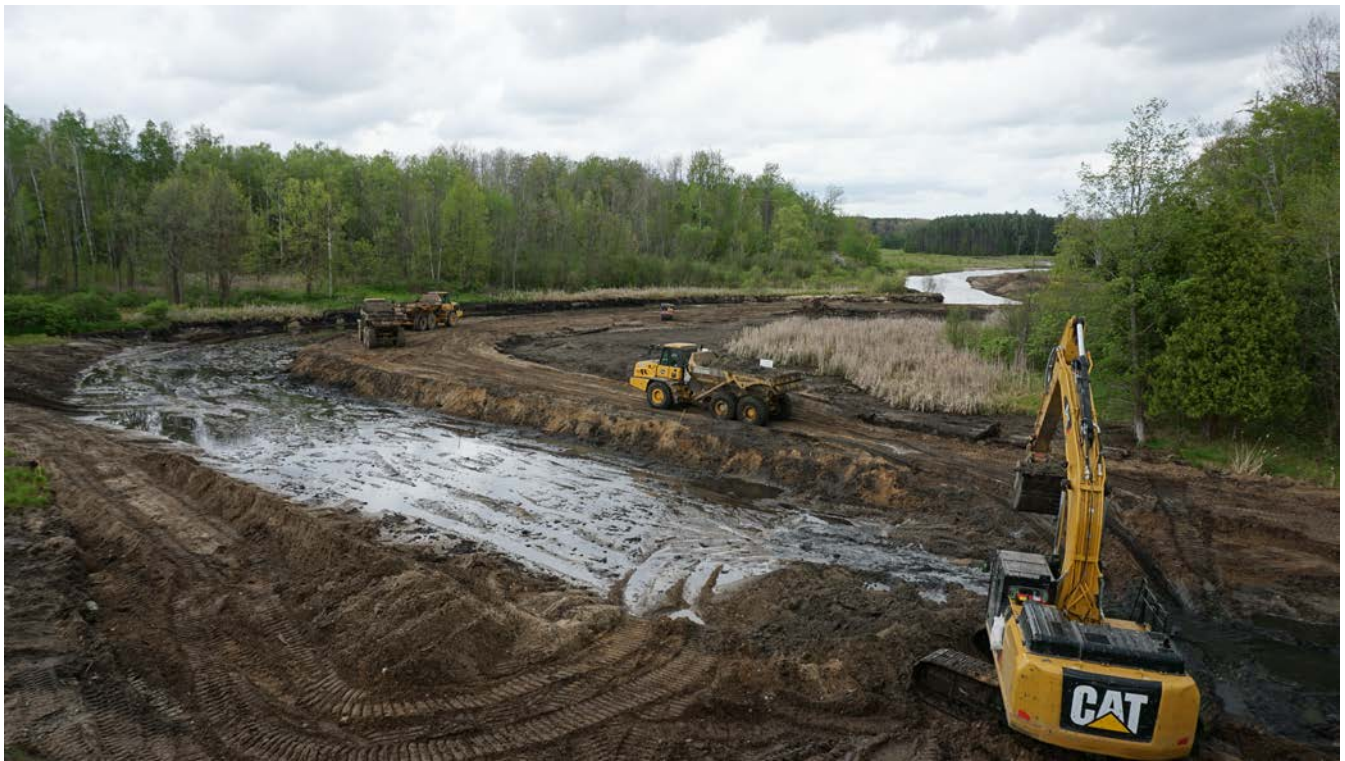
May 2017 – In the thick of it, earthwork to return what once was. A sediment trap & the Sabin Dam impoundment downstream will catch mobilized sediment.

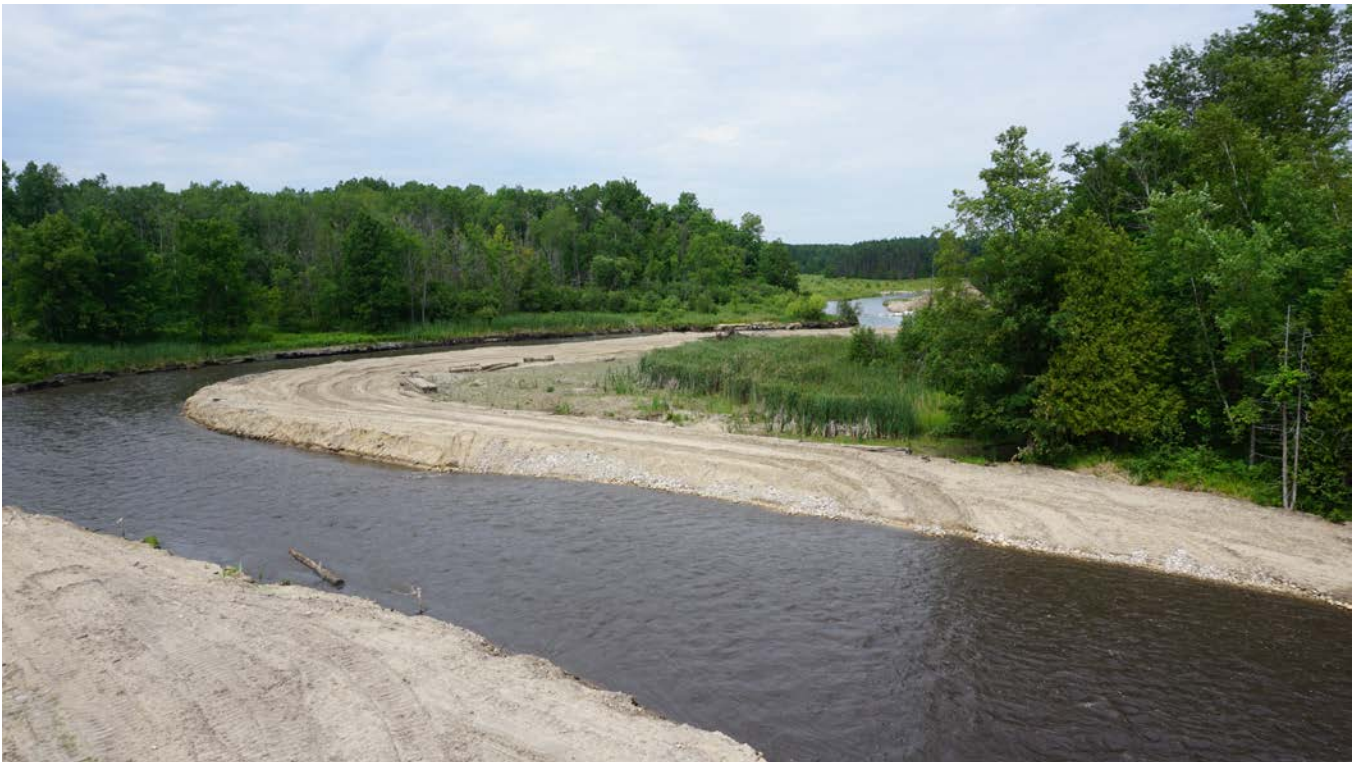
July 2017 – River channel returned and water will flow “cloudy” until the drawdown of the impoundment is complete.

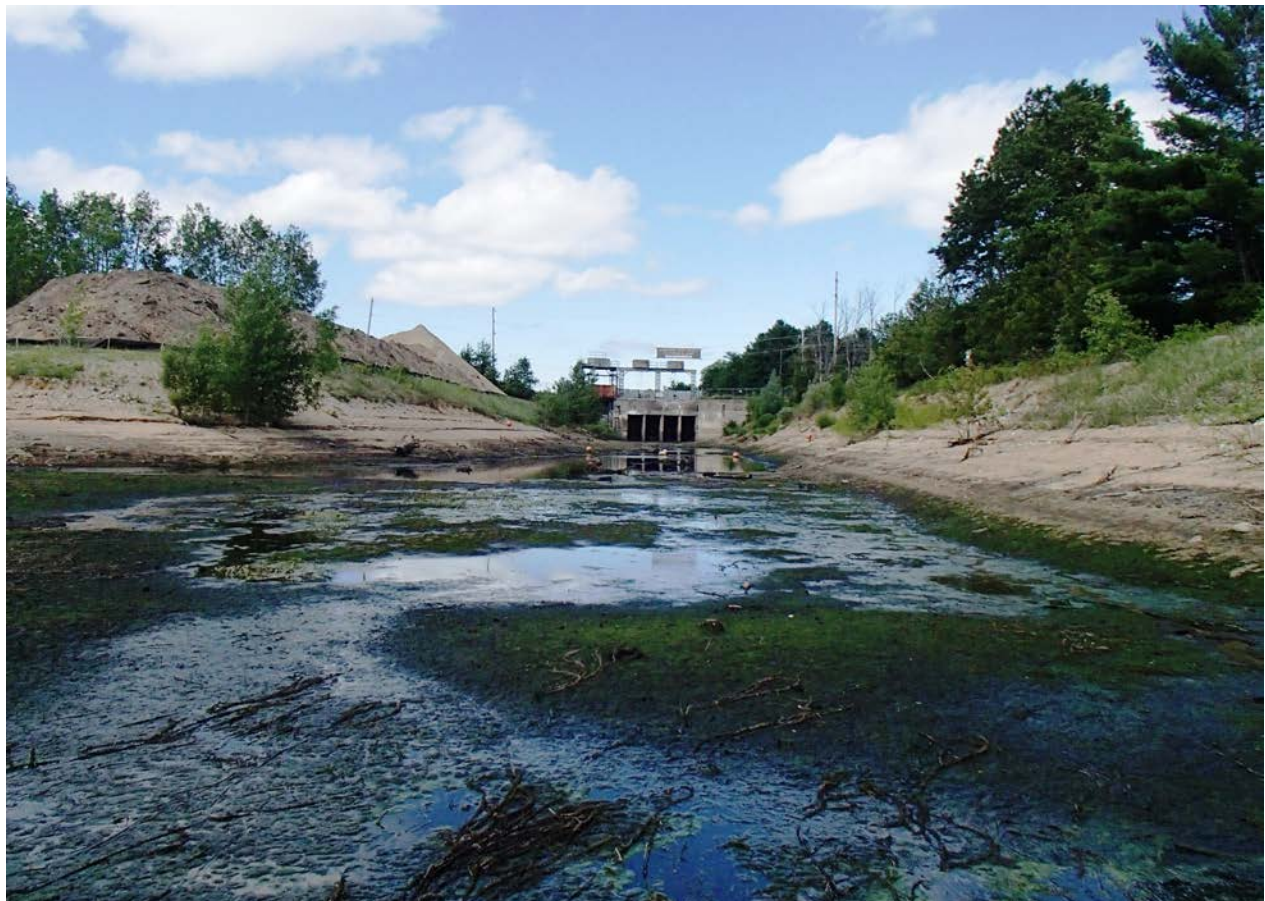
July 2017 – Looking upstream at the powerhouse and water control structure. This “intake” channel is now dry & no longer a maintenance headache to keep clear of fallen trees, branches and debris.

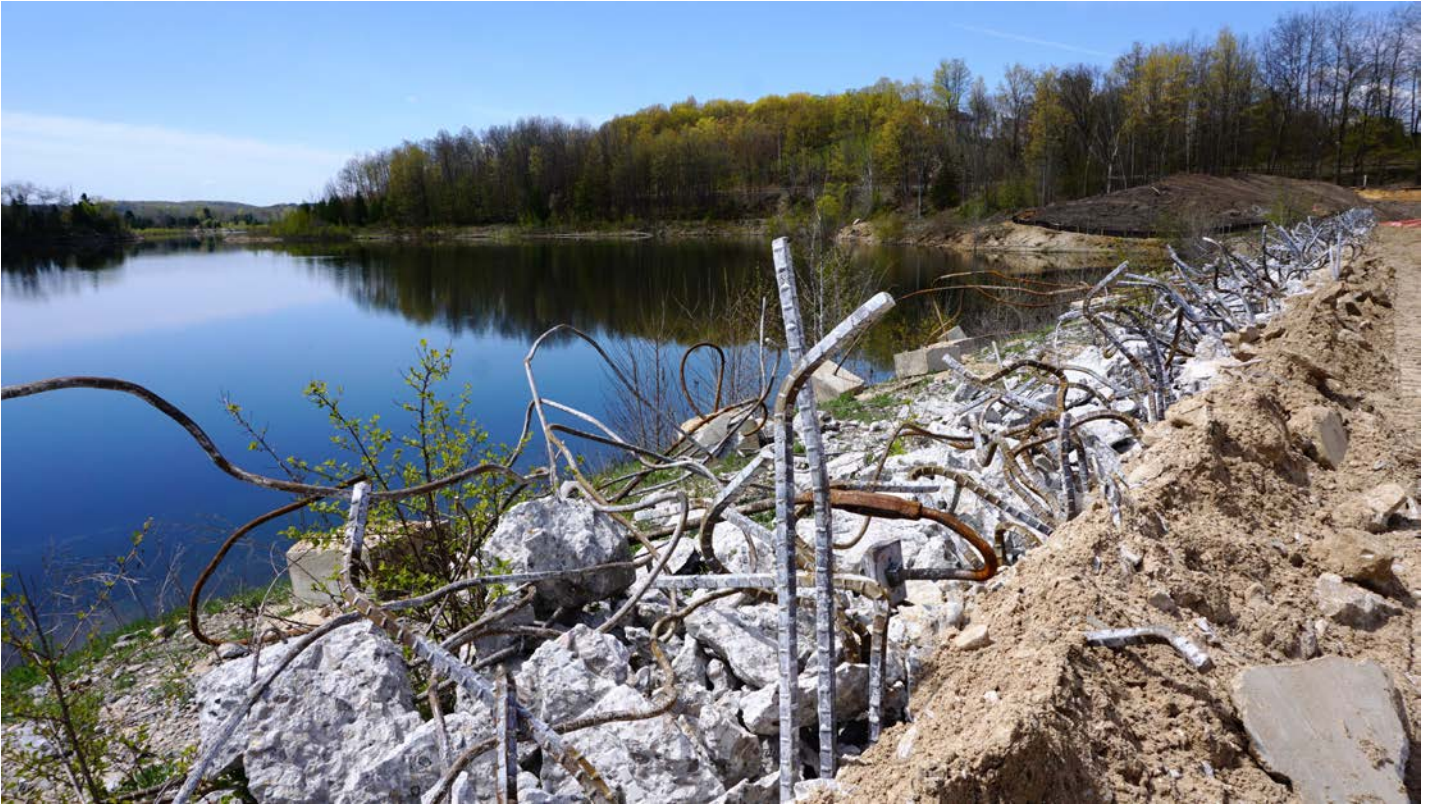
June 2017 – What’s a dam made of? Sand, clay, concrete & lots of rebar. This dam was 650’ long & “detached” from the powerhouse located 400’ to the east. The concrete wall was 15” thick & 33’ high.

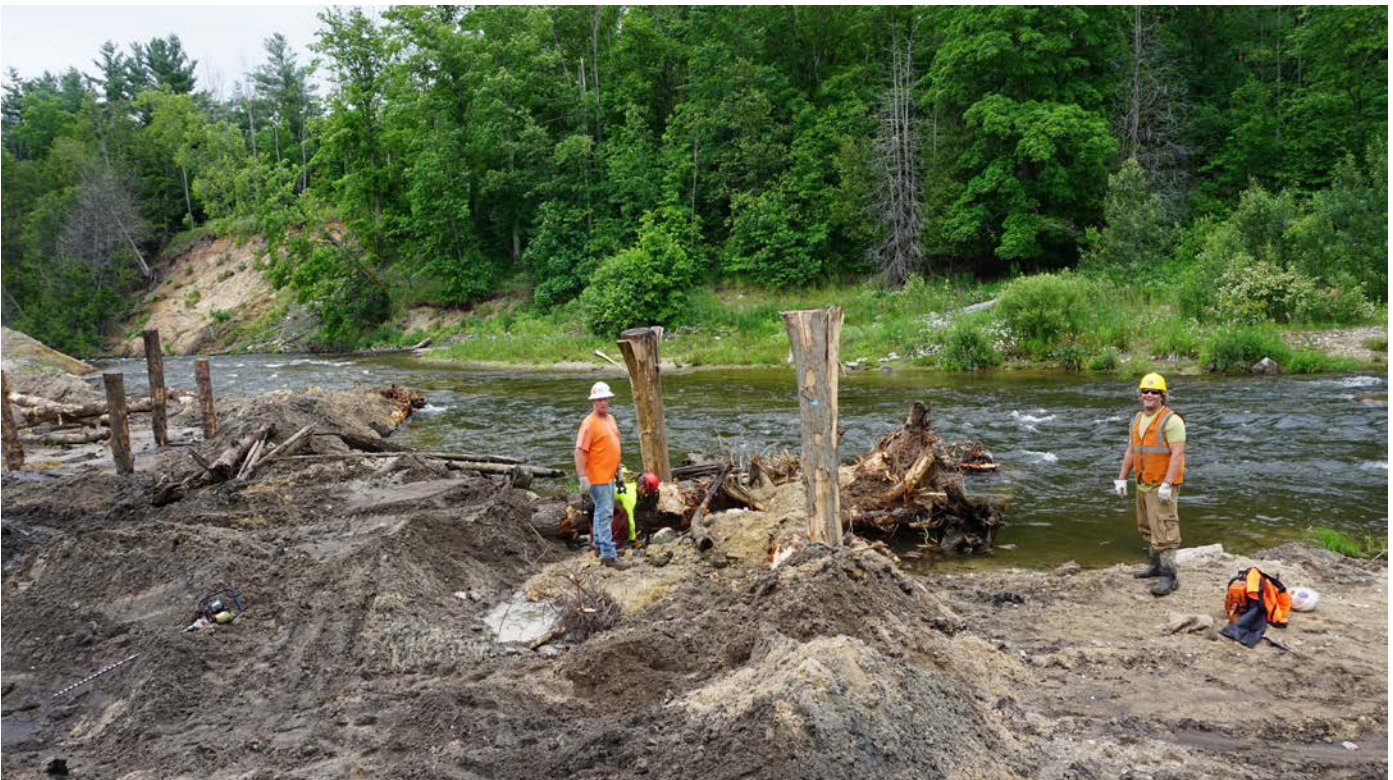
June 2017 – Happy workers installing “toe wood.” Healthy rivers have log jams; excellent places for fish, otter, mink, turtles, frogs and aquatic insects to live and hide.

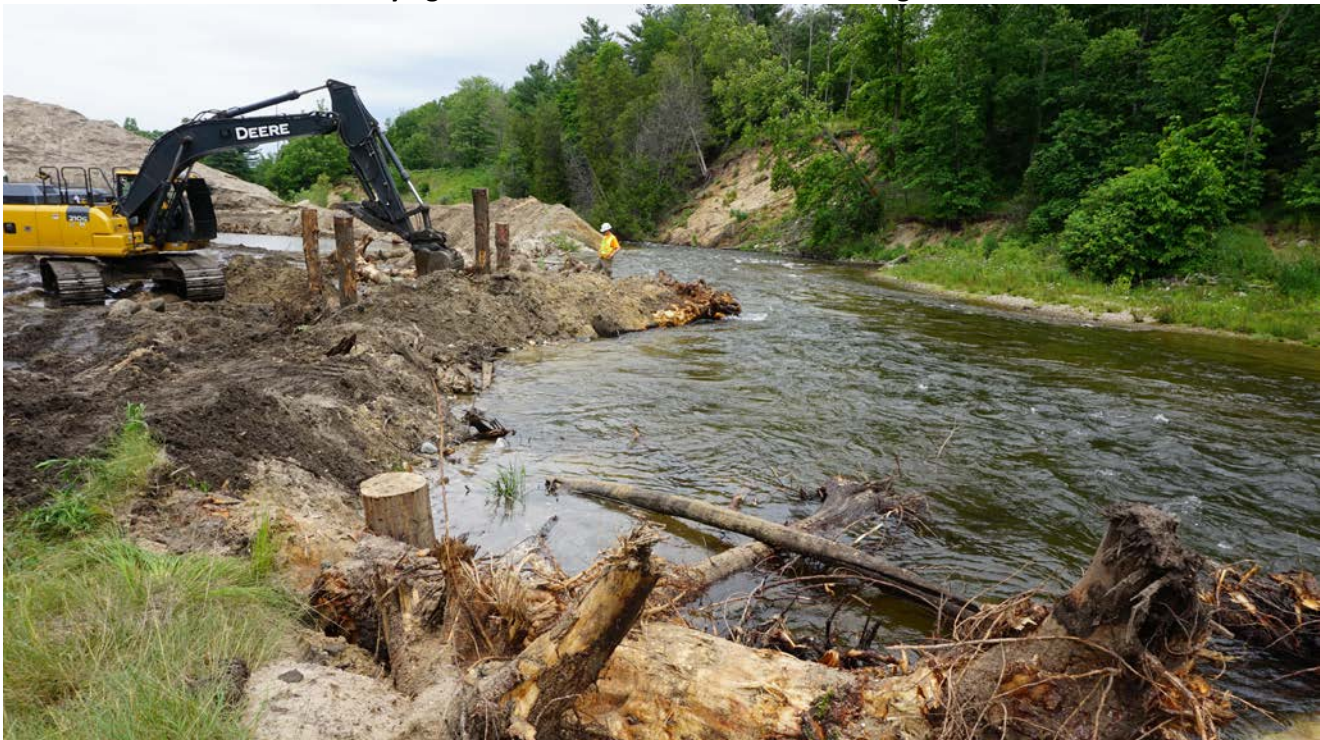
June 2017 – Burying rootwads in streambanks & anchoring with more wood.
