Boardman River Dam Removal, River Restoration & Cass Bridge - Project Photos

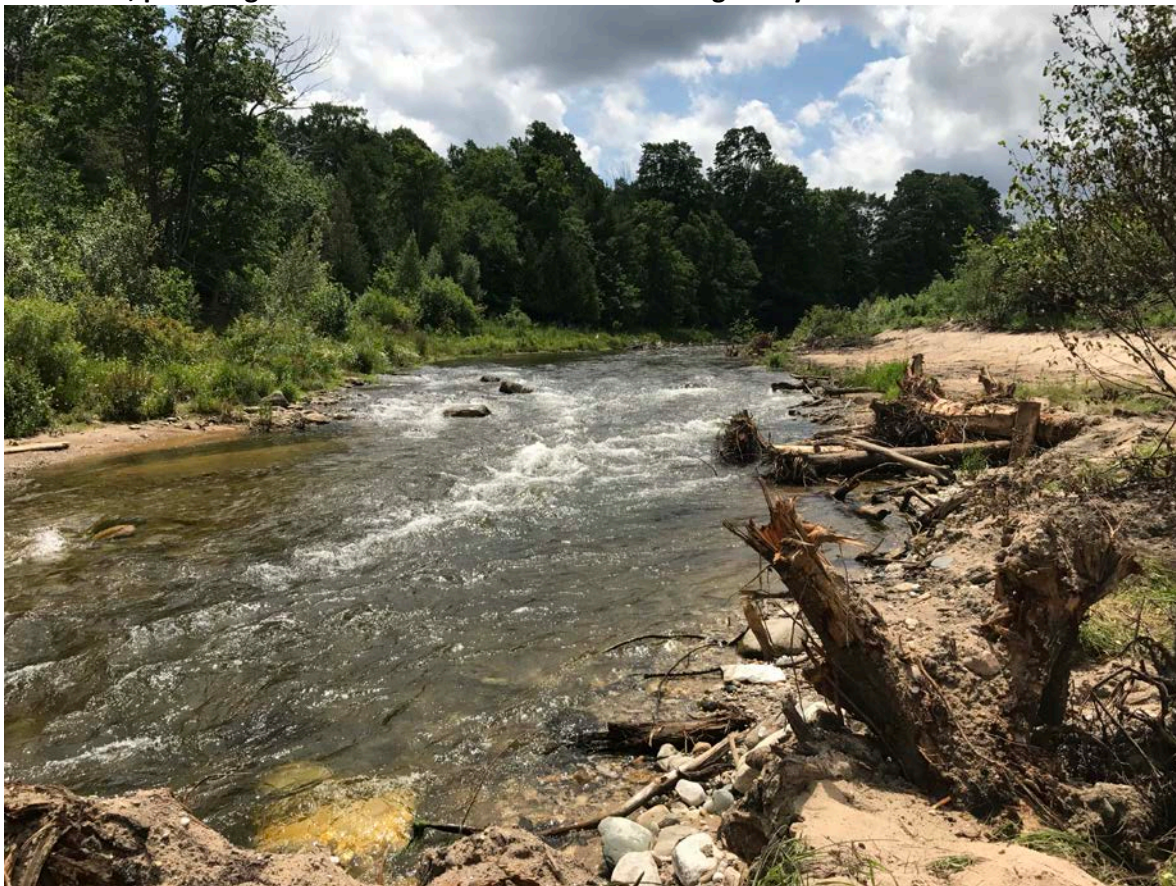
July 2017 – Completed “wood work.” Anchored wood looks natural & what critter wouldn’t want to live there? Note how the most rapid river flow is directed towards the middle of the channel & there is sufficient floodplain on either side, providing room for “extra” water to flow during heavy rain & snowmelt events.

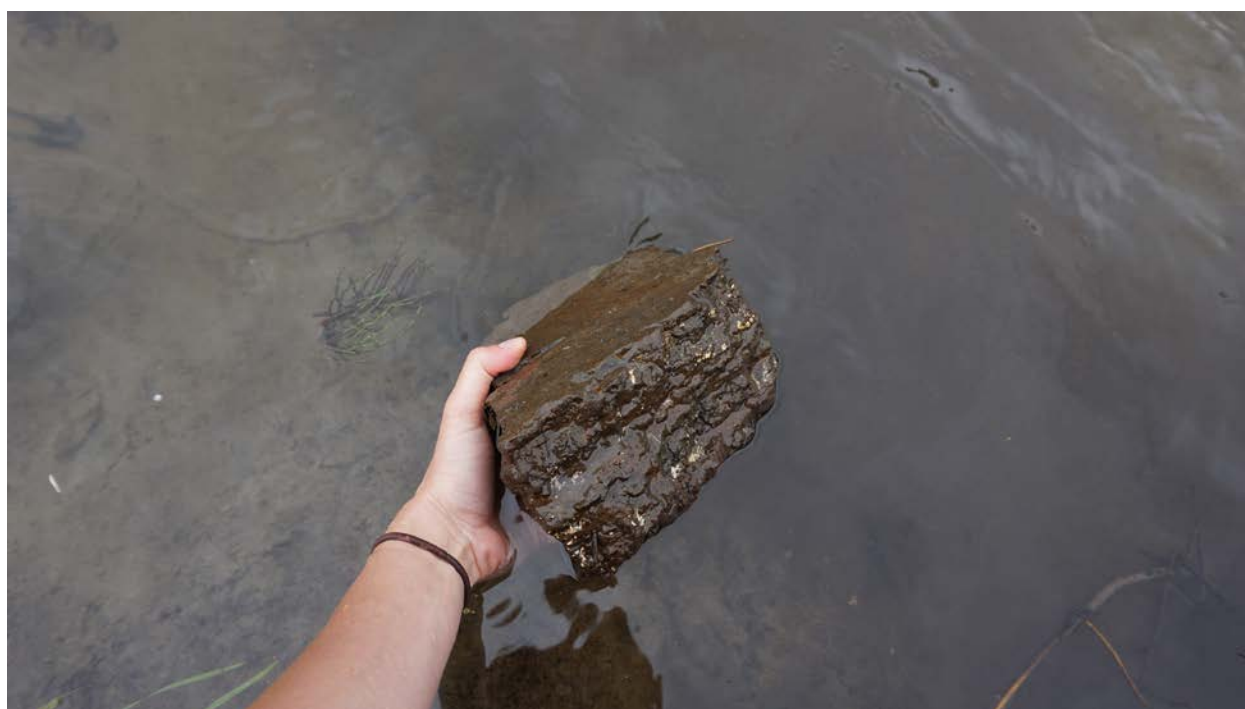
June 2017 – Rivers move a lot of things including sediment. Dams disrupt that natural movement & sediment builds up, creating underwater shelves of muck & sand over time. One day, equipment got stuck in 13’ of muck.

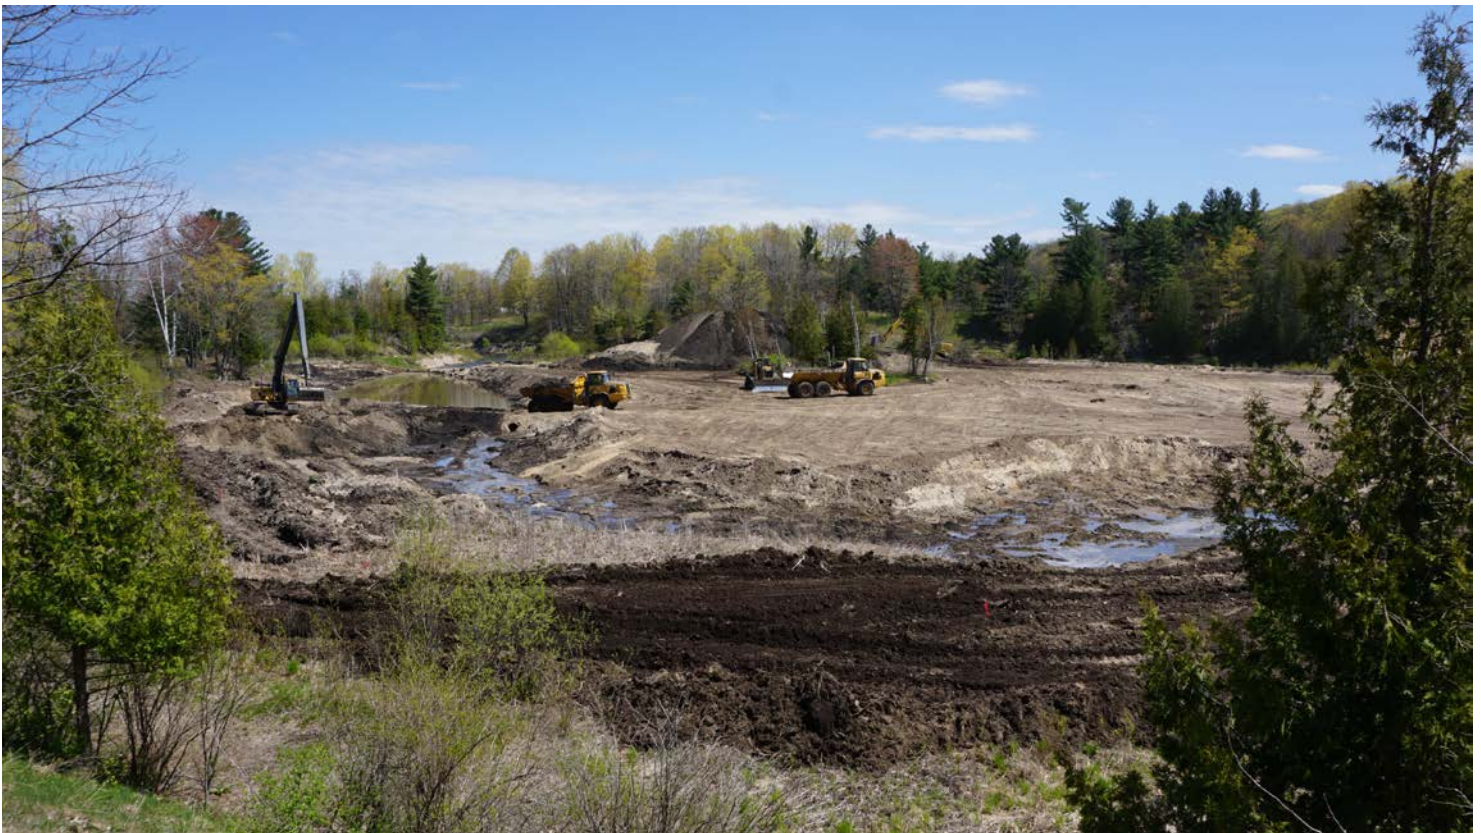
April 2017 – “Before” shot of the first river bend to be returned. A shell game of moving sediment & water. An estimated 285,000 cubic yards of sediment is being managed during this dam removal.

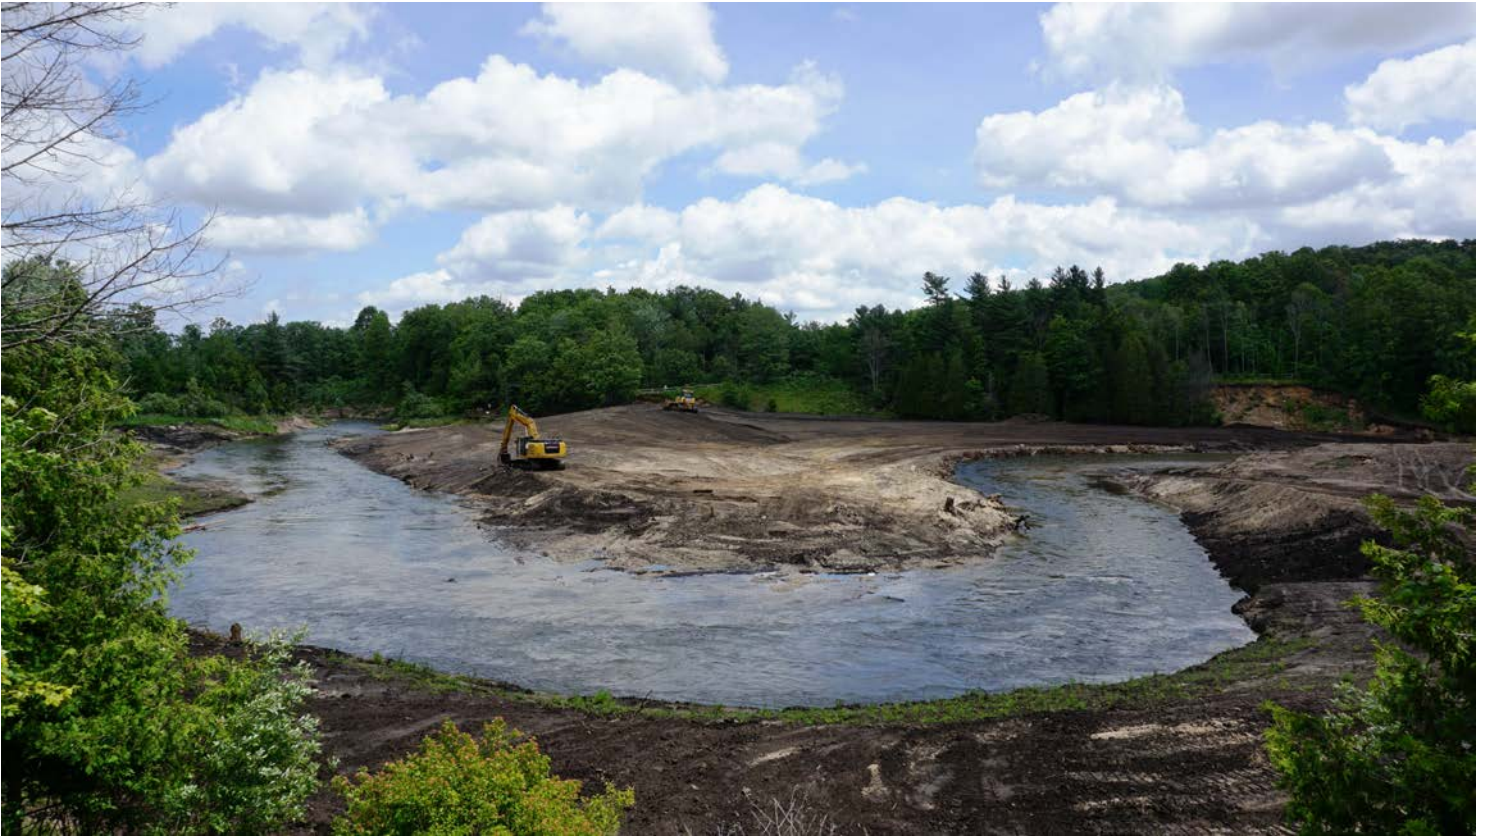
July 2017 – Looking good at the same river bend, with more to come...

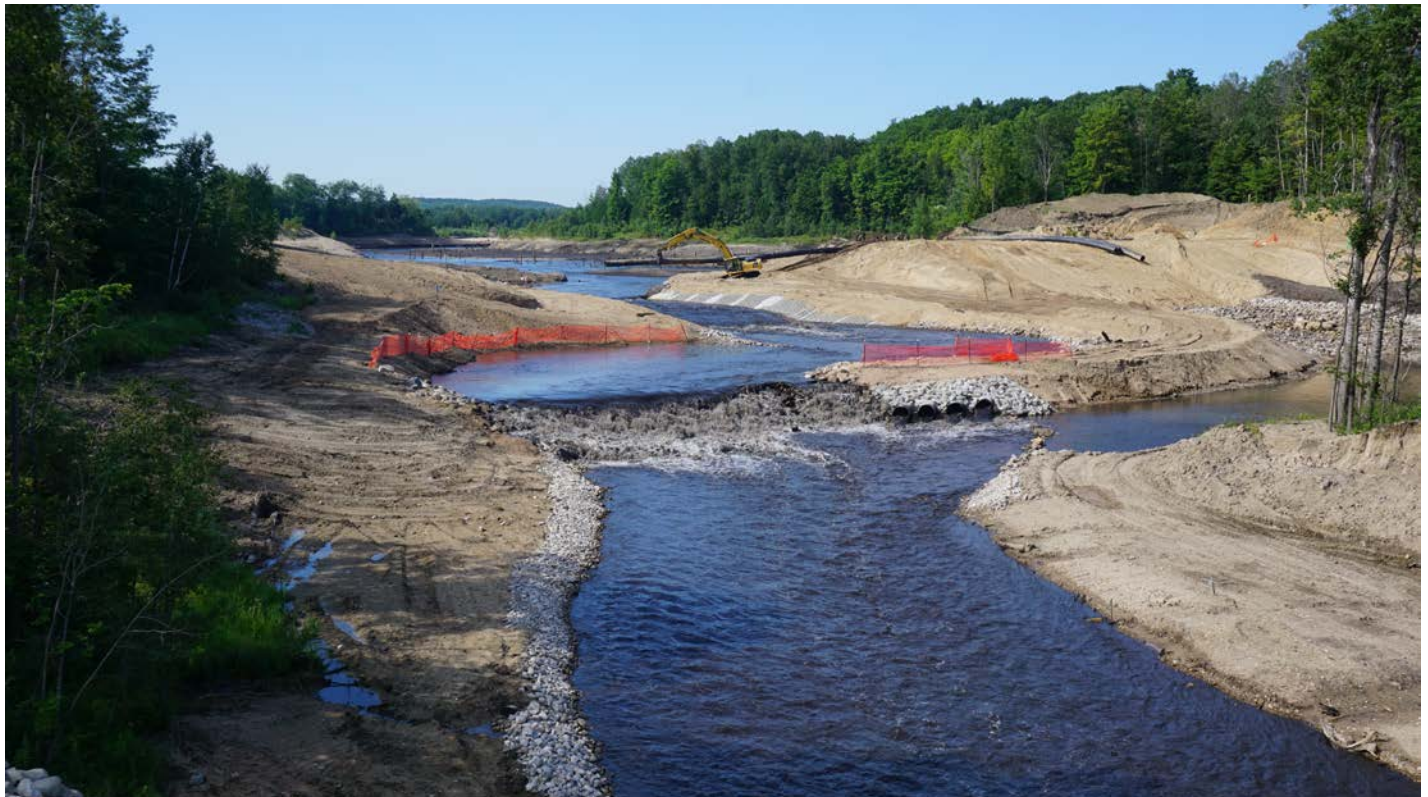
July 2017 – Auxiliary channel functioning with 8' of dam height left to be removed. Note excavator hauling sections of the siphons back across the water to be removed from the project site.

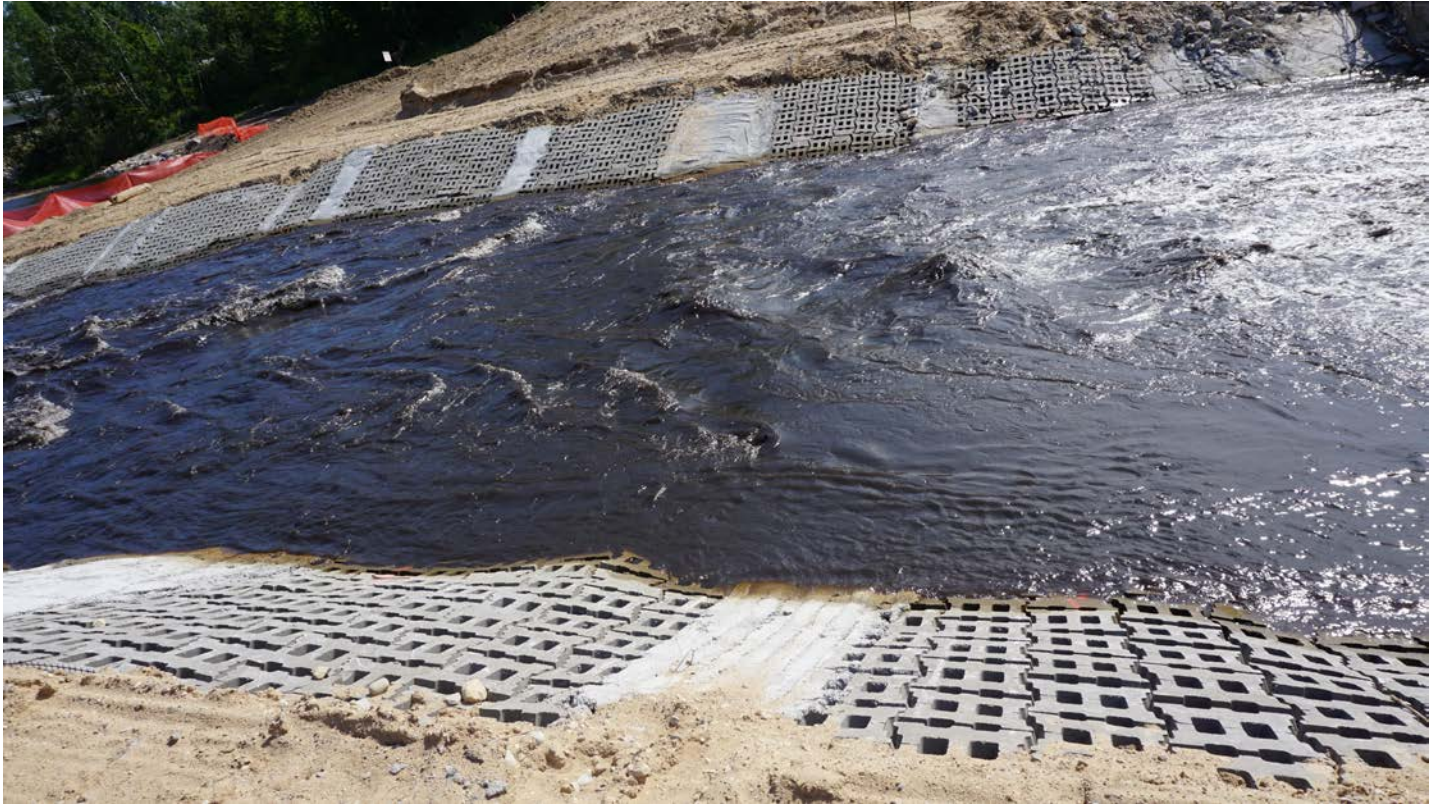
July 2017 - Auxiliary channel is 40' wide, 70' long & comprised of drainage stone covered with mesh geotextile, overlaid with articulated concrete block mats grouted in between to ensure water doesn't undermine the channel.

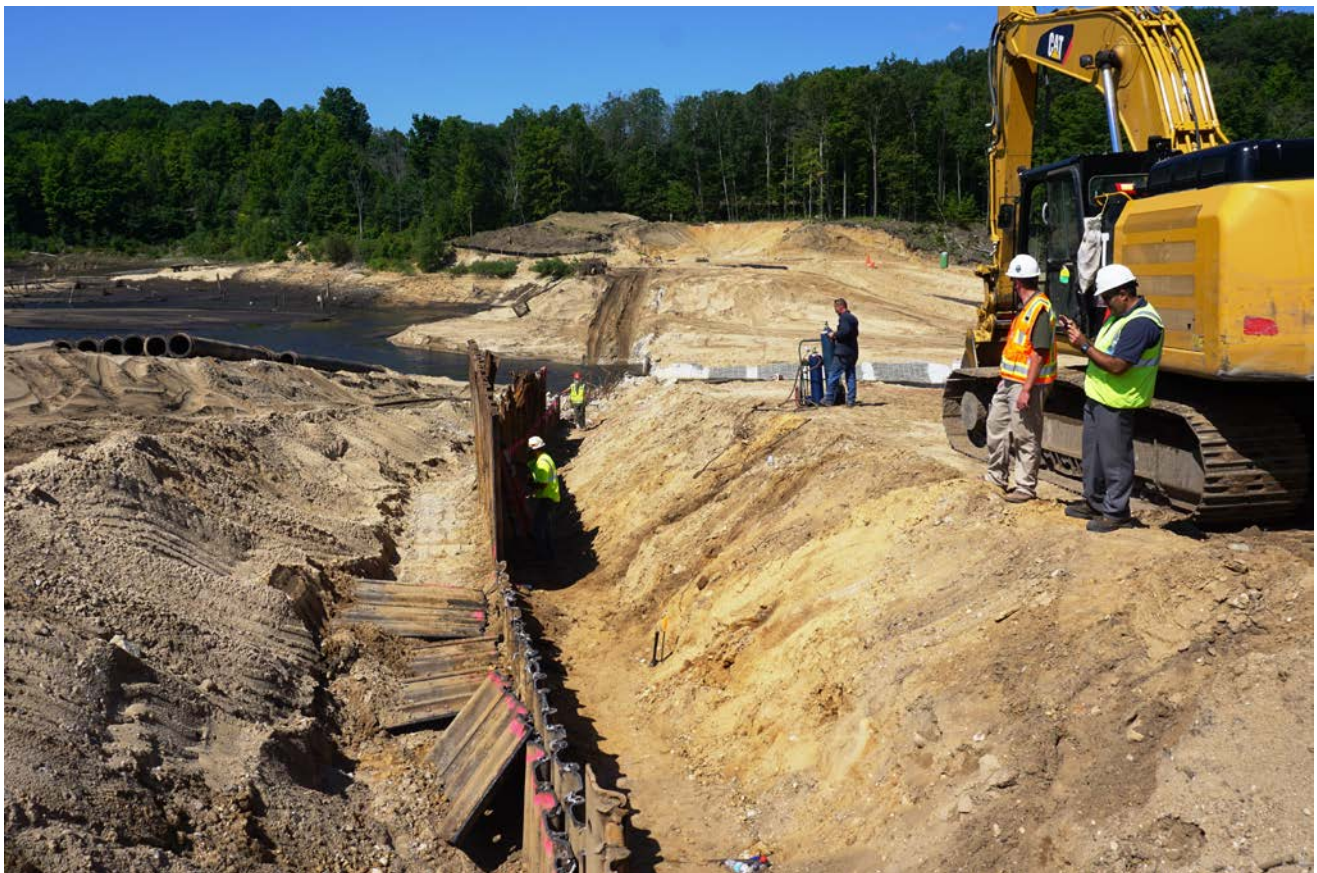
July 2017 - Cutting apart the sheet pile that was underneath part of the concrete wall in the dam embankment.

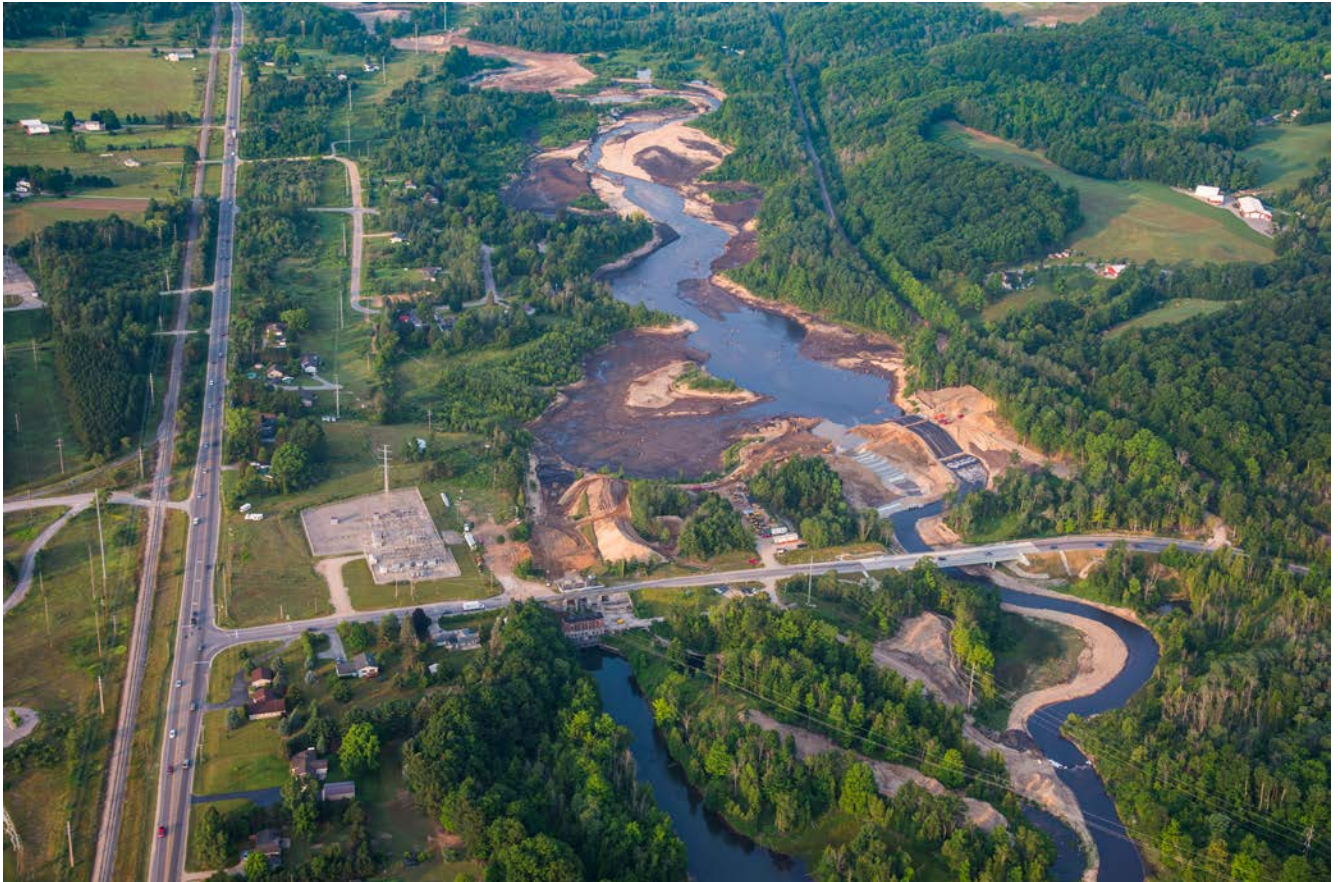
July 2017 – Boardman pond being drawn down with water flowing through siphons & not through the powerhouse.

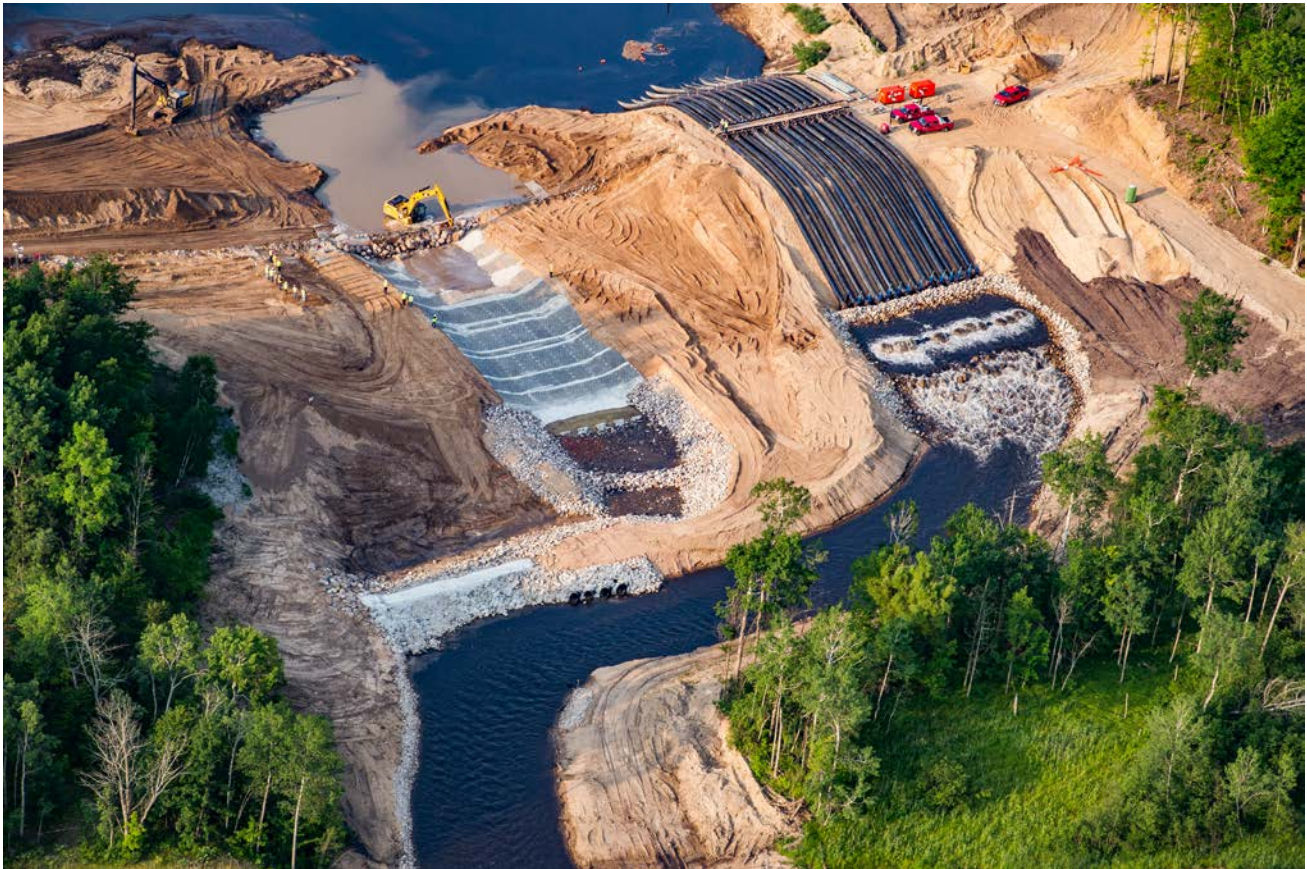
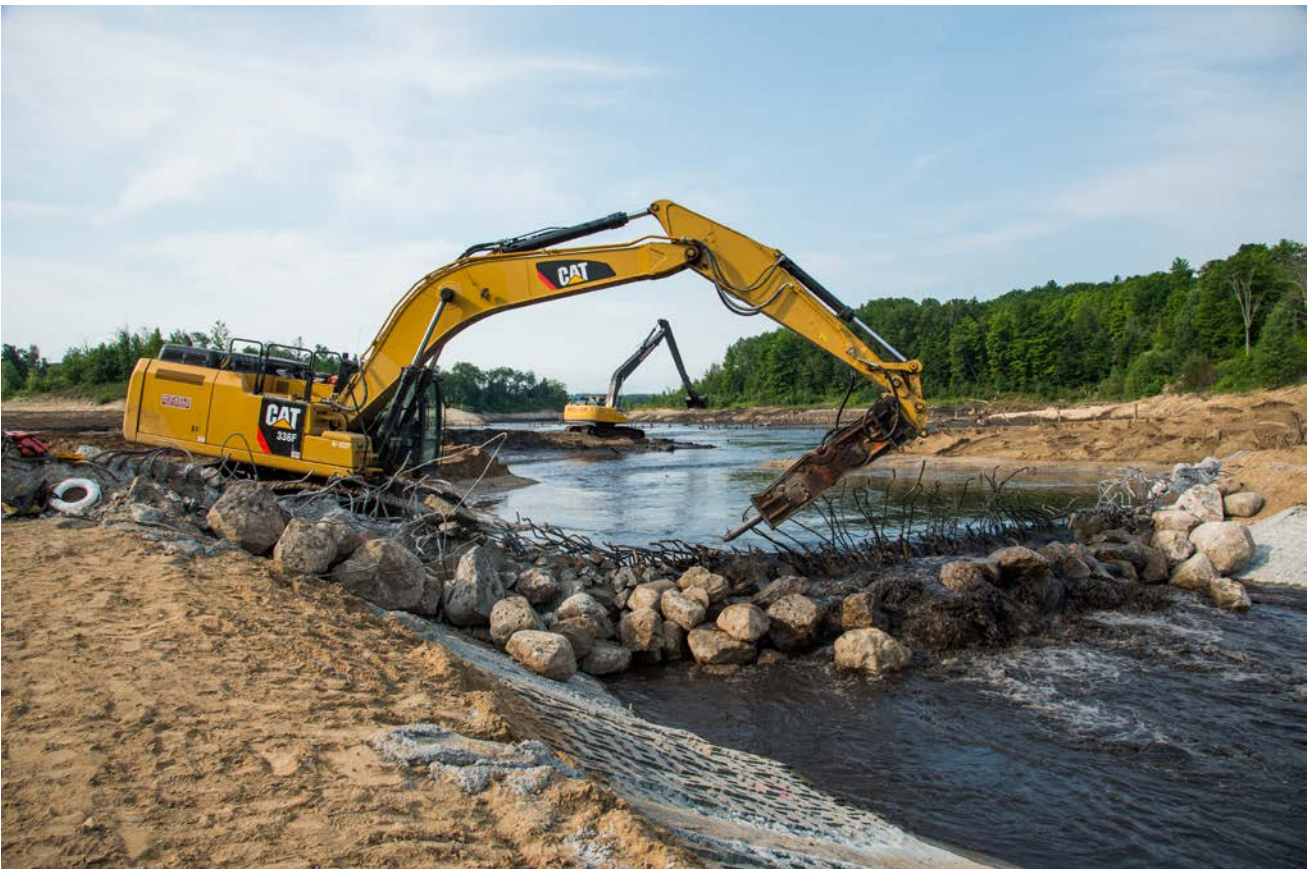
July 21, 2017 – The big day. Breaking apart more of the dam to allow water into the auxiliary spillway (on the left) where the remaining pond water will drain while the siphon tubes (on the right) are removed & the final river channel is excavated in their place. This overall endeavor will return the river to its historic channel.

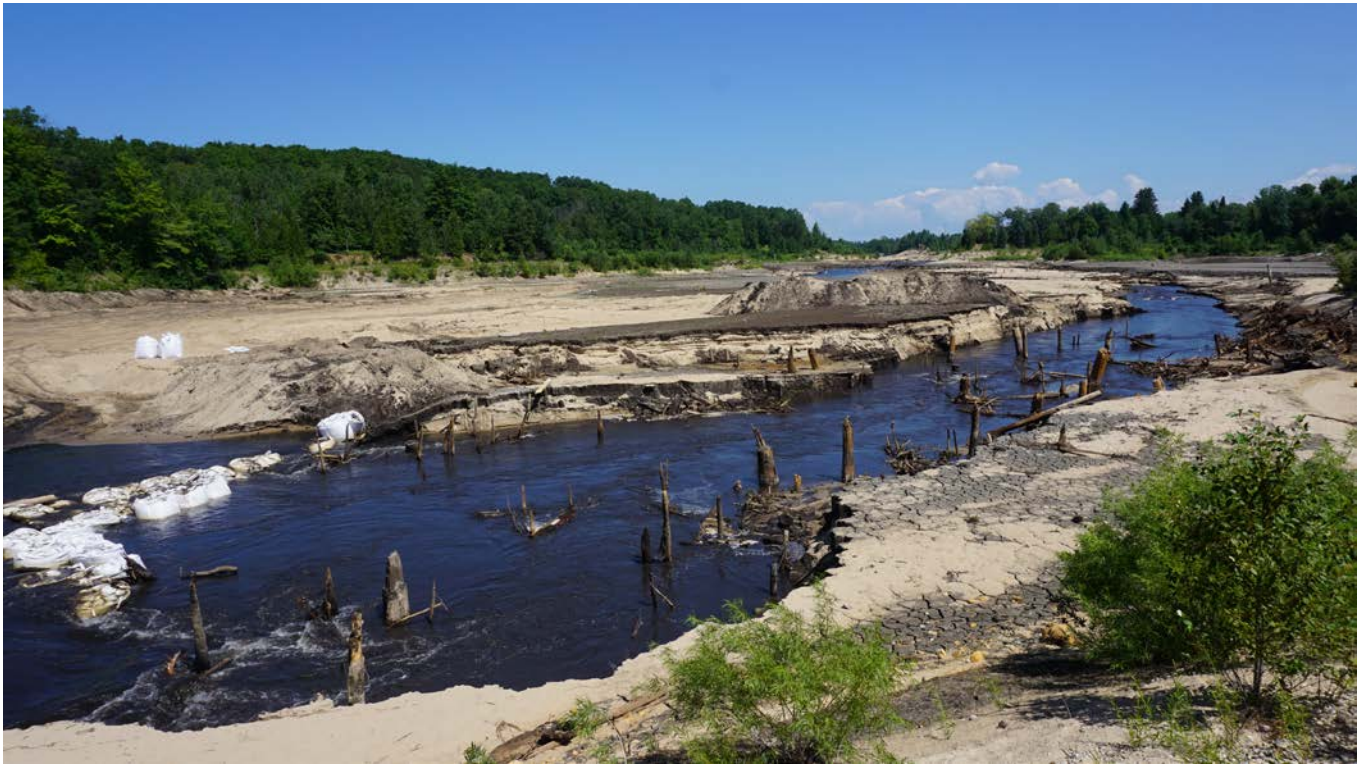
July 2017 - Water flowing through the “sediment wedge” in the former pond takes the path of least resistance in an area once forested, with tree stumps & trunks as evidence. Large, heavy white “sand” bags slow down the movement of water & sediment giving excavators time to recreate the river channel & floodplain upstream.
