FINAL NARRATIVE REPORT
North Branch White River at 176th Avenue
Oceana County, Michigan

Background/Overview

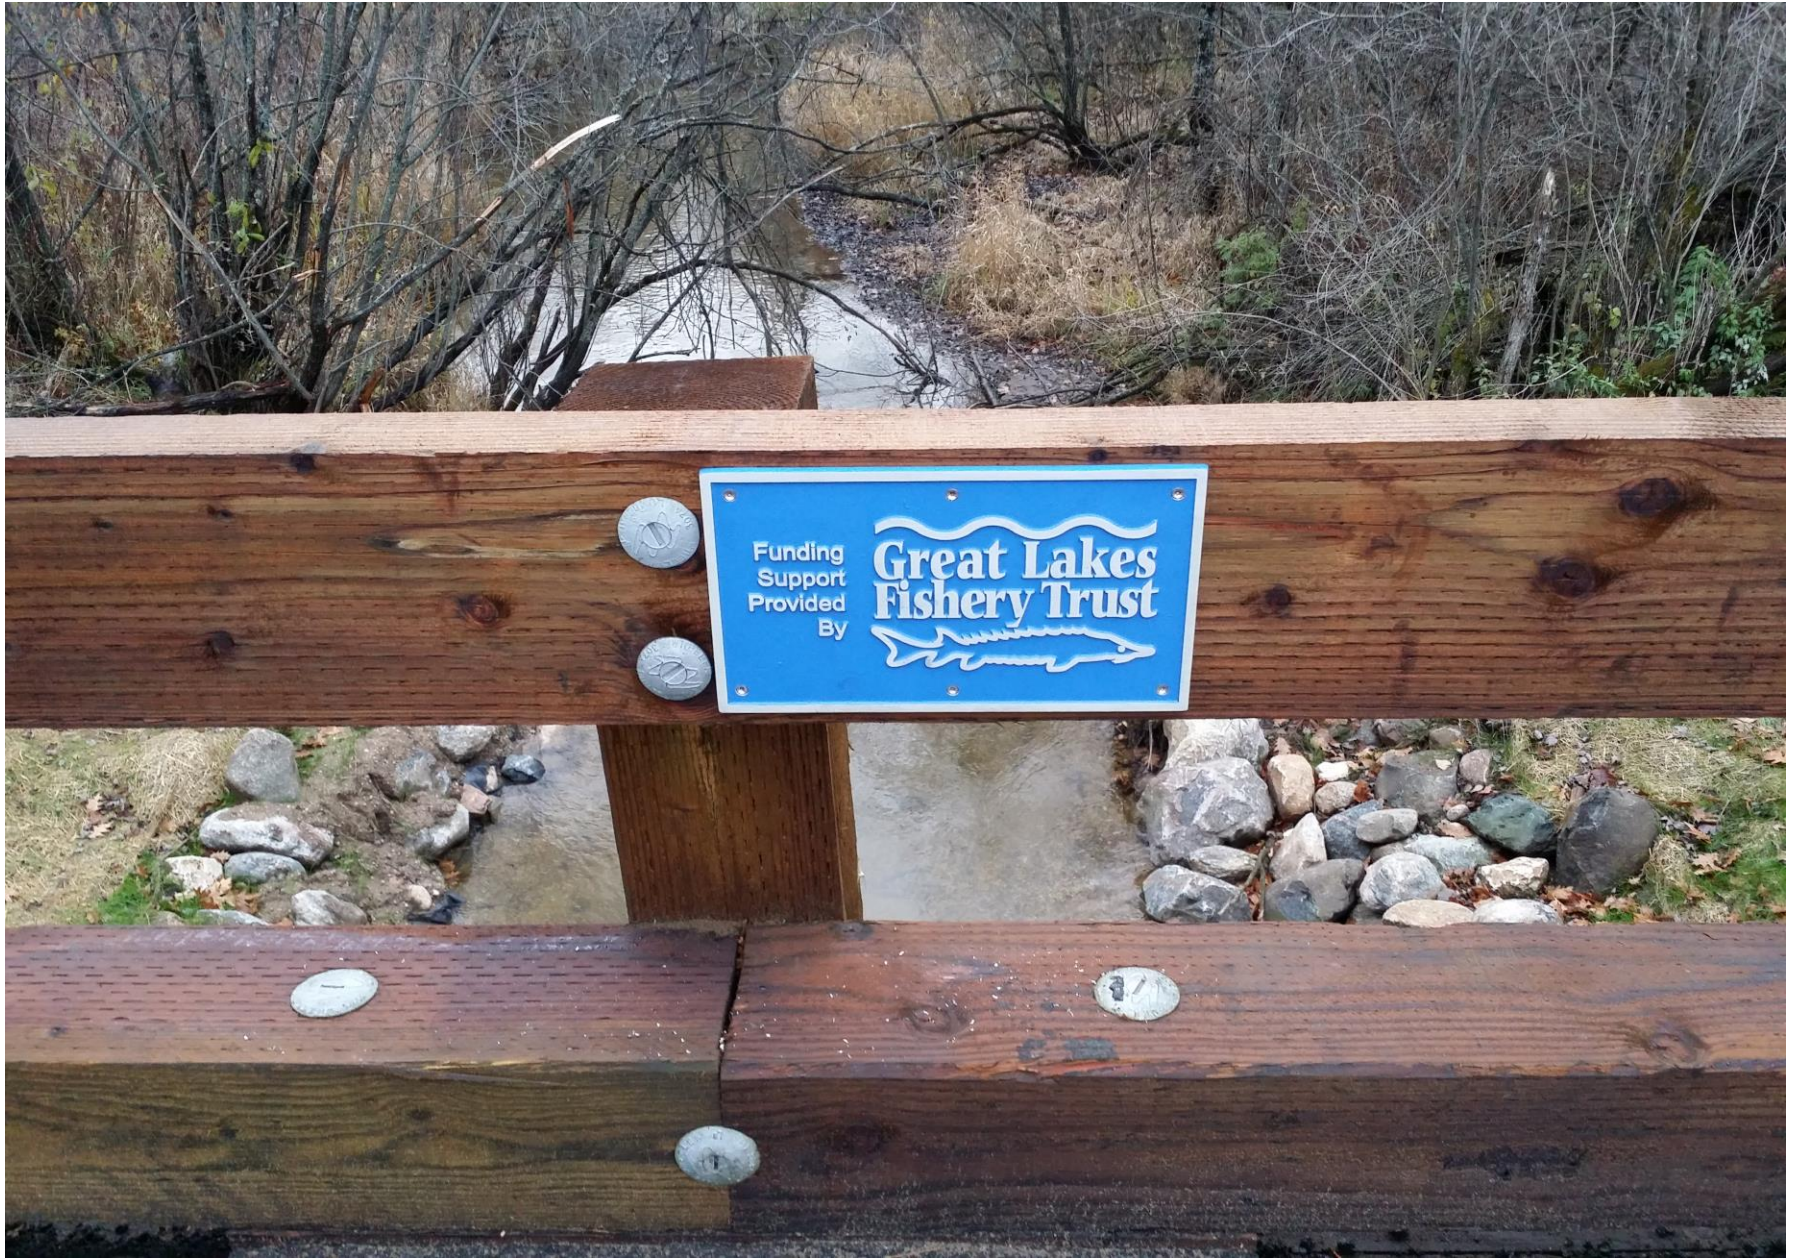
- 1. Provide at least three (3) photos of the completed project.
- 2. The Great Lakes Fishery Trust requires each project it funds to have suitable permanent public acknowledgement of GLFT assistance. The GLFT has provided this sign to you and requires photo verification of the posting of the sign before it will process your final reimbursement request. The plaque was installed on November 12, 2015.
